PRE-LISTING HOME INSPECTION REPORT

108 Brownridge Dr, Vaughan, Ontario

Report Number : 21050252

Inspection Date: 2021-05-13

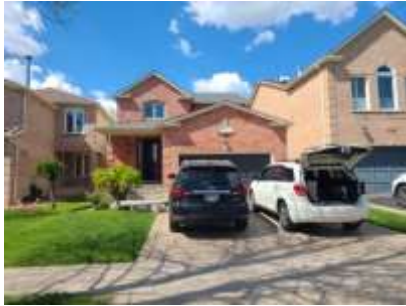
Pic. 1: Front view

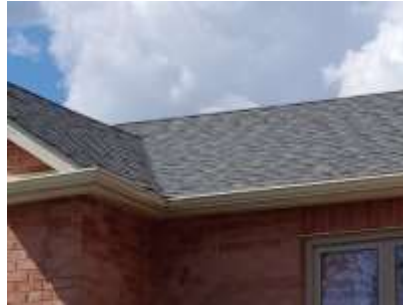
Roof covering appeared in overall satisfactory condition at the time of the inspection.

Pic. 2: Updated roof covering

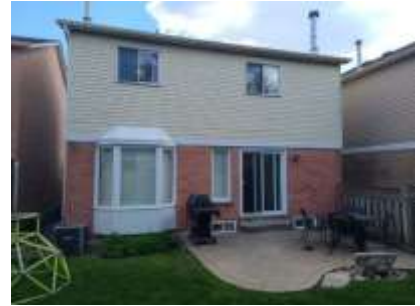
Pic. 3: Back view

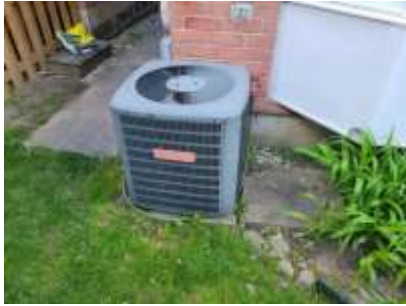
Pic. 4: AC unit 2009

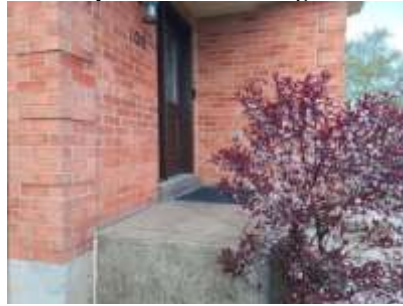
Pic. 5: Railing advised for front porch

Fencing is not part of a home inspection. General site drainage was properly sloping away from the house. Maintain a positive drainage slope away from the foundation. Railing advised for front porch for safety.

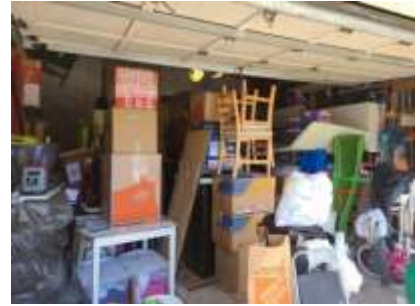
Pic. 6: Garage

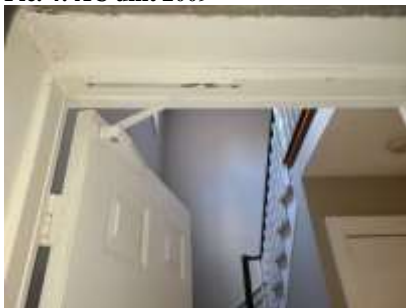
Pic. 7: Garage entry door auto closer weak, does not close door on its own

Doors were reviewed and found to be in working order. Lights appeared to be in normal condition: not all lights were tested. Exterior outlets tested were in normal working order. Garage door auto closer is very weak and does not close the door, adjust for replace accordingly.

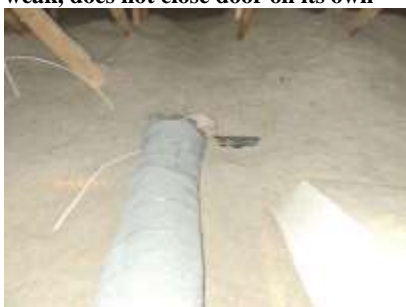
Pic. 10: Master bathroom exhaust fan venting directly not the attic

Trusses showed no major defects or damage at the time of inspection. Roof sheathing, examined from the attic, showed no major defects or moisture damage. Insulation was sufficient for homes in this area. Ventilation was normal. Vapour barrier not visible. Master bathroom exhaust fan is venting directly into the attic and should be vented to the exterior of the home, correct accordingly.

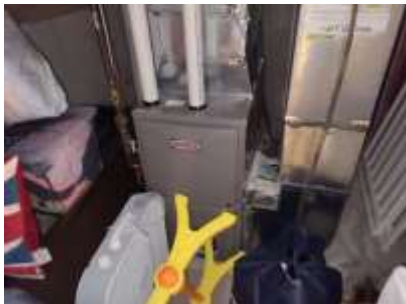
Pic. 28: New gas furnace 2020

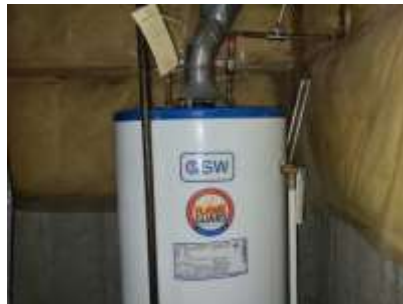
Pic. 29: Rental hot water tank 2009

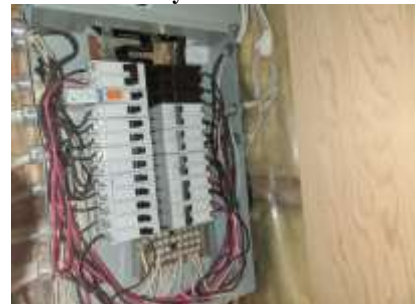
Panel size appeared to be compatible to service size. Branch breaker distribution appeared normal. No signs of overheating were evident at the time of the inspection. Outlets were randomly tested and had correct polarity, except as noted.

Pic. 30: 100 amp breaker panel with all copper wire
