PRE-LISTING HOME INSPECTION REPORT

109 McKenzie Way, Bradford, Ontario

Report Number : 21050244

Inspection Date: 2021-05-10

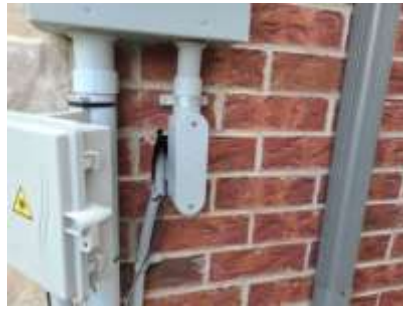
Pic. 2: Gap around main power line should be sealed

Panel size appeared to be compatible to service size. Branch breaker distribution appeared normal. No signs of overheating were evident at the time of the inspection. Outlets were randomly tested and had correct polarity, except as noted. There is a gap in the brick around the main power feed wires from the exterior of the home, recommend sealing this gap accordingly.

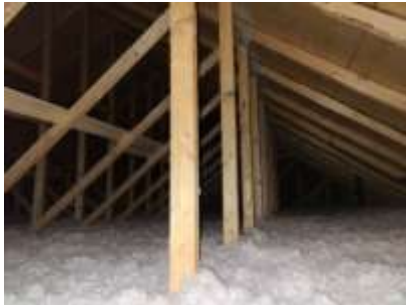
Pic. 7: Attic

Trusses showed no major defects or damage at the time of inspection. Roof sheathing, examined from the attic, showed no major defects or moisture damage. Gas to fireplace was shut off and could not be tested.

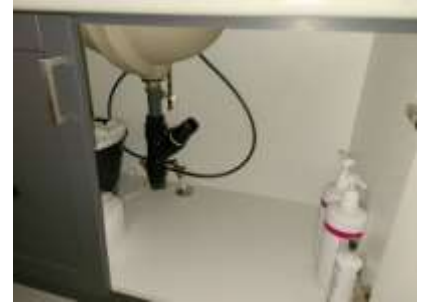
Left side sink was disconnected at the time of the inspection, vendor advised sink will be repaired and functional before closing.

Pic. 15: Left side sink not functional – to be repaired before closing
