# INSPECTION REPORT

For the Property at:  
**111 MORaine HILL DRIVE**  
VAUGHAN, ON L6A 0Z8

Prepared for: DAVE ELFASSY  
Inspection Date: Tuesday, January 30, 2024  
Prepared by: Stefano Ramacciato

RE: Report No. 3168  
111 Moraine Hill Drive  
Vaughan, ON  
L6A 0Z8

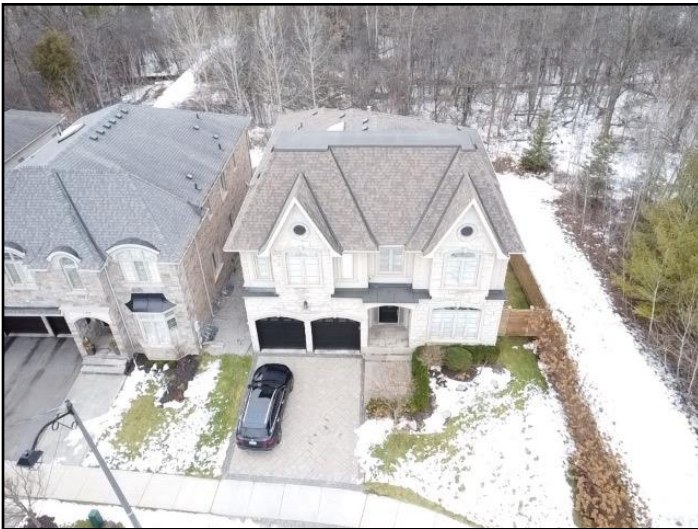
1.

In great condition.

Approximately age 14 years old.

Probability of leakage is low.

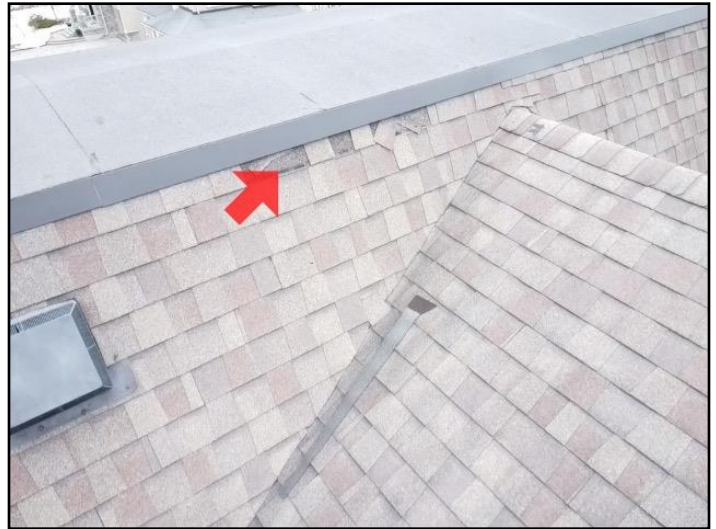
Noticed a few blown away Asphalt Shingles in the rear roof repair it.

4. *Blown away Asphalt Shingles*

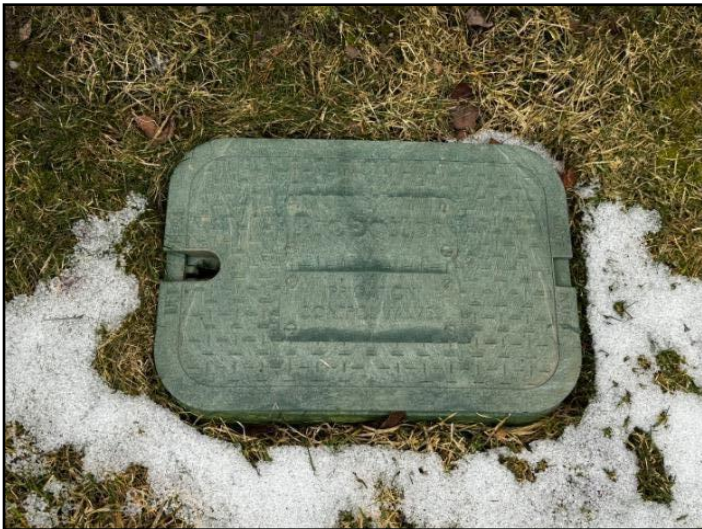
10. Control valves

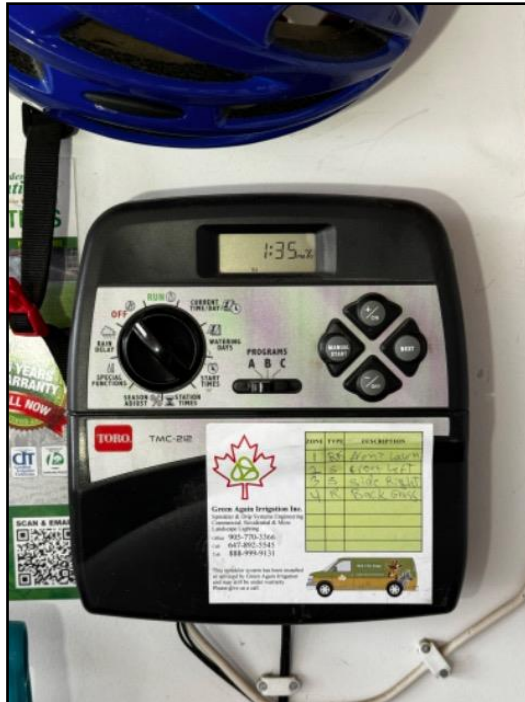
12. Control pad

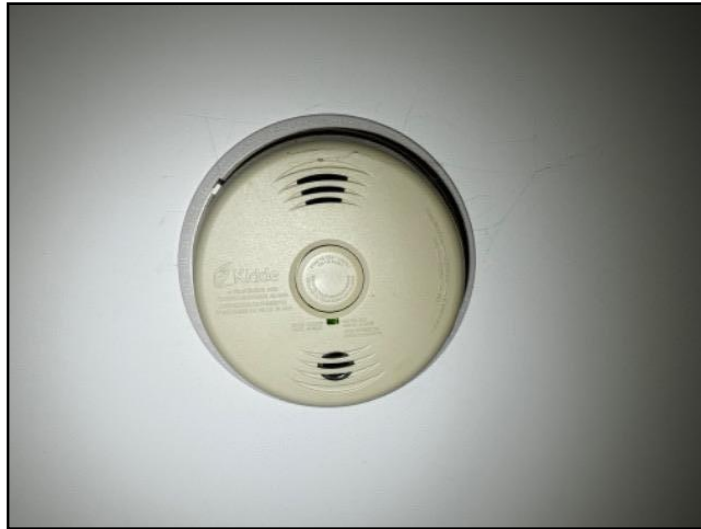
16.

Combo unit installed Carbon Monoxide & Smoke.

Units are expiring in 2027.

Replace units every 10 years.

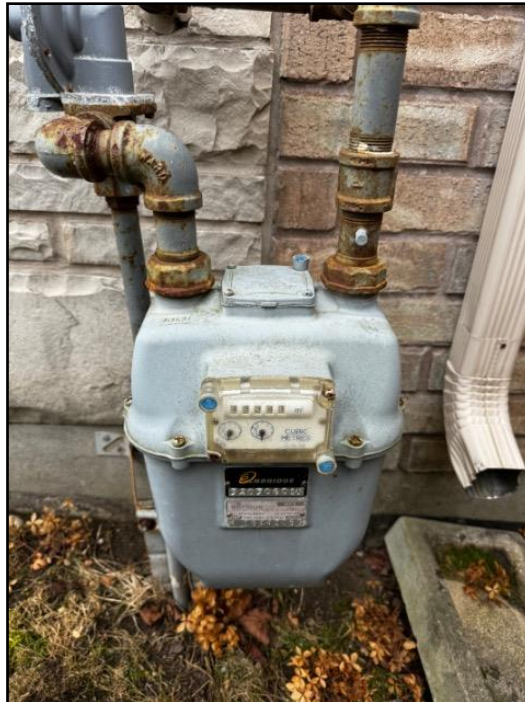
Rusty gas pipe, contact Enbridge to service.

23. Meter

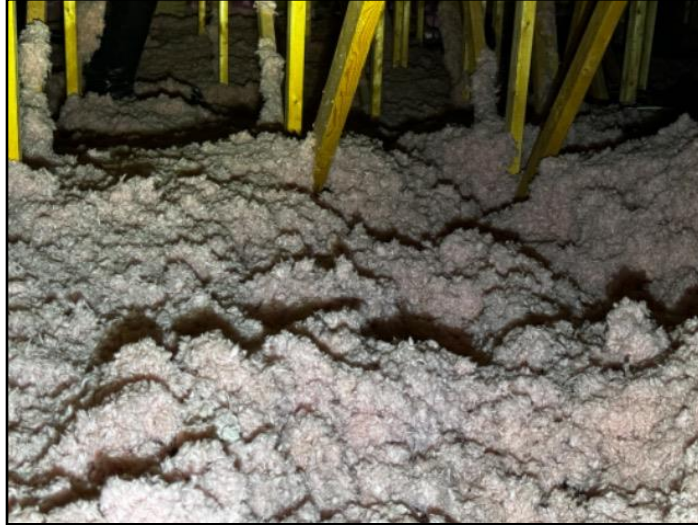
Upgrade in the future.

27. Glass fiber

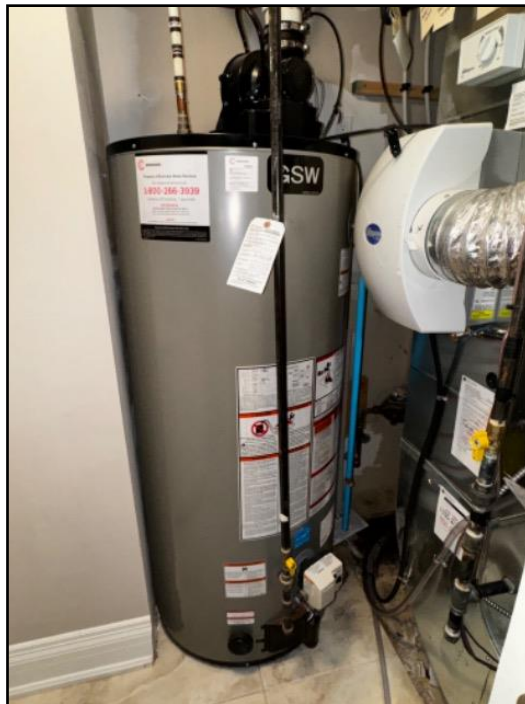
Mixing valve not installed.

29. Rental

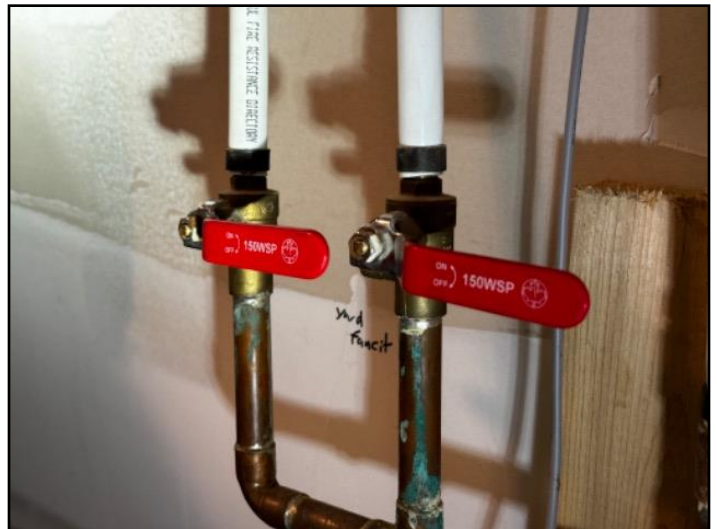
31. Hosebib shut off valves

This shutoff must be turned off and the water drained between this point and the exterior hose bib before the outside temperature drops below freezing. Damage will occur to your plumbing if this is not performed.

Turn this valve off and unscrew the small cap on the side of the shutoff. Open hose bib outside of your house or in the garage. Once all the water has been drained out of the pipe between the small cap and the hose bib, proceed to tighten the small cap. Do not reopen this shutoff until the exterior hose bib is once again needed in the spring.
