PRE-LISTING HOME INSPECTION REPORT

111 Timberwolf Cres, Vaughan, Ontario

Report Number : 21030195

Inspection Date: 2021-03-31

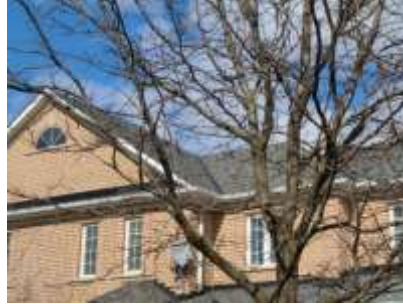
Pic. 2: Update roof covering

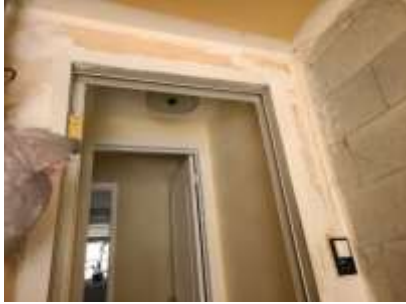
Doors were reviewed and found to be in working order. Lights appeared to be in normal condition: not all lights were tested. Exterior outlets tested were in normal working order. An auto closer is required for safety on the garage entry door.

Pic. 4: Auto closer is needed for garage entry door

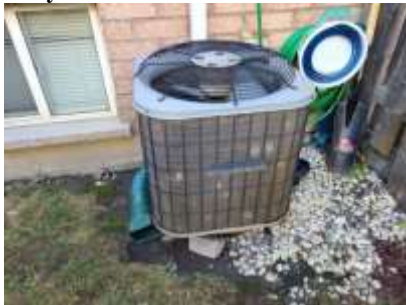
Pic. 7: AC unit 2002

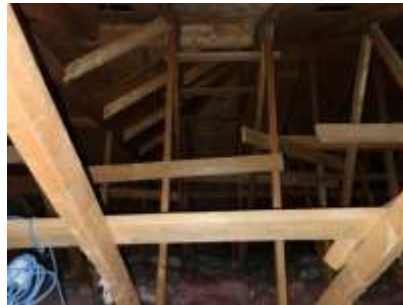
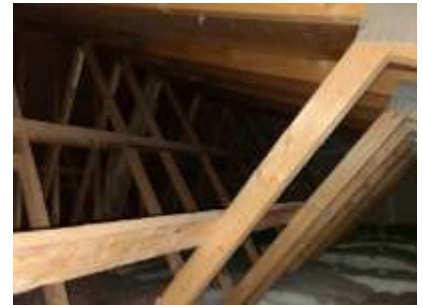
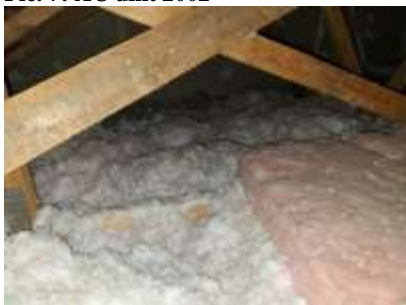
Trusses showed no major defects or damage at the time of inspection. Roof sheathing, examined from the attic, showed no major defects or moisture damage. Insulation was sufficient for homes in this area. Ventilation was normal. Vapour barrier not visible. Smoke detectors on the main floor and in the basement are dated and should be replaced.

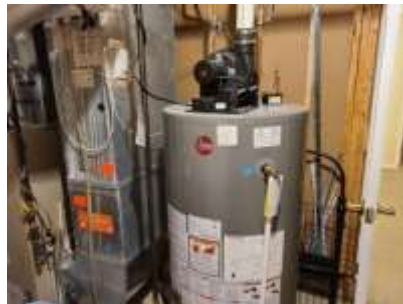
Pic. 26: Rental hot water tank 2016

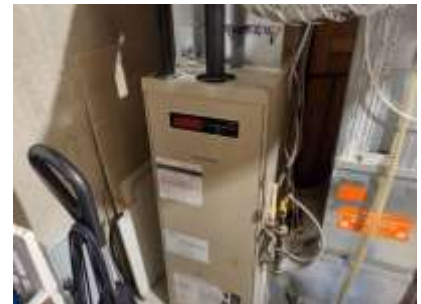
Pic. 27: Original gas furnace 2002

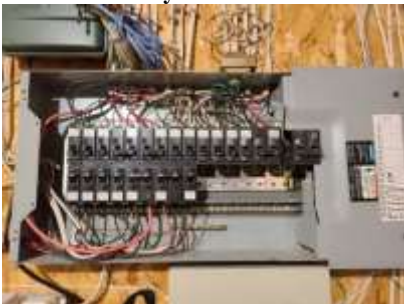
Panel size appeared to be compatible to service size. Branch breaker distribution appeared normal. No signs of overheating were evident at the time of the inspection. Outlets were randomly tested and had correct polarity, except as noted.

Pic. 28: 100 amp breaker panel
