PRE-LISTING HOME INSPECTION REPORT

11 Lillian Ave, Thornhill, Ontario

Report Number: 21110455

Inspection Date: 2021-11-16

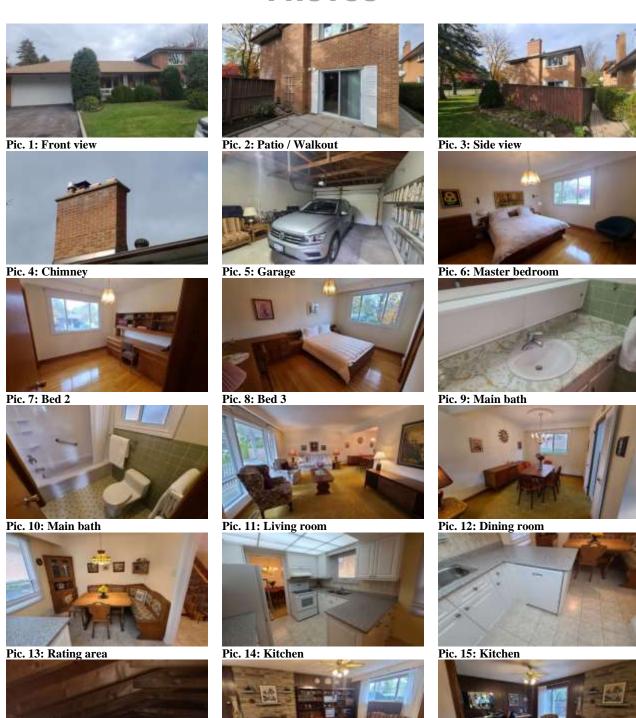
Pic. 16: Attic

Rafters showed no major defects or damage at the time of inspection. Roof sheathing, examined from the attic, showed no major defects or moisture damage. Insulation was sufficient for homes in this area. Ventilation was normal. Vapour barrier not visible. Smoke detectors are past their normal life expectancy and should be replaced.
