# INSPECTION REPORT

For the Property at:  
**12 MILL RIVER DRIVE**  
VAUGHAN, ON L6A 0Y7

Prepared for: DAVE ELFASSY  
Inspection Date: Friday, February 23, 2024  
Prepared by: Stefano Ramacciato

RE: Report No. 3197, v.2  
12 Mill River Drive  
Vaughan, ON  
L6A 0Y7

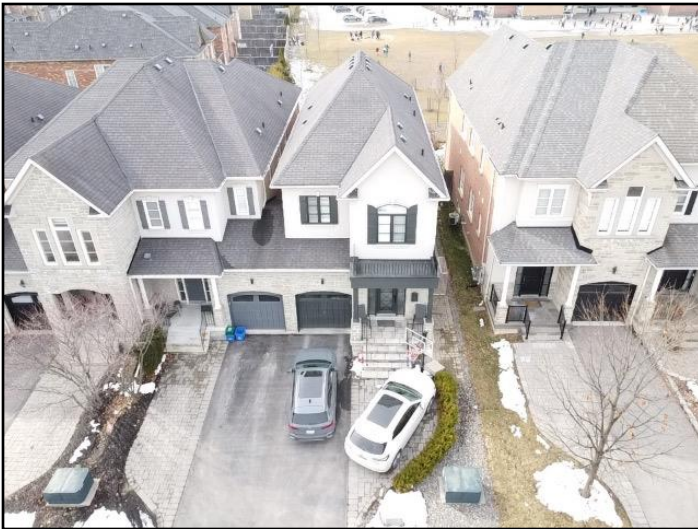
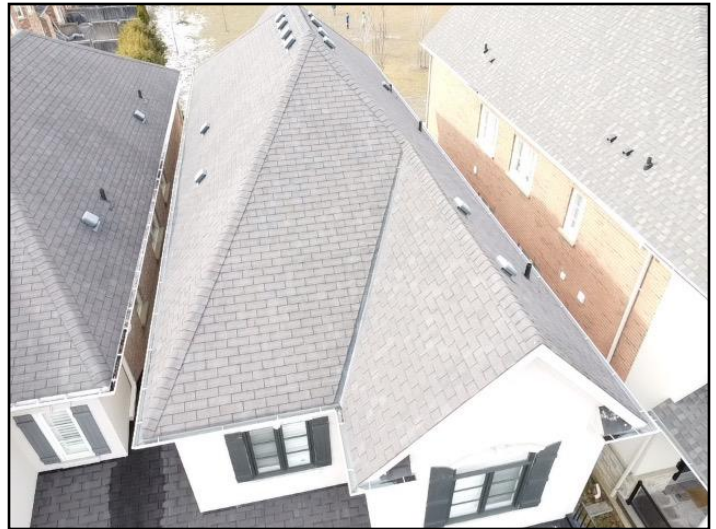
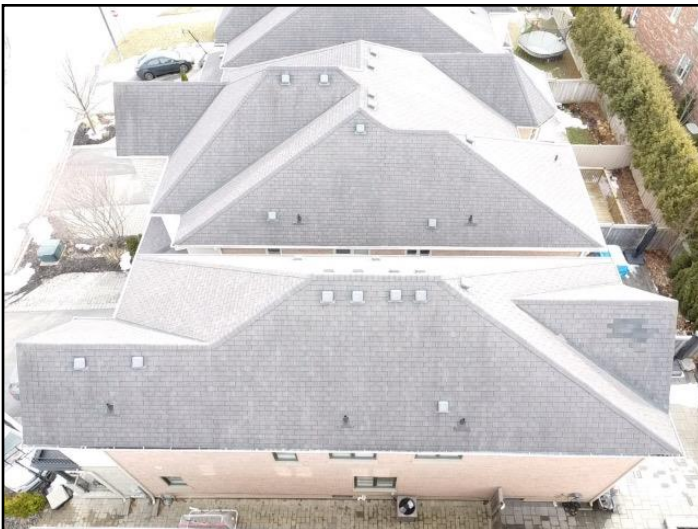
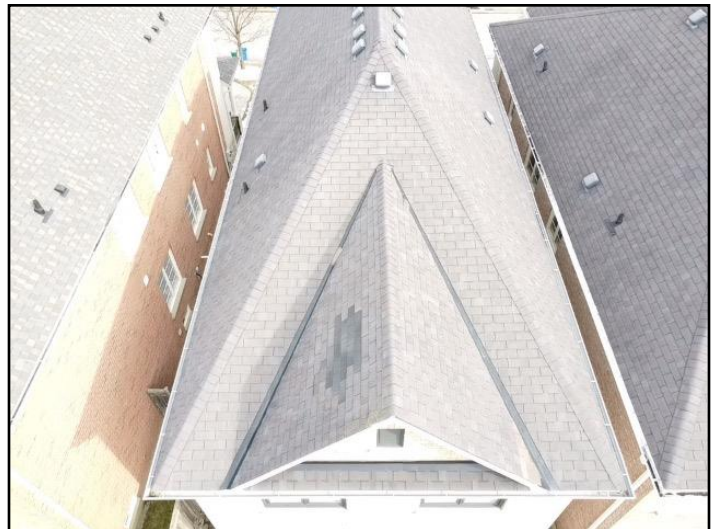
In great condition.

Noticed some repair work was done in the rear roof and a few blown away

Asphalt Shingle tabs.

Approximately age 15 years old.

High grade Asphalt Shingles.

Probability of leakage is low.

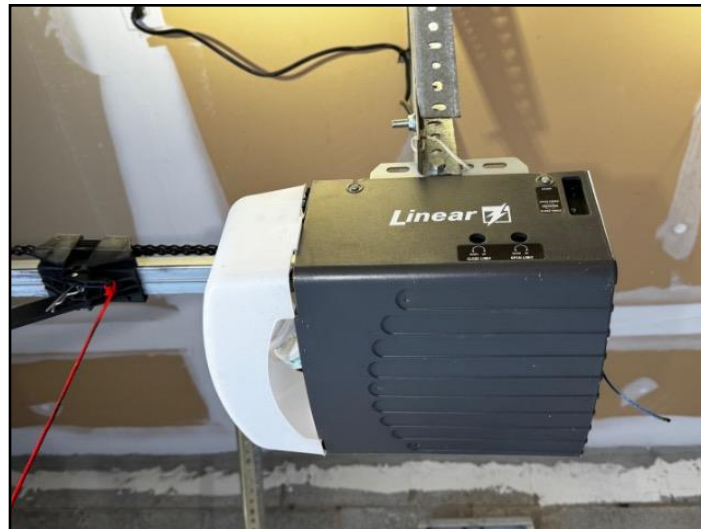
7.

In good working condition.

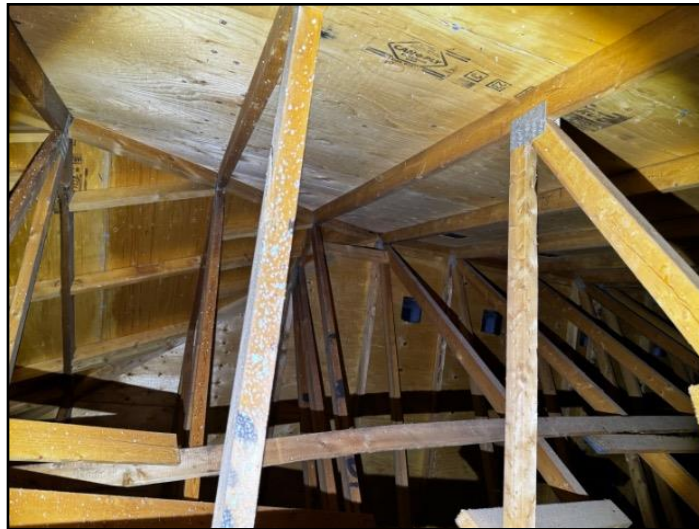
8.

No visible water damage or mold.

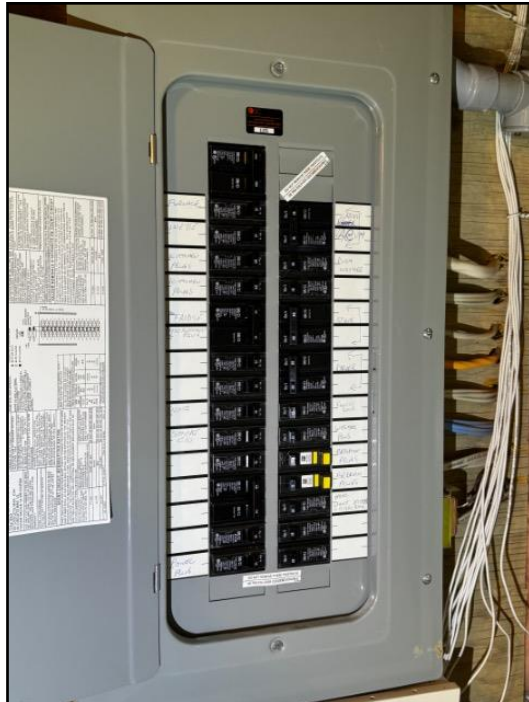
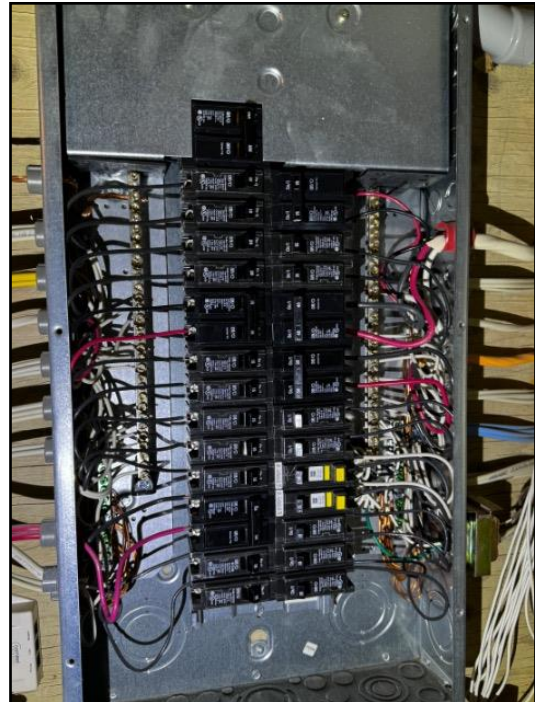
Located front basement.

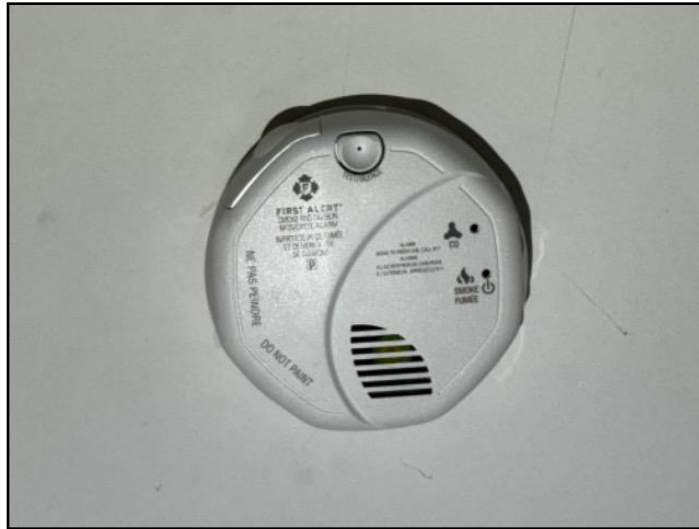
11.

Combo unit installed, Carbon Monoxide & Smoke.

Test monthly.

Replace units every 10 years.

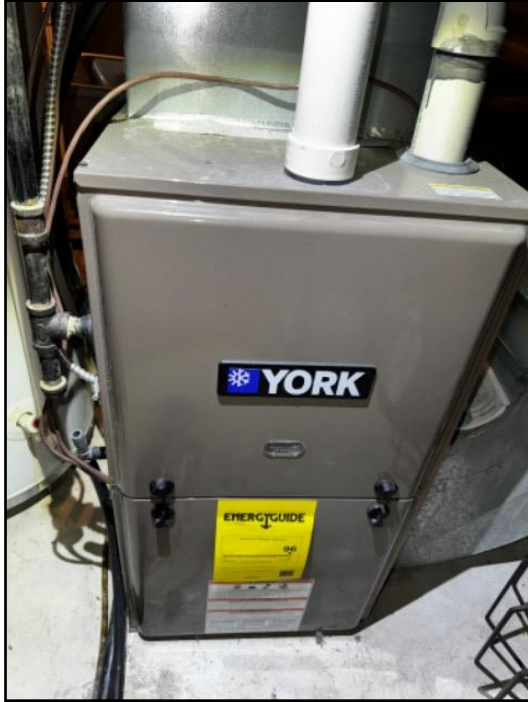
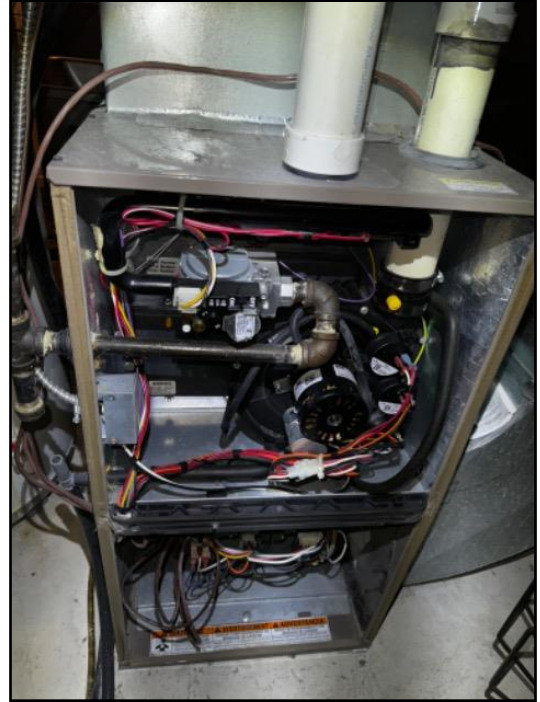
Model Year 2018

High Efficiency

80,000 BTU'S

In good working condition.

Replace filter every 3 months.

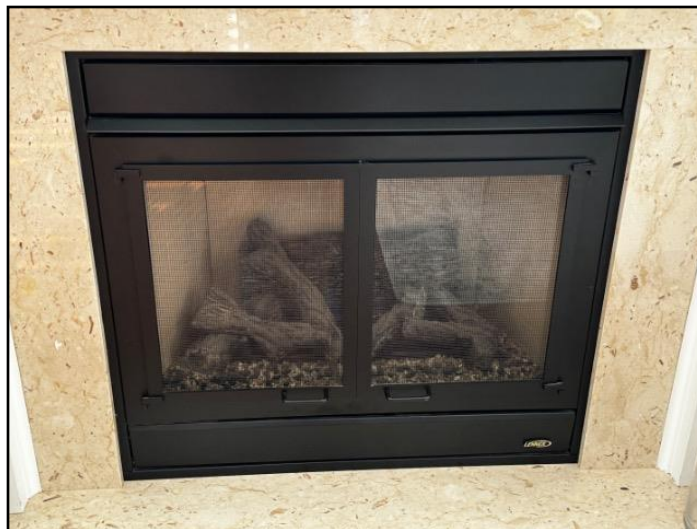
14.

Gas fireplace in good working condition.

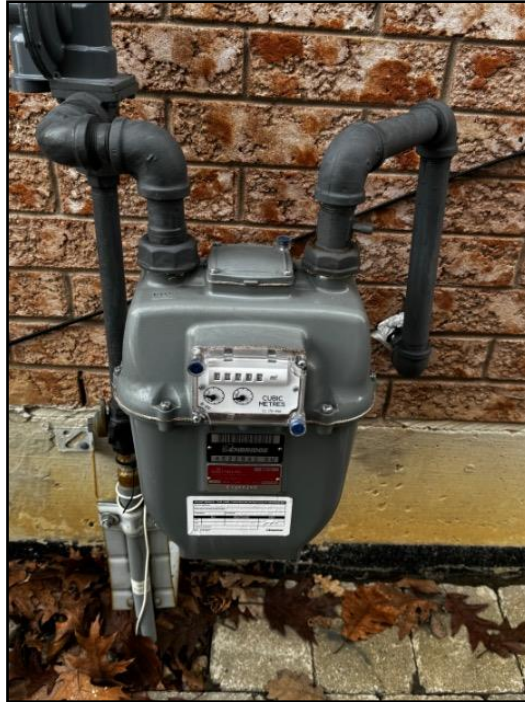
15. Meter

Located right side exterior wall.

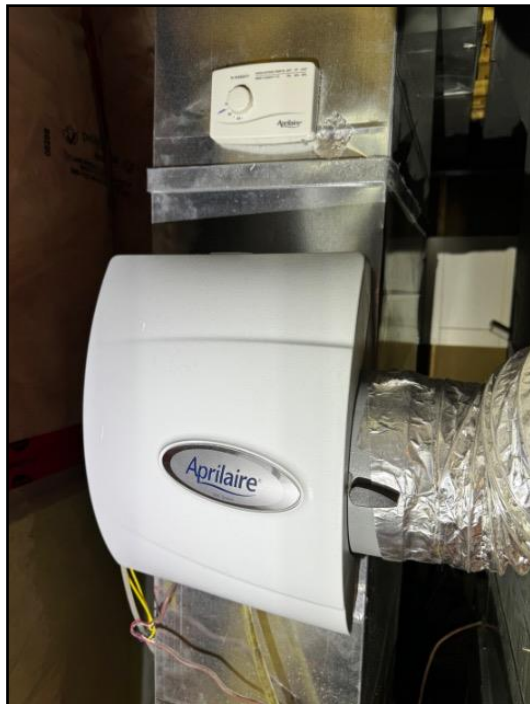
16. Trickle/cascade type

Located behind the furnace.

Replace filter every fall.

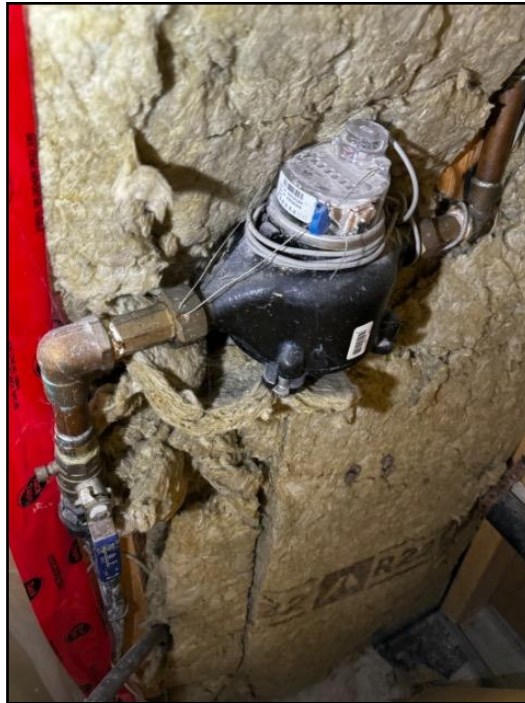
21. Meter

Located in the basement furnace room.

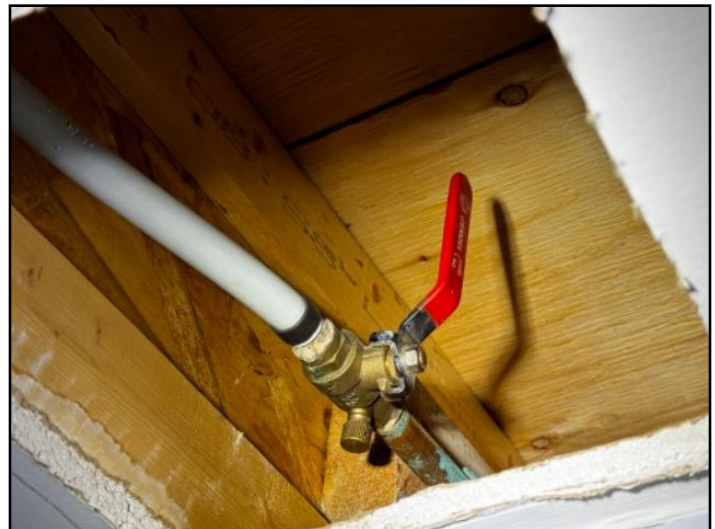
23. Hosebib shut off valve

Shut off valves are located front & rear basement.

This shutoff must be turned off and the water drained between this point and the exterior hose bib before the outside temperature drops below freezing. Damage will occur to your plumbing if this is not performed.

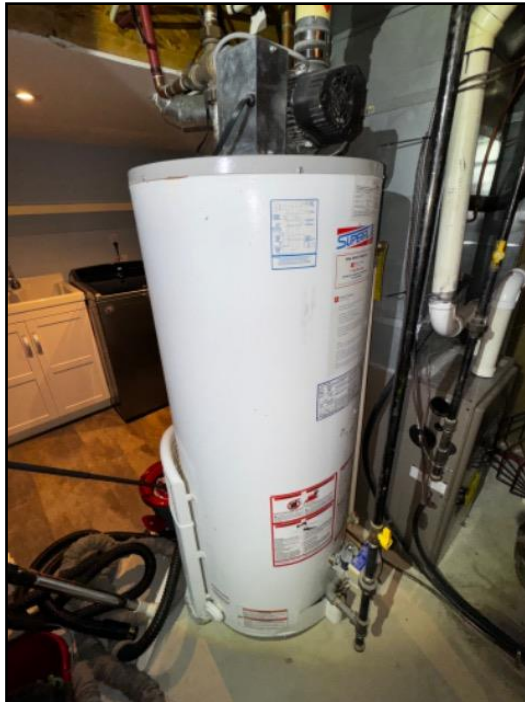
24.

**2. Condition:** • Past life expectancy

Rental Unit

Model Year 2009

227 Litres

**Implication(s):** Chance of water damage to structure, finishes and contents | No hot water

**Task:** Upgrade

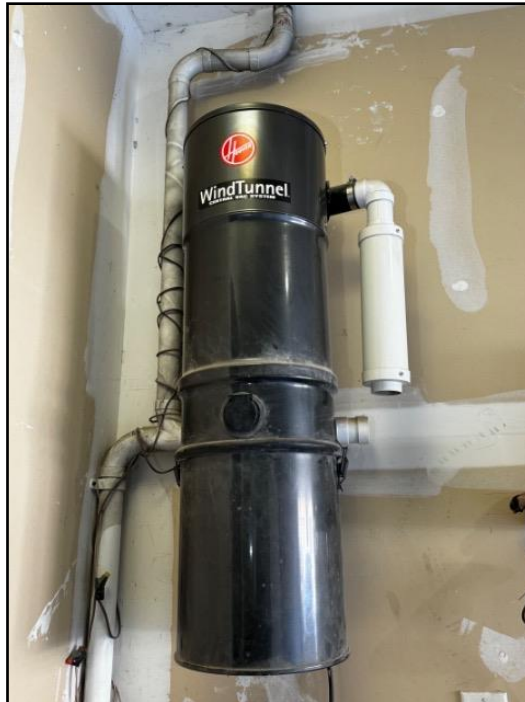
33.

**Inventory Central Vacuum:** • In good working condition.
