PRE-LISTING HOME INSPECTION REPORT

1398 Andros Blvd, Mississauga, Ontario

Report Number: 23020151

Inspection Date: 2023-02-16

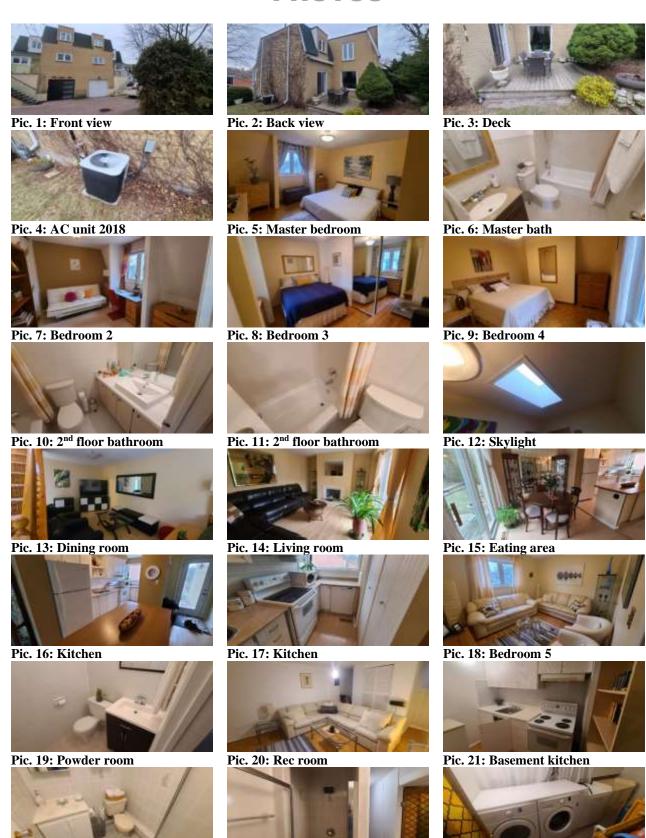
Pic. 23: Basement bath

Pic. 24: Laundry
