PRE-LISTING HOME INSPECTION REPORT

150 Carrington Dr, Richmond Hill, Ontario

Report Number: 23070366

Inspection Date: 2023-07-12

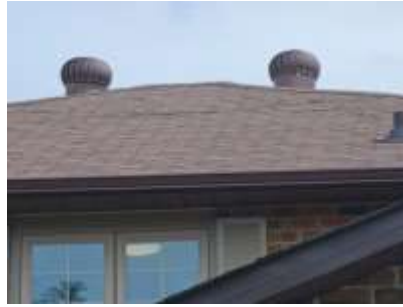
Roof was showing normal wear, but was in overall adequate condition. There appears to be one torn shingle on the front of the roof which should be repaired. There is evidence of previous repairs to the front of the roof.

Pic. 2: Roof covering – appears one shingle tab is torn

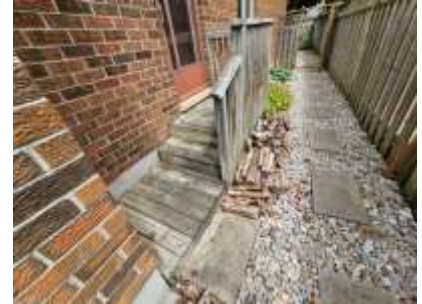
Fencing is not part of a home inspection. General site drainage was properly sloping away from the house. Maintain a positive drainage slope away from the foundation. Wooden side entrance steps and landing are sloping, recommend review and repair as necessary.

Pic. 6: Side steps in need of repair

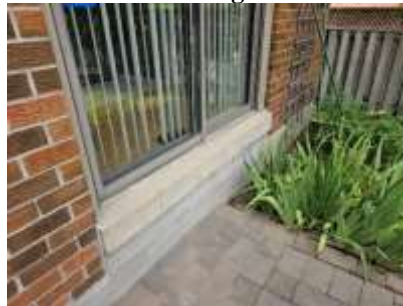
At the time of the inspection the room was found to be in overall satisfactory condition. Steps, Juliet railing or patio door need to be made inoperable for safety.

Pic. 8: Steps, railing or patio door needs to be made inoperable for safety

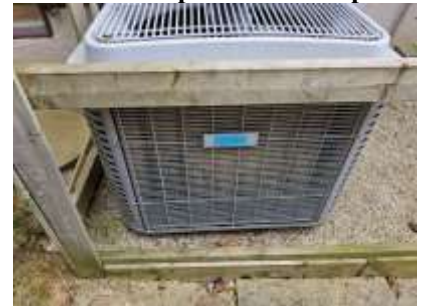
Pic. 9: Ac unit 2009

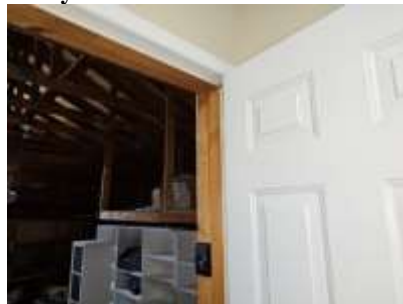
Doors were reviewed and found to be in working order. Lights appeared to be in normal condition: not all lights were tested. Exterior outlets tested were in normal working order. An auto closer for the garage entry door is required for safety.

Pic. 11: Auto closer needed for safety

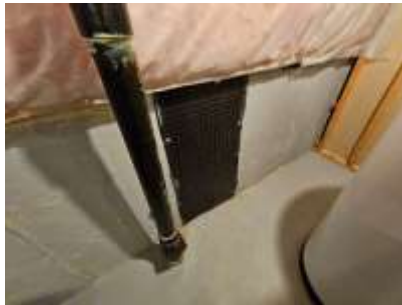
Pic. 35: Foundation repair

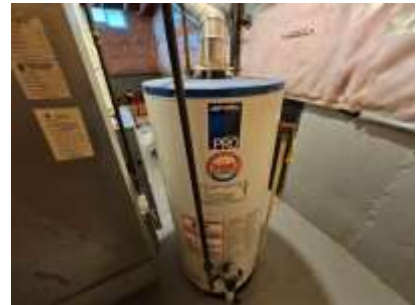
Pic. 36: Hot water tank 2009

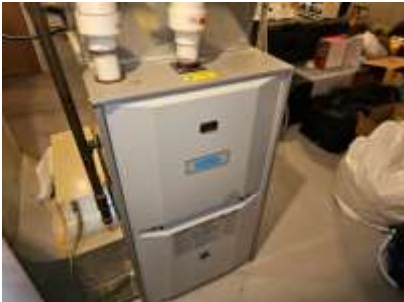
Pic. 37: Gas furnace 2009

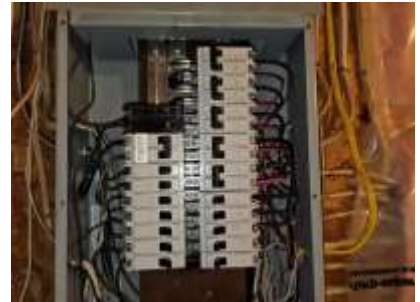
Panel size appeared to be compatible to service size. Branch breaker distribution appeared normal. No signs of overheating were evident at the time of the inspection. Outlets were randomly tested and had correct polarity, except as noted.

Pic. 39: 150 amp breaker panel
