## **PRE-LISTING HOME INSPECTION REPORT**

**16 Horse Rake, Vaughan, Ontario**

**Report Number : 21050248**

**Inspection Date: 2021-05-11**

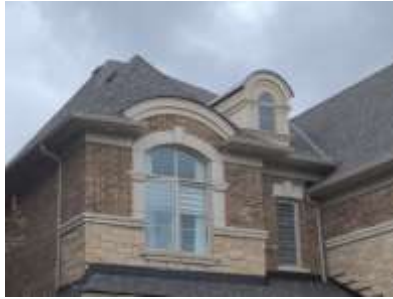
Roof covering appeared in overall satisfactory condition at the time of the inspection.

**Pic. 2: Roof covering**

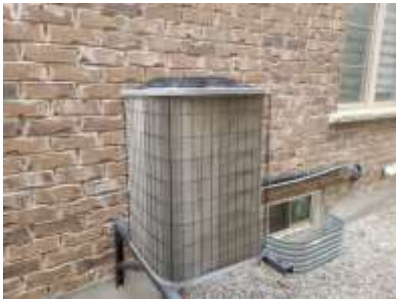
**Pic. 4: AC unit 2015**

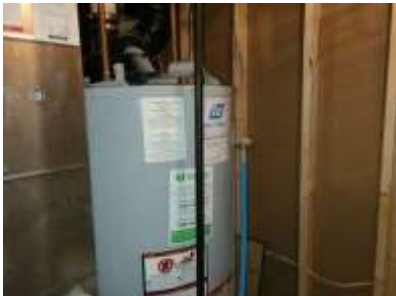
**Pic. 37: Rental hot water tank**

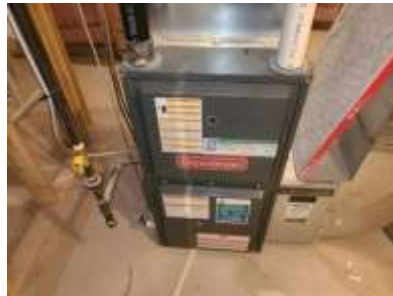
**Pic. 38: Gas furnace 2015**

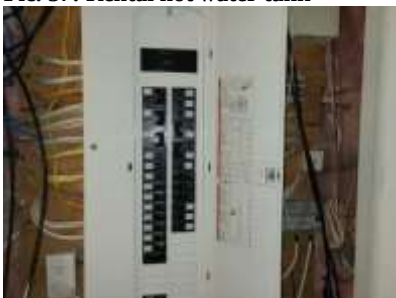
Panel size appeared to be compatible to service size. Branch breaker distribution appeared normal. No signs of overheating were evident at the time of the inspection. Outlets were randomly tested and had correct polarity, except as noted.

**Pic. 40: 200 amp breaker panel**
