PRE-LISTING HOME INSPECTION REPORT

1750 Listowell Cres, Pickering, Ontario

Report Number : 23100519

Inspection Date: 2023-10-14

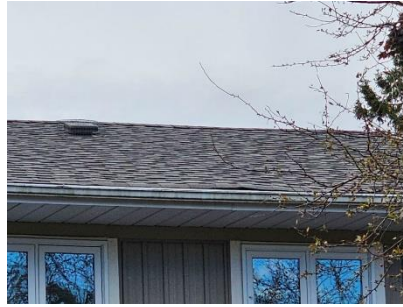
Pic. 2: Roof covering

Roof covering appeared in overall satisfactory condition at the time of the inspection.

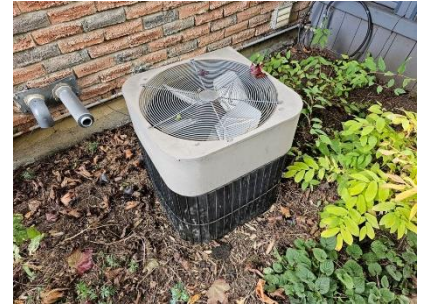
Pic. 3: AC unit 1989

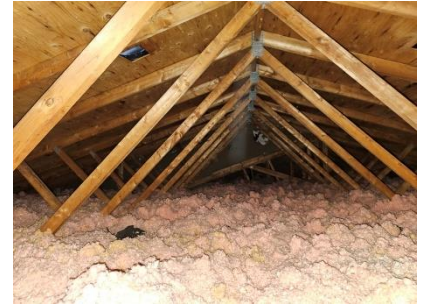
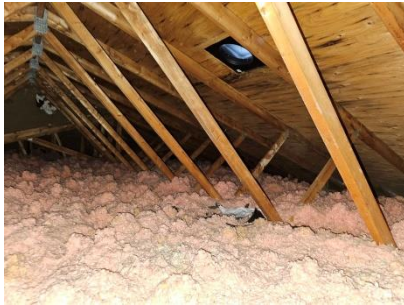
Pic. 6: Attic

Trusses showed no major defects or damage at the time of inspection. Roof sheathing, examined from the attic, showed no major defects or moisture damage. Insulation level has been upgraded. Ventilation was normal. Vapour barrier not visible.

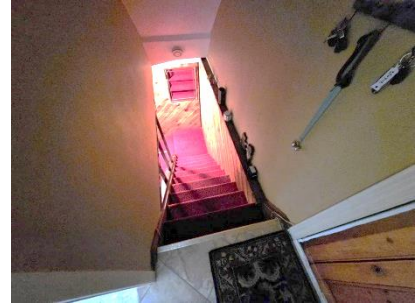
Pic. 21: Handrailing advised for basement stairwell

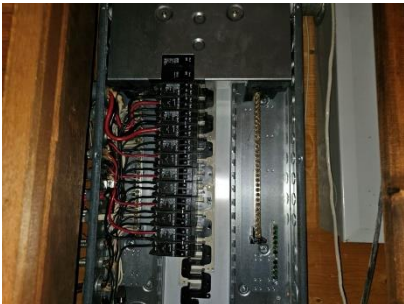
Property appears to have a 200 amp service entering the building but the main panel is only a 100 amp panel. Panel size appeared to be compatible to service size. Branch breaker distribution appeared normal. No signs of overheating were evident at the time of the inspection. Outlets were randomly tested and had correct polarity, except as noted. With the presence of solid conductor branch aluminum wiring, insurance companies may require an ESA (Electrical Safety Authority) inspection confirming correct bonding of the aluminum wiring for insurability of the home. Fixtures reviewed do not appear to be bonded correctly and should be corrected accordingly.

Pic. 22: 100 amp main breaker panel – mix of aluminum and copper wire

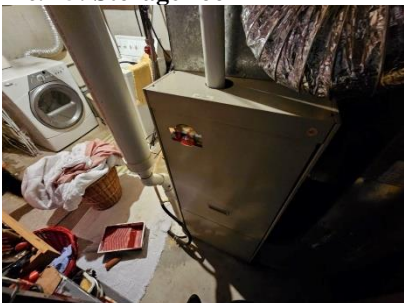
Pic. 28: Gas furnace 1990
