INSPECTION REPORT

For the Property at:
193 SOUTHVALE DRIVE
VAUGHAN, ON L6A 0Y9

Prepared for: DAVE ELFASSY
Inspection Date: Sunday, May 26, 2024
Prepared by: Stefano Ramacciato

RE: Report No. 3296
193 Southvale Drive
Vaughan, ON
L6A 0Y9

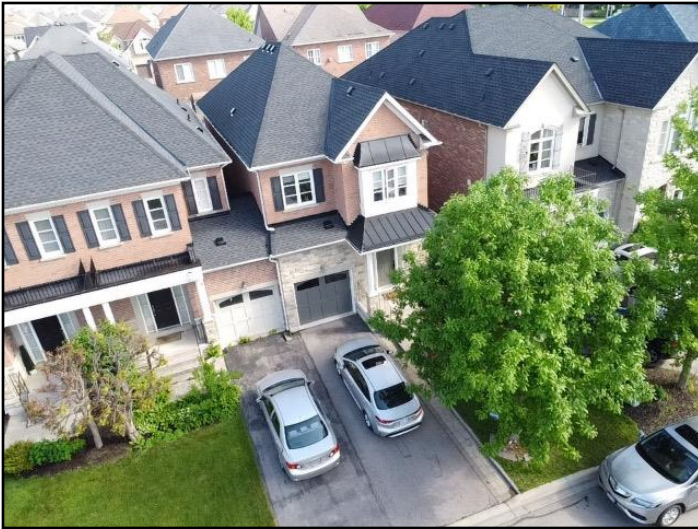
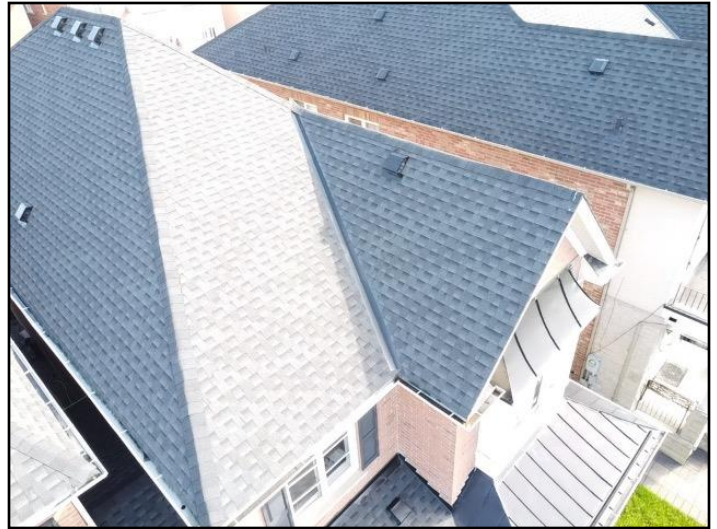
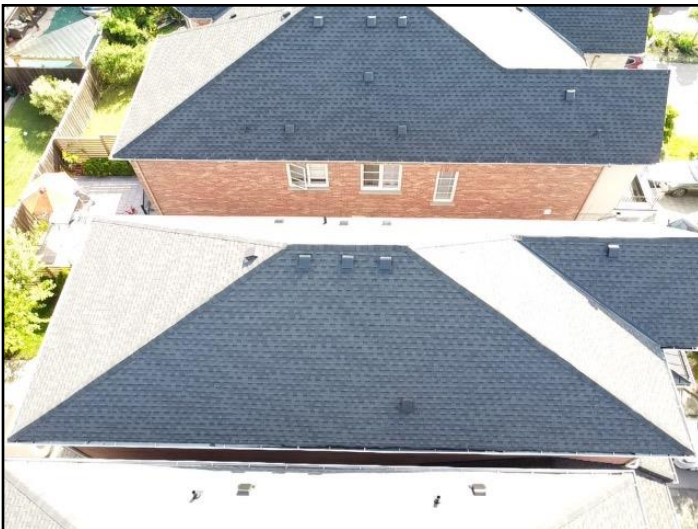
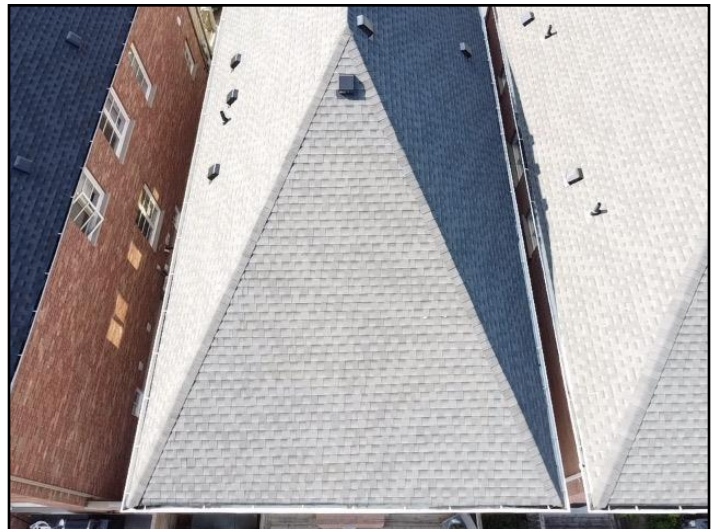
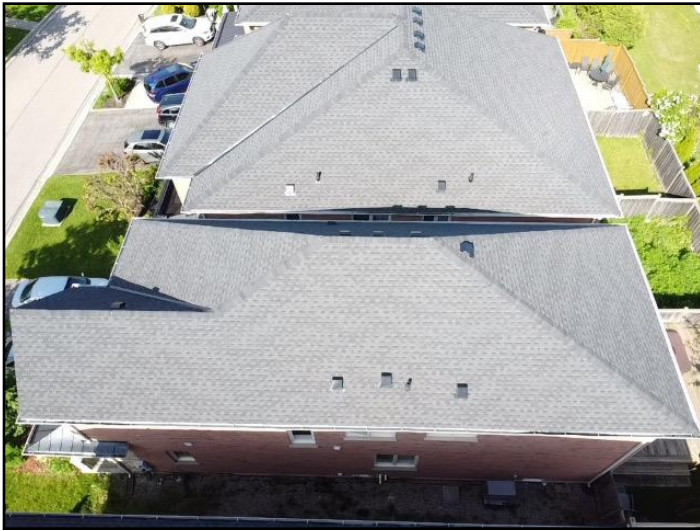
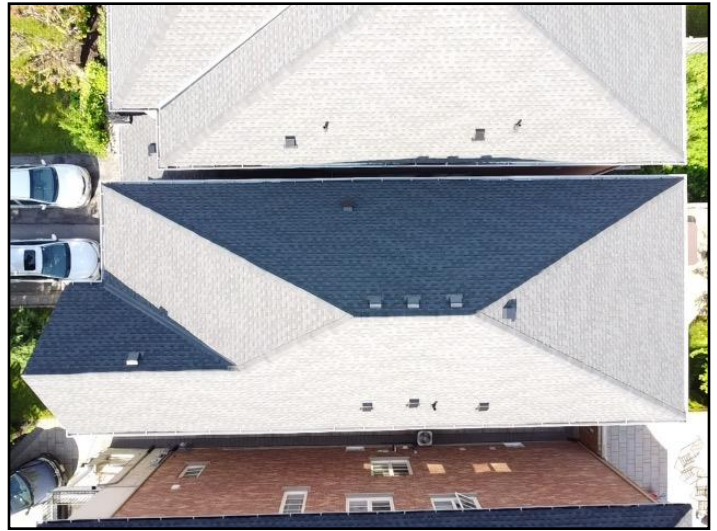
In great condition.

Approximately age 2 years old.

Probability of leakage is low.

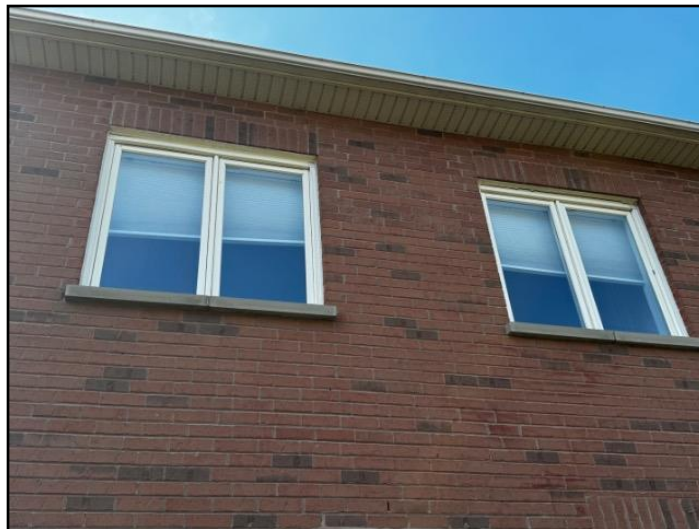
11.

1. **Condition:** • Cracked outdoor caulking

Location: Throughout Exterior Wall

Task: Repair

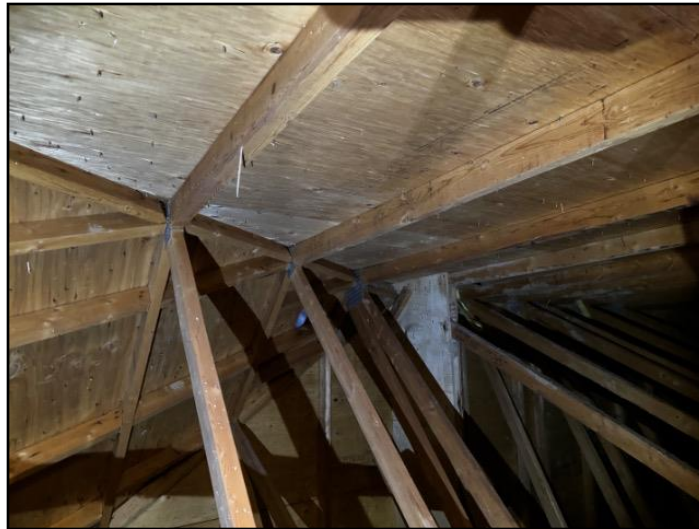
12.

No signs of water damage, mold or structural issues.

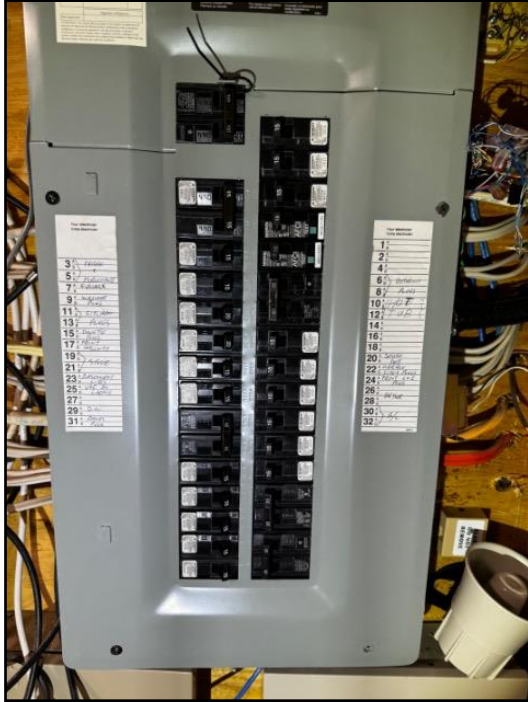
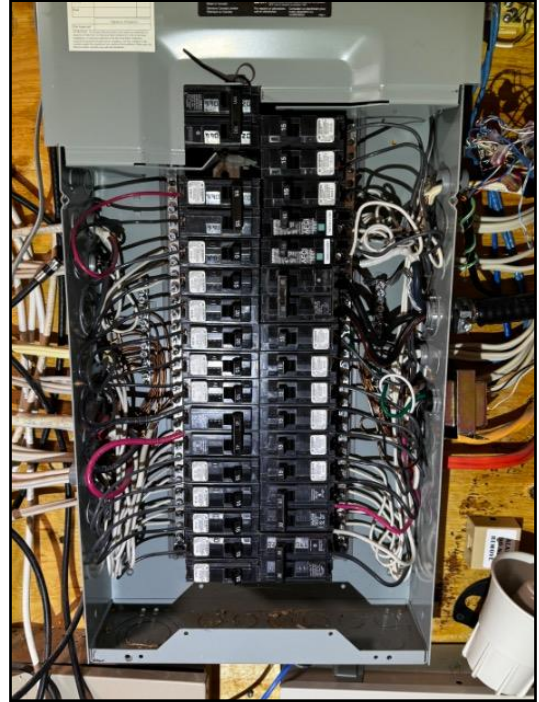
Missing two screws on the front panel replace it.

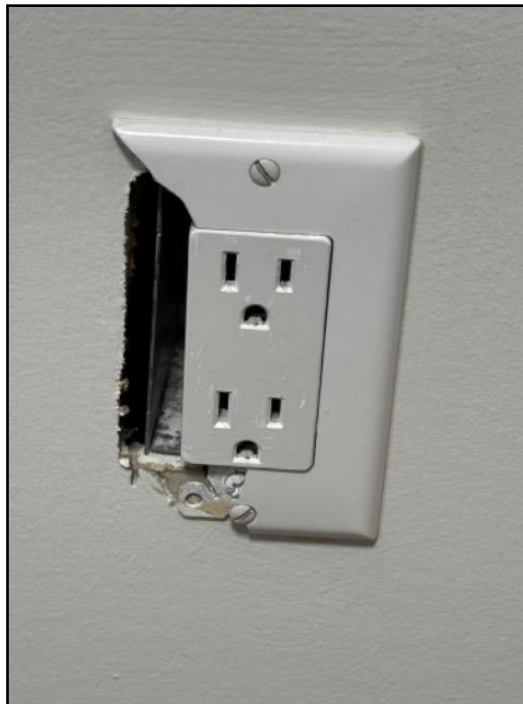
16.

3. Condition: • Damage cover plate

Location: Front Basement

Task: Replace

Time: ASAP

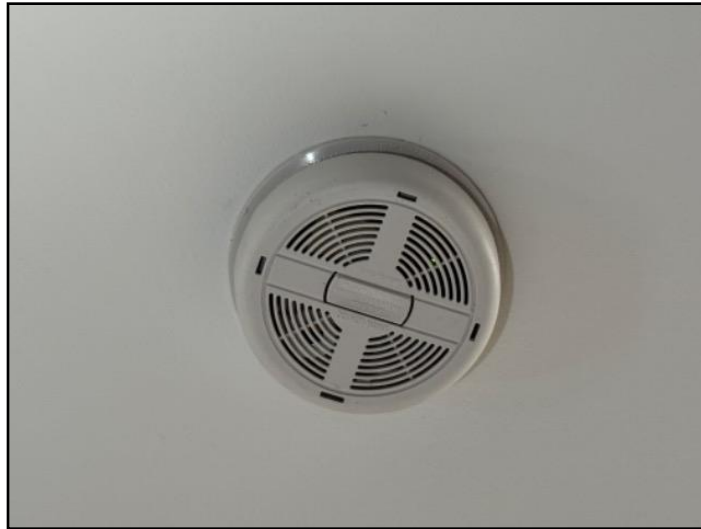
17. Old

6. **Condition:** • Old

Location: First Floor & Basement

Install combo units, Carbon Monoxide & Smoke

Task: Replace

Time: ASAP

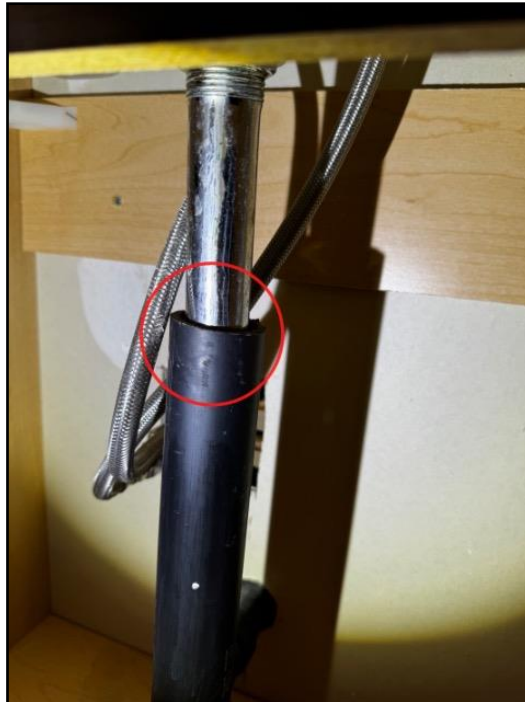
28.

7. Condition: • Missing pipe ring fitting

Location: Basement Bathroom

Task: Repair

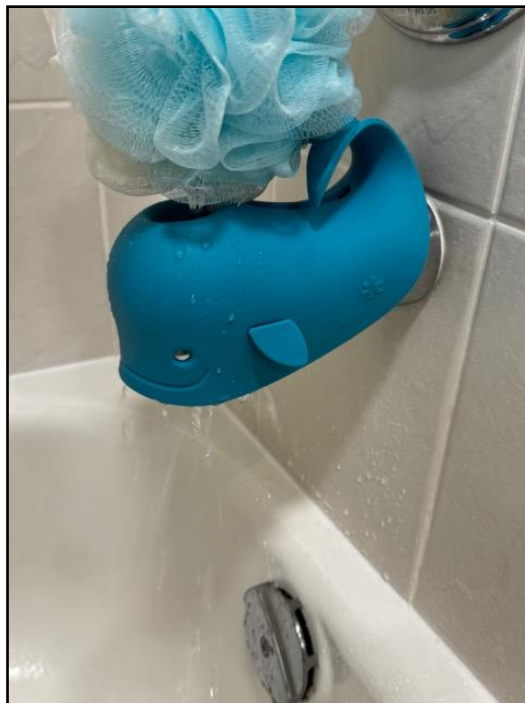
29.

8. Condition: • Replace the spout

Location: Second Floor Bathroom

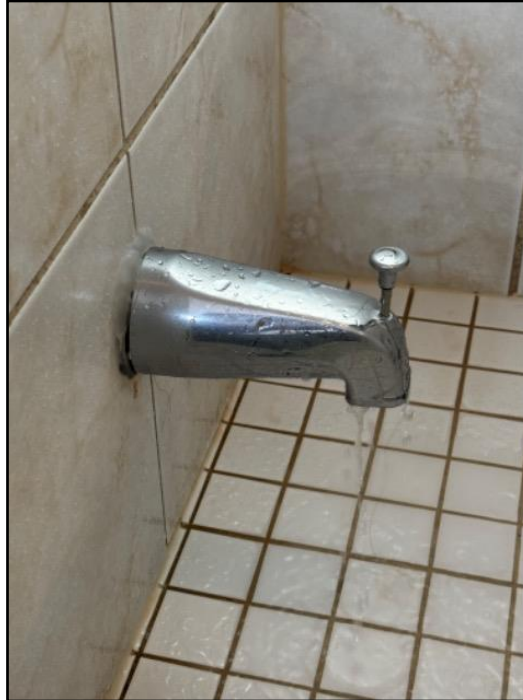
30.

9. Condition: • Replace the spouts

Location: Ensuite bathroom & Front Bathroom

Task: Replace

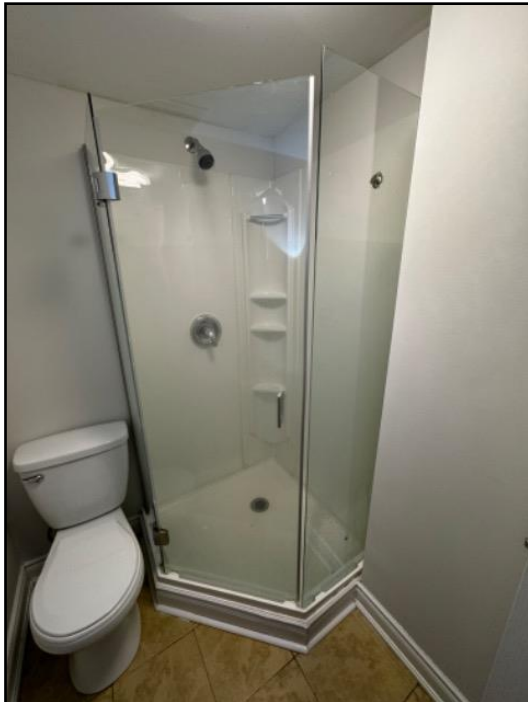
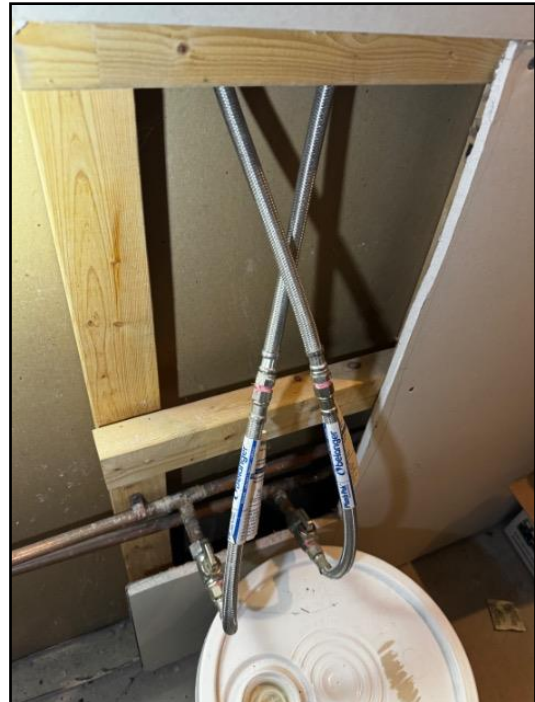
10. Condition: • Glass enclosure needs adjustment

Implication(s): Chance of water damage to contents, finishes and/or structure.

Location: Basement Bathroom

Also replace the flex plumbing pipes with a solid pex pipes.

Task: Repair

Time: ASAP

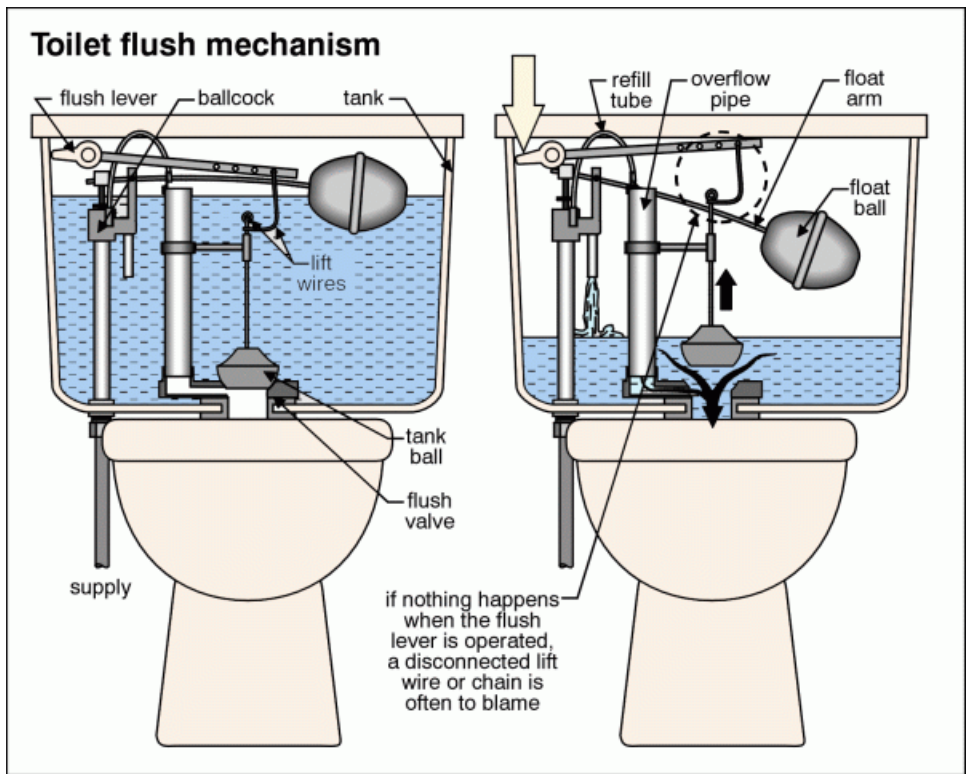
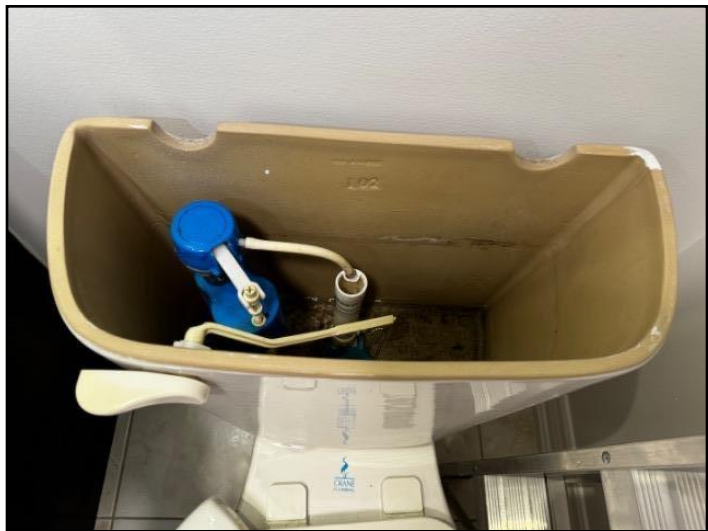
33. *Running continuously*

11. Condition: • [Running continuously](#)

Implication(s): Chance of condensation damage to finishes and/or structure | Increased water consumption

Location: Second Floor Bathroom

Replace the flushing flap.

Time: ASAP

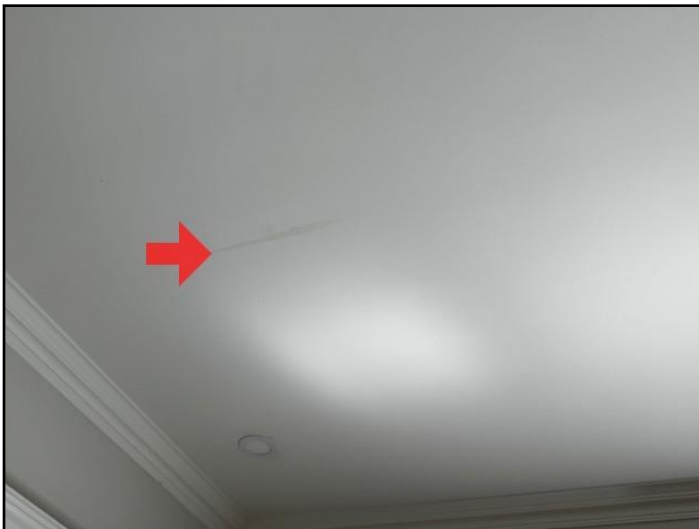
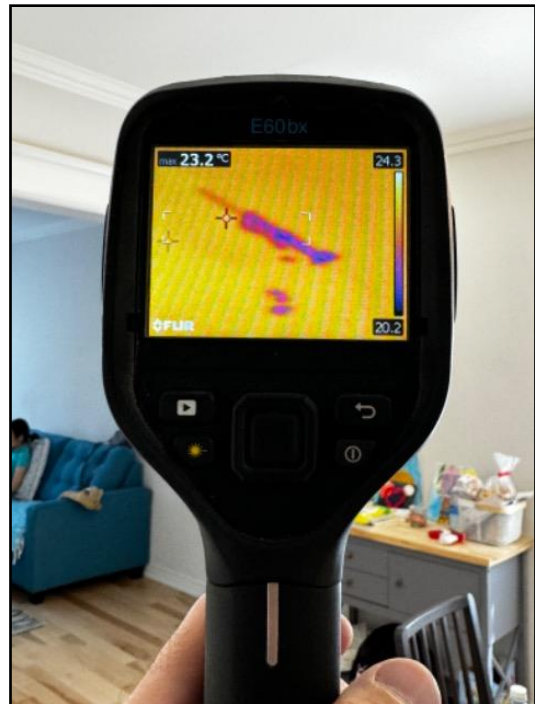
12. Condition: • Visible signs of water damage coming from the ensuite bathroom.
Contact a licensed plumber.

Location: Dining Room Ceiling

Task: Repair

Time: Immediate

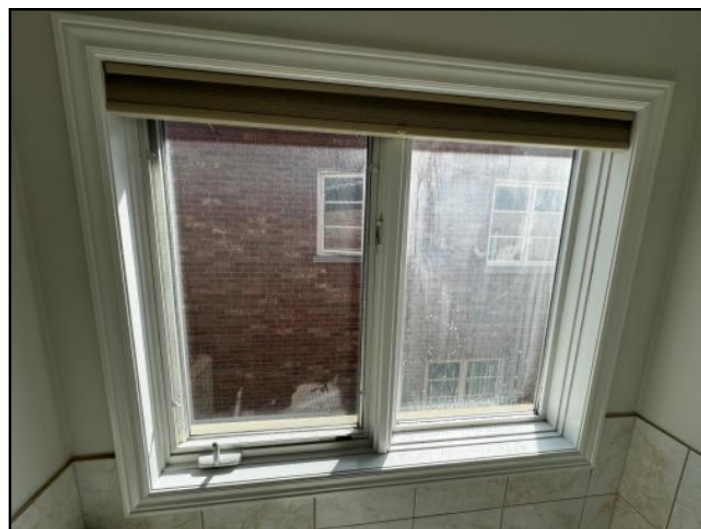
44.

13. **Condition:** • [Lost seal on double or triple glazing](#)

Implication(s): Shortened life expectancy of material

Location: Ensuite Bathroom, Front & Middle Bedrooms

Task: Replace

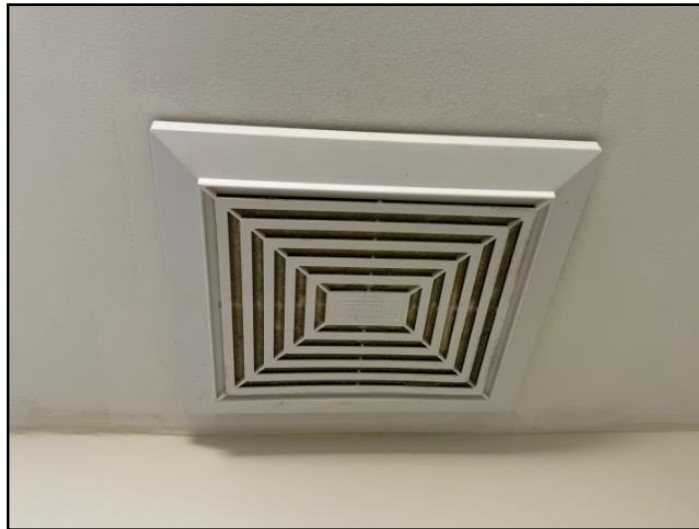
45.

16. Condition: • Not venting to the exterior wall.

Venting into the furnace room.

Implication(s): Chance of condensation

Location: Basement Bathroom

Task: Correct

Time: ASAP

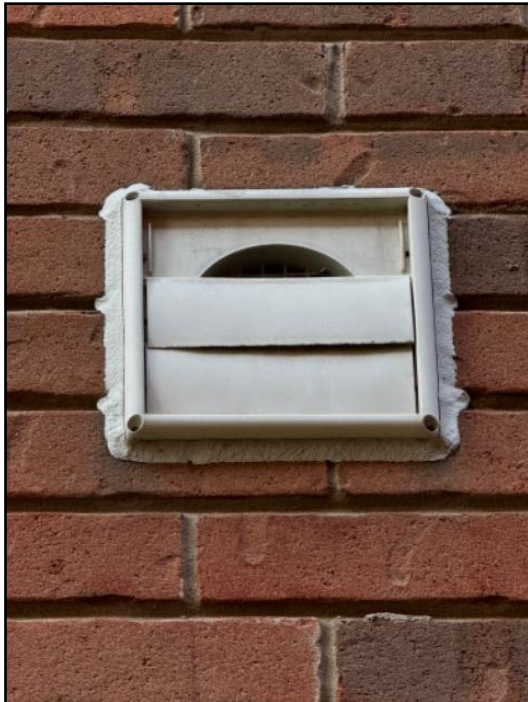
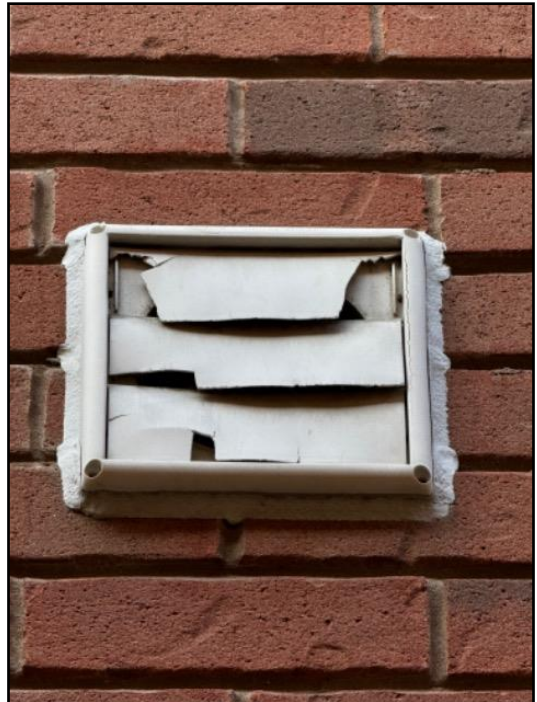
17. Condition: • Damage weather hoods

Location: Right Side Exterior Wall

Task: Replace

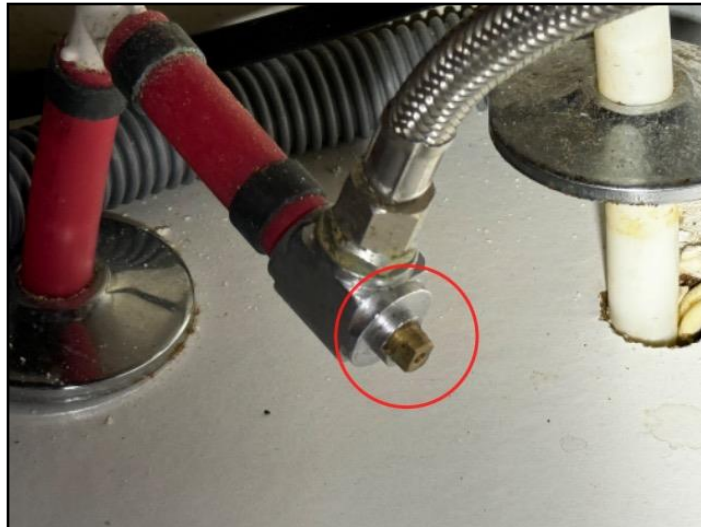
48.

18. Condition: • Missing shut off valve handle.

Location: Kitchen

Task: Replace
