PRE-LISTING HOME INSPECTION REPORT

20 Islay Cres, Vaughan, Ontario

Report Number : 20010006

Inspection Date: 2020-01-13

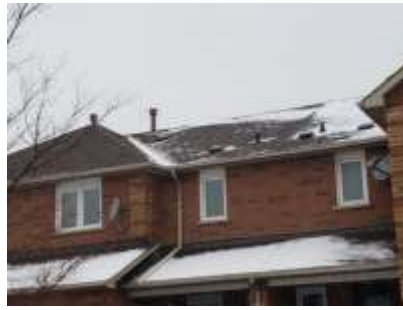
Roof covering appeared in overall satisfactory condition at the time of the inspection. Review of the roof covering and some of its related elements was limited by snow covering

Pic. 2: Roof covering

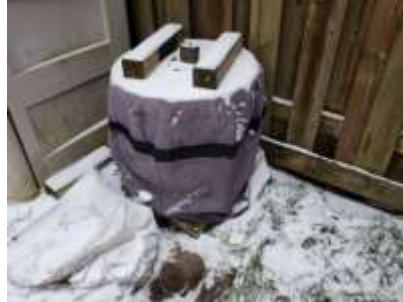
Doors were reviewed and found to be in working order. Lights appeared to be in normal condition: not all lights were tested. Exterior outlets tested were in normal working order. AC unit was covered and cover was frozen to the unit and could not be reviewed therefore the age and condition of the compressor unit could not be reviewed.

Pic. 5: Covered AC unit could not be reviewed

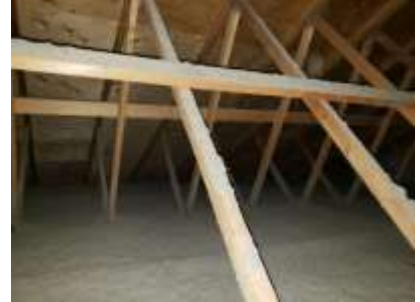
Trusses showed no major defects or damage at the time of inspection. Roof sheathing, examined from the attic, showed no major defects or moisture damage. Insulation was sufficient for homes in this area. Ventilation was normal. Vapour barrier not visible.

Pic. 6: Attic

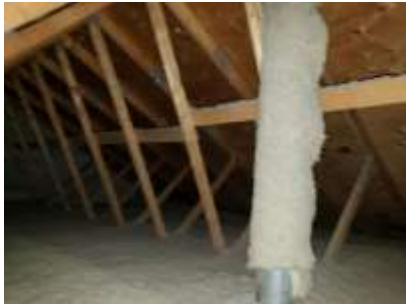
Pic. 7: Attic

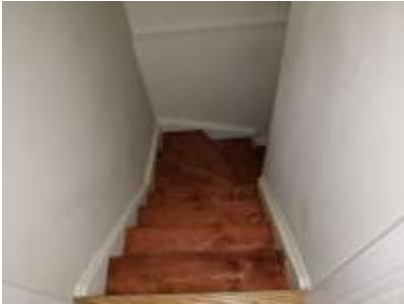
Foundation appeared to be in overall satisfactory condition. Foundation walls were covered/partially covered with paneling/drywall/insulation and were not visible. No representation can be made to the conditions of the covered/partially covered walls. Floor appeared to be in overall satisfactory condition. No active seepage visible at the time of the inspection. No representation can be made to future leaking of the basement walls. A handrail is needed for safety for the basement stairwell.

Pic. 18: Handrailing needed in basement stairwell

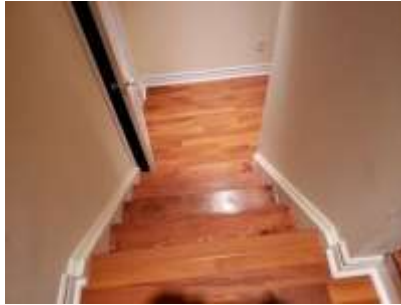
Pic. 19: Handrailing needed in basement stairwell

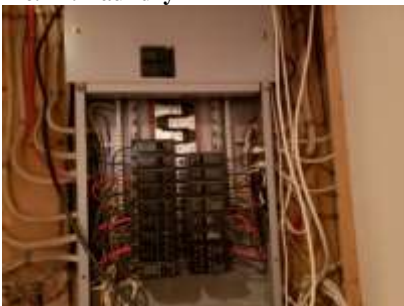
Panel size appeared to be compatible to service size. Branch breaker distribution appeared normal. No signs of overheating were evident at the time of the inspection. Outlets were randomly tested and had correct polarity, except as noted.

Pic. 24: 100 amp breaker panel with all copper wire
