PRE-LISTING HOME INSPECTION REPORT

211 Worthview Dr, Vaughan, Ontario

Report Number : 21060278

Inspection Date: 2021-06-12

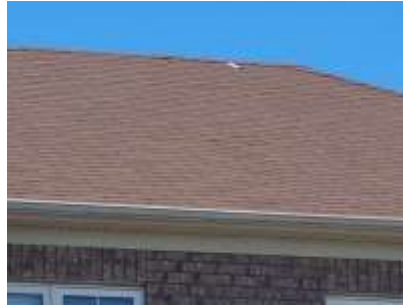
Roof covering is aging, typical builder's original roof covering has about a 15 year life expectancy, budgeting for replacement is advised. There is some cupping of the shingle on one side of the roof and a missing shingle tab, have reviewed and repaired accordingly.

Pic. 2: Original roof covering

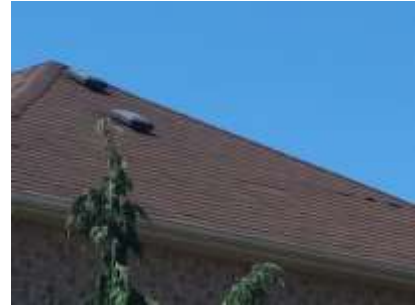
Pic. 3: 1 missing shingle tab and some cupping of the roof covering

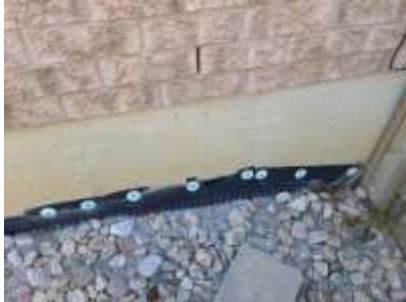
Pic. 4: Typical foundation settlement crack

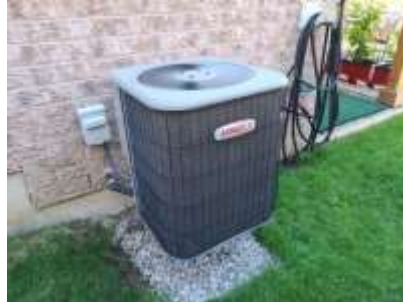
A/C unit was operating in satisfactory condition.

Pic. 5: AC unit 2007

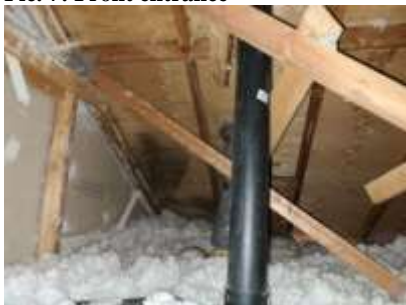
Pic. 10: Attic – one section with old staining – no active moisture present

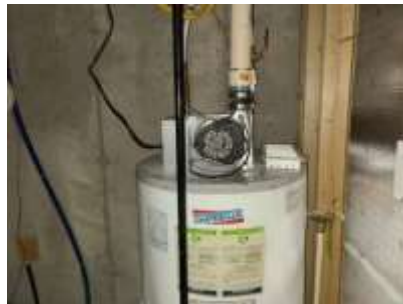
Pic. 23: Rental hot water tank

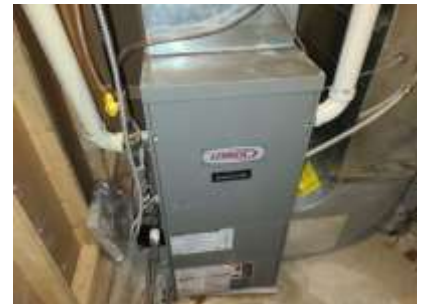
Pic. 24: Gas furnace 2007

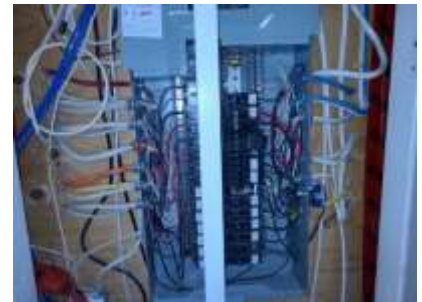
Panel size appeared to be compatible to service size. Branch breaker distribution appeared normal. No signs of overheating were evident at the time of the inspection. Outlets were randomly tested and had correct polarity, except as noted.

Pic. 27: 100 amp breaker panel
