## **PRE-LISTING HOME INSPECTION REPORT**

**262 Kathryn Cres, Newmarket, Ontario**

**Report Number : 21040220**

**Inspection Date: 2021-04-26**

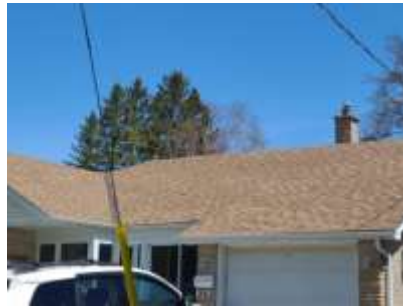
Roof covering appeared in overall satisfactory condition at the time of the inspection.

**Pic. 2: Updated roof covering**

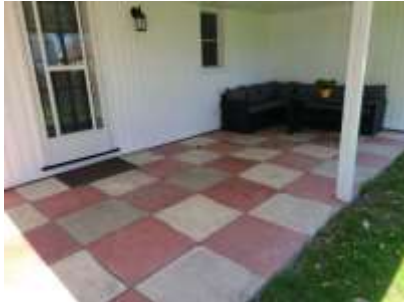
Fencing is not part of a home inspection. General site drainage was properly sloping away from the house. Maintain a positive drainage slope away from the foundation. Rear patio stone do have some slope towards the house recommend leveling the stone to drain away from the foundation.

**Pic. 4: Patio stones with a slight slope towards the foundation, recommended correction**

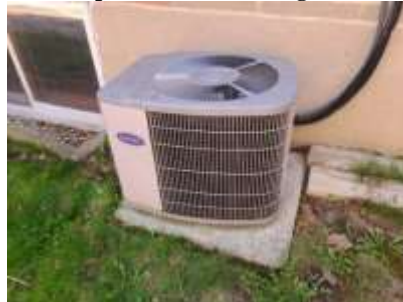
**Pic. 5: AC unit 2005**

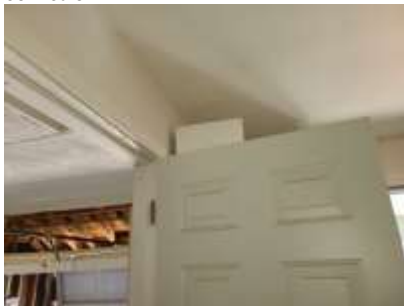
Doors were reviewed and found to be in working order. Lights appeared to be in normal condition: not all lights were tested. Exterior outlets tested were in normal working order. An auto closer is required on the garage entry door for safety.

**Pic. 7: Auto closer needed for garage entry door**

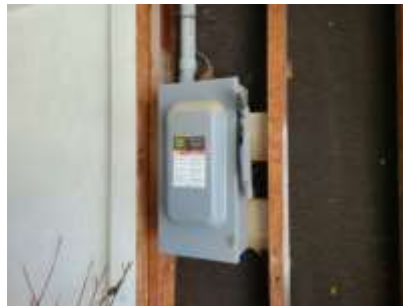
**Pic. 8: Main power disconnect located in garage**

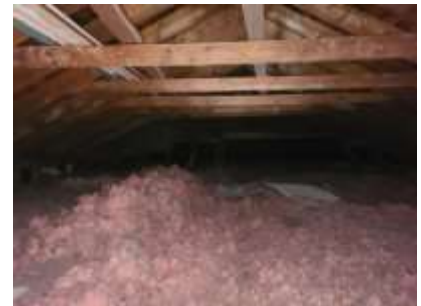
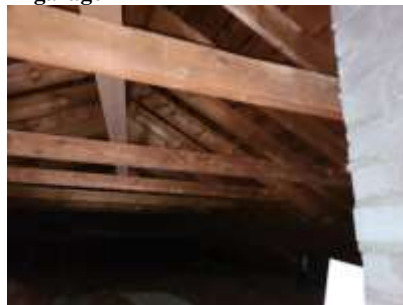
**Pic. 9: Attic**

Trusses showed no major defects or damage at the time of inspection. Roof sheathing, examined from the attic, showed no major defects or moisture damage. Insulation was sufficient for homes in this area. Ventilation was normal. Vapour barrier not visible.

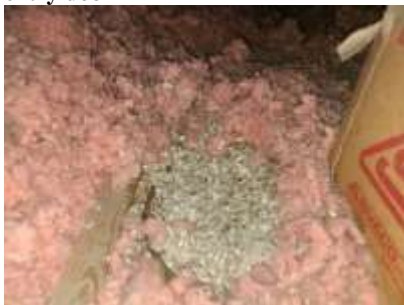
**Pic. 10: Vermiculite insulation present**

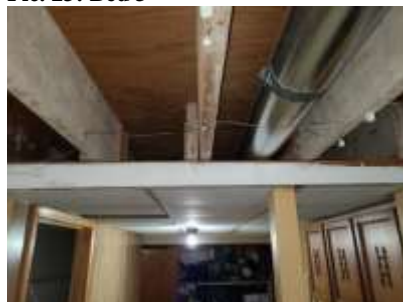
**Pic. 26: Support beam in laundry room, recommend review for proper structural support**

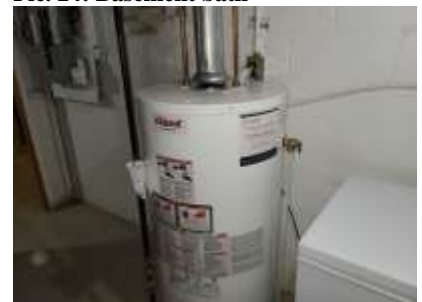
**Pic. 27: Rental hot water tank 2020**

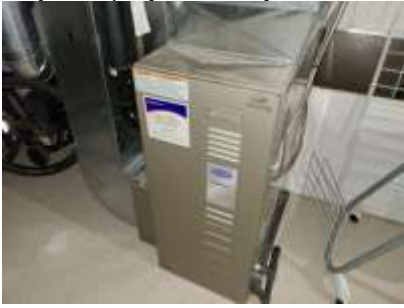
**Pic. 28: Gas furnace 2005**

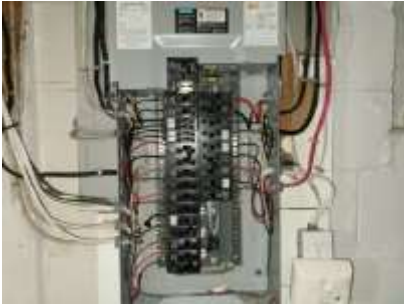
Panel size appeared to be compatible to service size. Branch breaker distribution appeared normal. No signs of overheating were evident at the time of the inspection. Outlets were randomly tested and had correct polarity, except as noted.

**Pic. 31: 100 amp breaker panel with all copper wire**
