PRE-LISTING HOME INSPECTION REPORT

2 Westolivia Trail, Vaughan, Ontario

Report Number : 21030196

Inspection Date: 2021-03-31

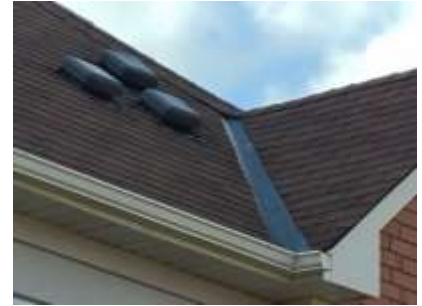
Roof was showing normal wear, but was in overall adequate condition. Budgeting for replacement of the roof covering with next 5 years is advised.

Pic. 3: Original roof covering

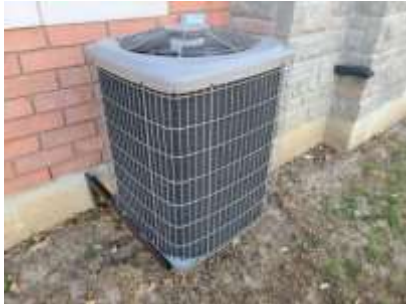
Pic. 4: Original AC unit

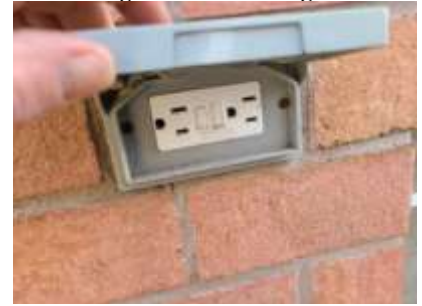
Doors were reviewed and found to be in working order. Lights appeared to be in normal condition: not all lights were tested. Rear exterior GFCI was not operating properly - Repair and/or replace as necessary.

Pic. 6: Rear GFCI outlet needs replacement

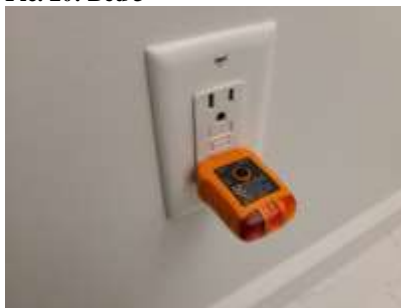
GFCI was not operating properly - Repair and/or replace as necessary. This GFCI outlet protects all three bathrooms.

Pic. 23: Bathroom GFCI defective and needs replacement

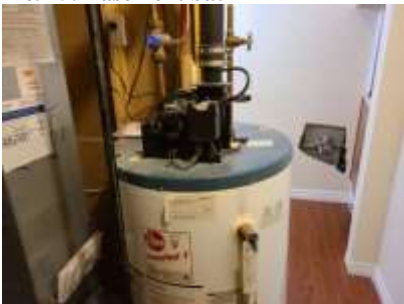
Pic. 28: Original rental hpt water tank

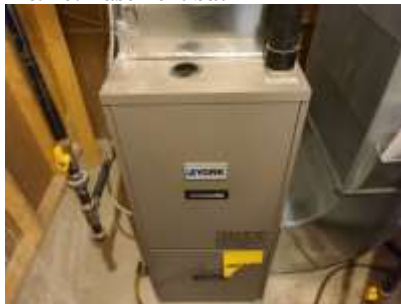
Pic. 29: Original gas furnace
