PRE-LISTING HOME INSPECTION REPORT

31 Mountbatten Rd, Vaughan, Ontario

Report Number : 22010103

Inspection Date: 2022-01-16

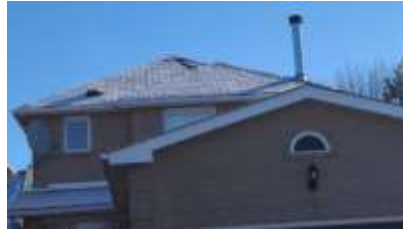
Pic. 2: Limited review of roof covering due to snow covering

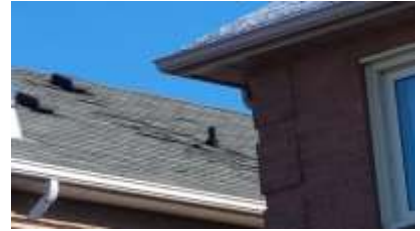
Roof covering in need of repairs - missing shingle tabs

Review of the roof covering was limited by snow covering. Visible section of the roof covering is showing as aging and several shingle tabs are missing, recommend review and repair / replacement as necessary.

Pic. 3: Visible missing shingle tabs on roof

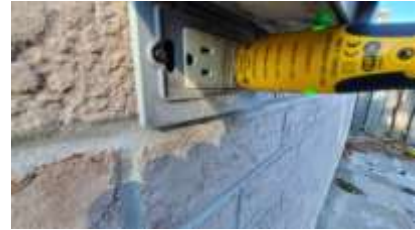
Exterior GFCI outlet defective, won't trip

Doors were reviewed and found to be in working order. Lights appeared to be in normal condition: not all lights were tested. Exterior GFCI was not operating properly - Repair and/or replace as necessary.

Pic. 6: Rear GFCI defective and needs to be replaced

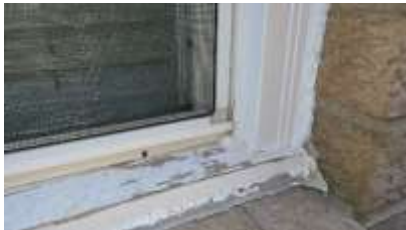
Pic. 7: Painting of window frames where necessary advised

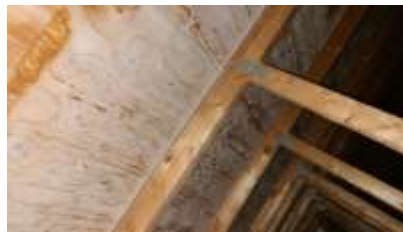
Pic. 11: Some frost buildup in attic

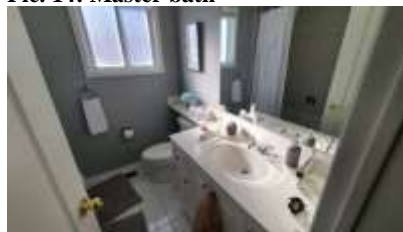
Bathroom GFCI outlet defective, won't trip

At the time of the inspection, the bathroom and its components were found to be in satisfactory condition except as noted. GFCI was not operating properly - Repair and/or replace as necessary.

Pic. 17: 2nd floor bath – GFCI outlet defective and needs to be replaced

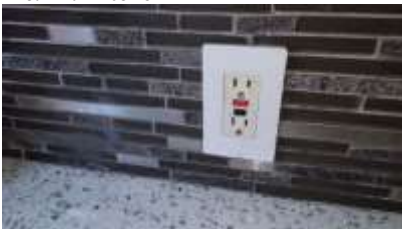
Pic. 25: 15 amp GFCI outlet in kitchen can cause nuisance tripping

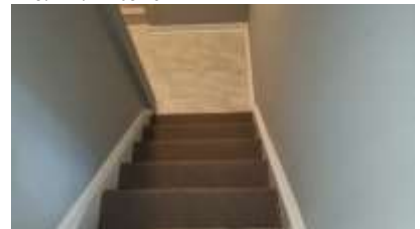
Pic. 27: Handrailing needed for basement stairwell

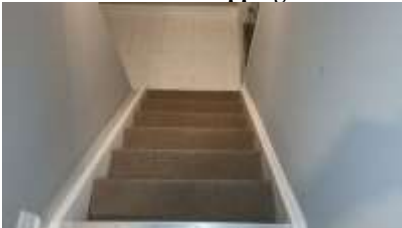
Pic. 28: Handrailing needed for basement stairwell

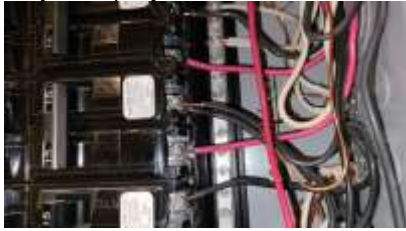
Panel size appeared to be compatible to service size. Branch breaker distribution appeared normal. Except for one breaker which is double tapped and should be reviewed and corrected accordingly. No signs of overheating were evident at the time of the inspection. Outlets were randomly tested and had correct polarity, except as noted.

Pic. 37: One breaker double tapped
