PRE-LISTING HOME INSPECTION REPORT

32 Proudbank Millway, Toronto, Ontario

Report Number : 22030172

Inspection Date: 2022-03-30

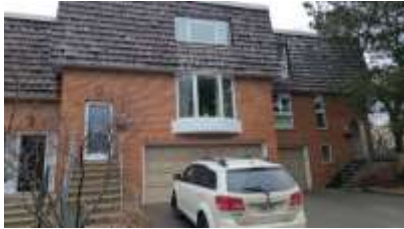
Pic. 1: Front view

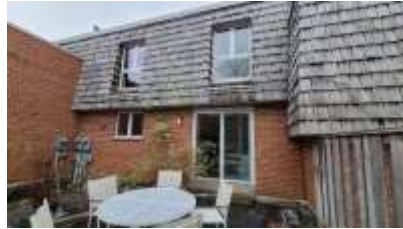
Pic. 2: Back view

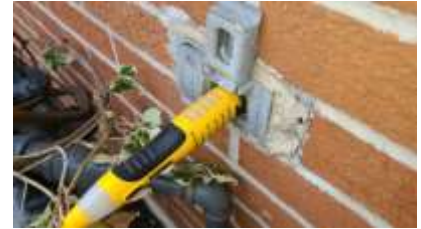
Pic. 3: No power at rear outlet

Doors were reviewed and found to be in working order. Lights appeared to be in normal condition: not all lights were tested. Exterior rear outlet has no power, have reviewed and corrected as necessary. Auto closer is required for the garage entry door for safety.

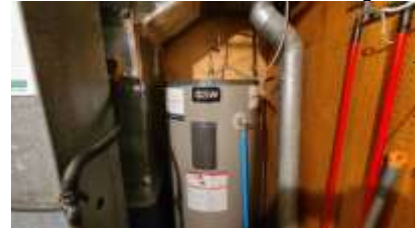
**Pic. 21: Electric hot water tank
2016**

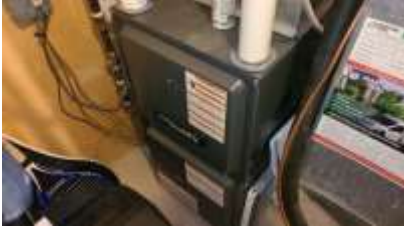
Pic. 22: Gas furnace 2020

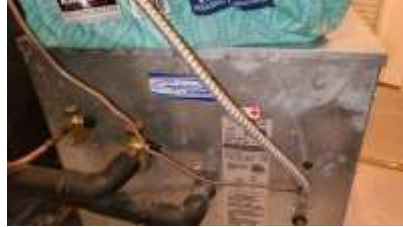
Pic. 23: Water cooled AC chiller

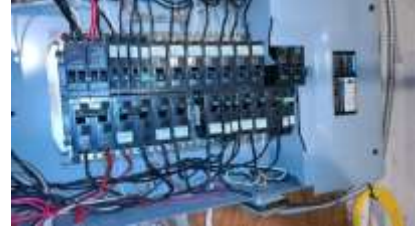
Panel size appeared to be compatible to service size. Branch breaker distribution appeared normal. No signs of overheating were evident at the time of the inspection. Outlets were randomly tested and had correct polarity, except as noted.

Pic. 24: 100 amp breaker panel

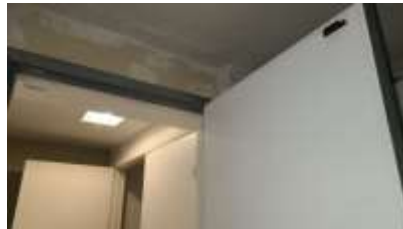
**Pic. 26: No auto closer on garage
entry door**
