PRE-LISTING HOME INSPECTION REPORT

341 La Rocca, Vaughan, Ontario

Report Number : 22020125

Inspection Date: 2022-02-10

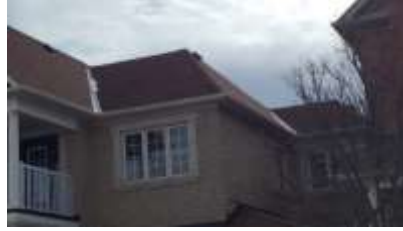
Roof covering appeared in overall satisfactory condition at the time of the inspection. Typical builder's original roof covering ahas an average life expectancy of about 15 years, budget for replacement accordingly.

Pic. 2: Original roof covering

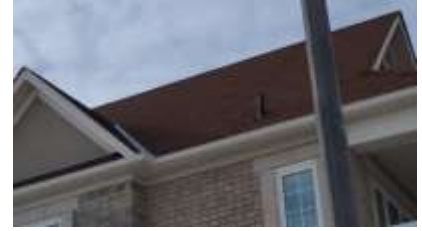
Pic. 3: Original roof covering

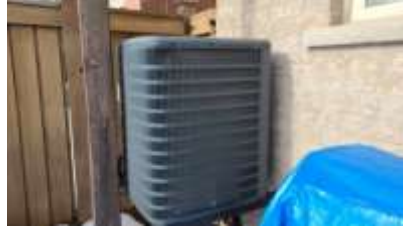
Pic. 5: AC unit 2015

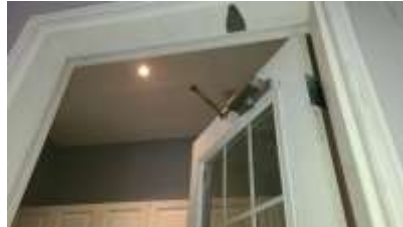
Doors were reviewed and found to be in working order. Lights appeared to be in normal condition: not all lights were tested. Exterior outlets tested were in normal working order. Garage entry door should be a fire rated door, with the window insert in the door it no longer qualifies as a fire rated door.

Pic. 8: Entry door not fire rated

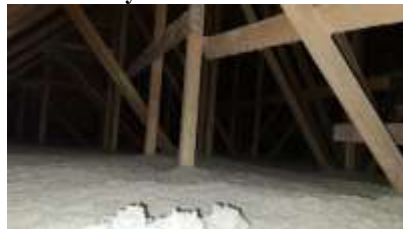
Pic. 11: Attic - updated insulation

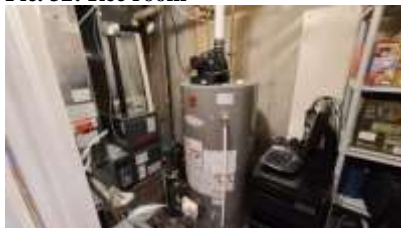
Pic. 35: Rental hot water tank 2015

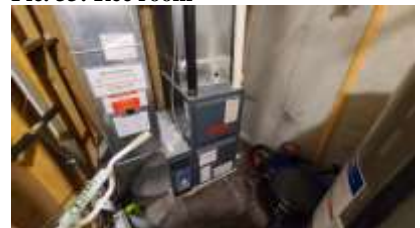
Pic. 36: Gas furnace 2015

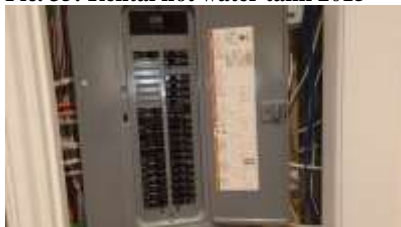
Panel size appeared to be compatible to service size. Branch breaker distribution appeared normal. No signs of overheating were evident at the time of the inspection. Outlets were randomly tested and had correct polarity, except as noted.

Pic. 38: 200 amp breaker panel
