PRE-LISTING HOME INSPECTION REPORT

38 Banshee Lane, Richmond Hill, Ontario

Report Number : 21090396

Inspection Date: 2021-09-27

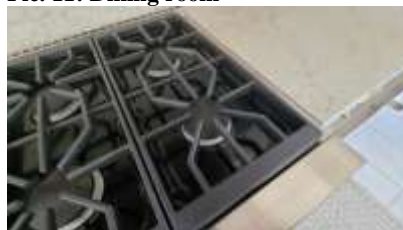
Ground floor deck walkout door - lock disabled as deck in not completed
Front right stove burner would not ignite

Counter top has normal wear. Cabinets have normal wear. Water flow was normal with several fixtures operated at the same time. There were no visible active piping leaks at the time of the inspection. Drain lines had no visible leaks or signs of backup at the time of inspection. Outlets were randomly tested and had correct polarity, except for the outlet to the left of the cooktop, outlet is wired with a reverse polarity and should be corrected accordingly. Front left burner would not ignited, have reviewed and corrected accordingly.

Pic. 14: Front right burner would not ignite

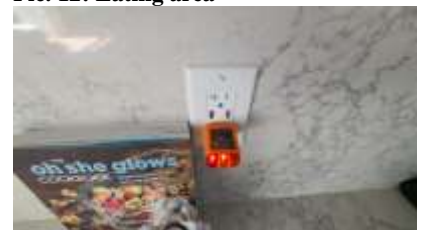
Pic. 15: Outlet to the left of cooktop wired incorrectly

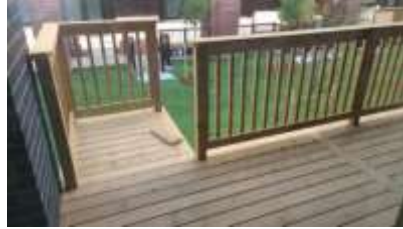
General site drainage was properly sloping away from the house. Maintain a positive drainage slope away from the foundation. Builder is still to install rear deck stairs.

Pic. 23: Stairs to be installed for rear deck by the builder

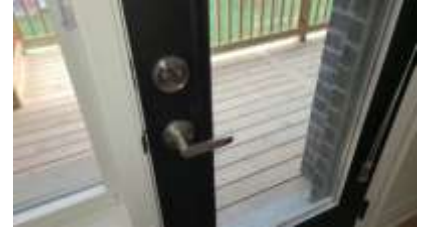
Pic. 24: Door disabled

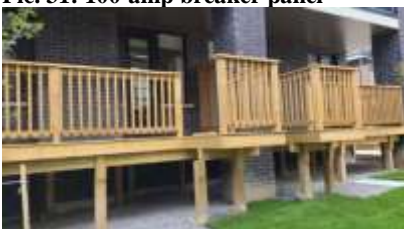
Pic. 34: Steps to be installed by builder for rear deck
