PRE-LISTING HOME INSPECTION REPORT

38 Iveagh Dr, Keswick, Ontario

Report Number : 23100520

Inspection Date: 2023-10-14

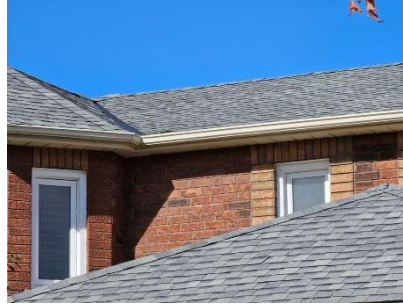
Roof covering appeared in overall satisfactory condition at the time of the inspection.

Pic. 2: Updated roof covering

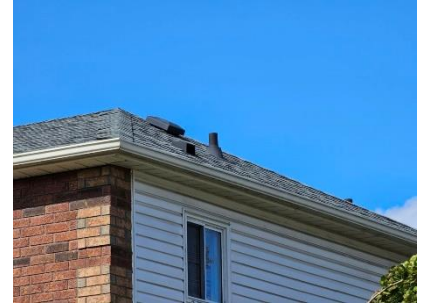
Pic. 3: Updated roof covering

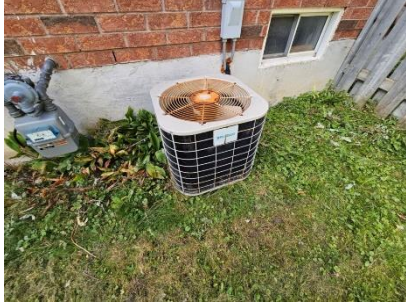
Pic. 4: AC unit – aged

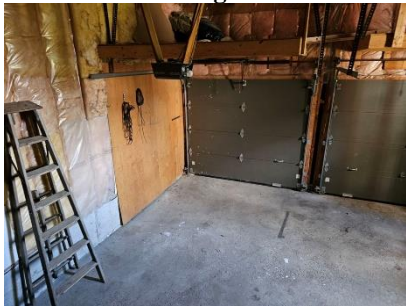
Doors were reviewed and found to be in working order. Lights appeared to be in normal condition: not all lights were tested. Exterior outlets tested were in normal working order. East garage door safety sensors re not properly aligned and need adjusting for door to close properly.

Pic. 7: Garage – east door safety sensor not properly aligned

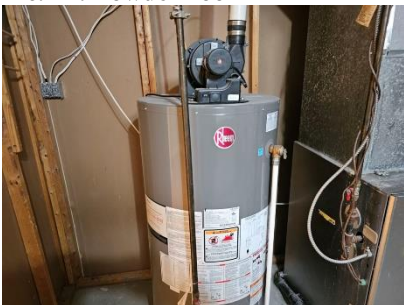
Pic. 25: Rental hot water tank 2015

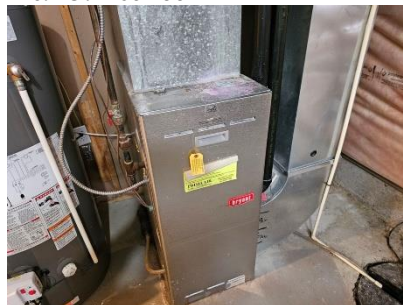
Pic. 26: Gas furnace 1997

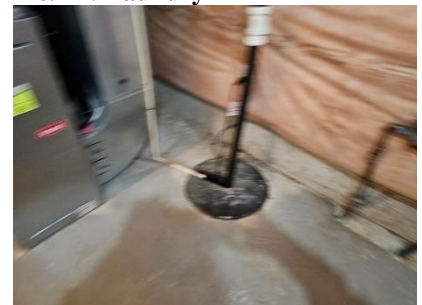
Pic. 27: Sump pump – not working

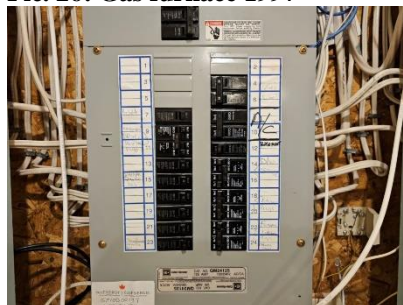
Panel size appeared to be compatible to service size. Branch breaker distribution appeared normal. No signs of overheating were evident at the time of the inspection. Outlets were randomly tested and had correct polarity, except as noted.

Pic. 29: 100 amp breaker panel
