PRE-LISTING HOME INSPECTION REPORT

39 Jerman St, Markham, Ontario

Report Number : 21040222

Inspection Date: 2021-04-27

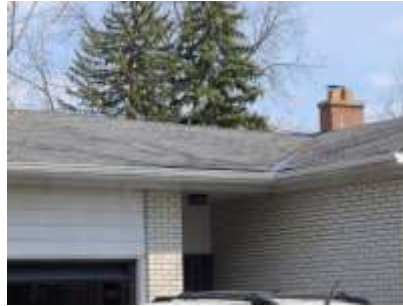
Roof was showing normal wear, but was in overall adequate condition. Roof covering is aging and will need to be replaced anytime within the next 5 years.

Pic. 2: Roof covering – aging but still functional

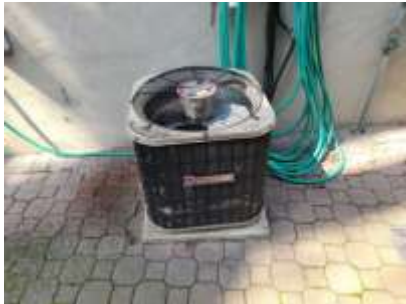
Doors were reviewed and found to be in working order. Lights appeared to be in normal condition: not all lights were tested. Exterior outlets tested were in normal working order. AC unit is aged and past its useful life expectancy, budget for replacement.

Pic. 4: AC unit 1984

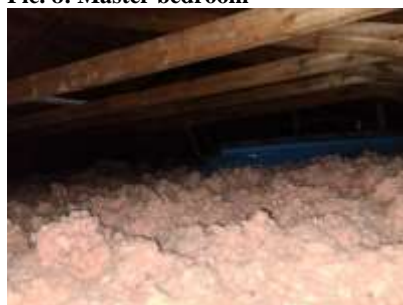
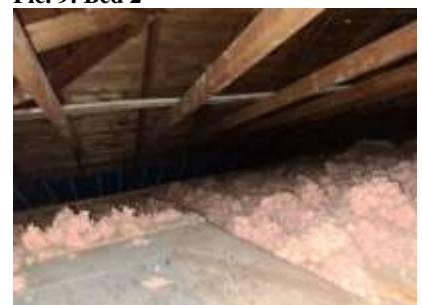
Trusses showed no major defects or damage at the time of inspection. Roof sheathing, examined from the attic, showed no major defects or moisture damage. Insulation was normal for the age of the home; additional insulation would be helpful. Ventilation was normal. Vapour barrier not visible.

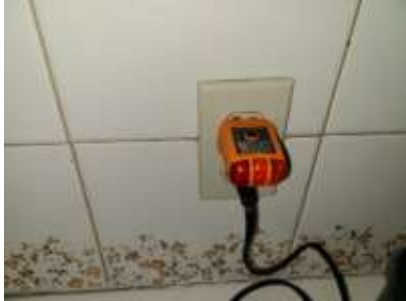
Counter top has normal wear. Several cabinet door & drawers are missing, recommend replacing where necessary. Water flow was normal with several fixtures operated at the same time. There were no visible active piping leaks at the time of the inspection. Drain lines had no visible leaks or signs of backup at the time of inspection. Outlet to the right of the sink has a reverse polarity and should be corrected for safety.

Pic. 19: Reverse polarity outlet in kitchen

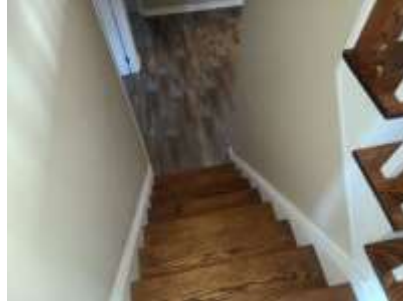
Foundation appeared to be in overall satisfactory condition. Foundation walls were covered/partially covered with paneling/drywall/insulation and were not visible. No representation can be made to the conditions of the covered/partially covered walls. Floor appeared to be in overall satisfactory condition. No active seepage visible at the time of the inspection. No representation can be made to future leaking of the basement walls. A handrailing for the basement stairwell is advised for safety.

Pic. 20: No hand railing for basement stairwell

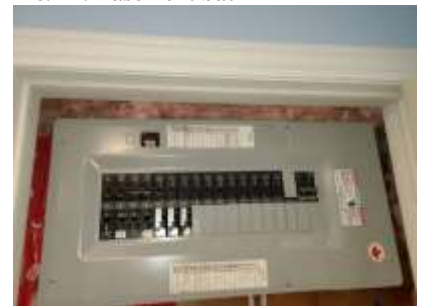
Panel size appeared to be compatible to service size. Branch breaker distribution appeared normal. No signs of overheating were evident at the time of the inspection. Outlets were randomly tested and had correct polarity, except as noted.

Pic. 27: 100 amp breaker panel
