INSPECTION REPORT

For the Property at:
40 GRAND TRUNK AVENUE
VAUGHAN, ON L6A 0X9

Prepared for: DAVE ELFASSY
Inspection Date: Monday, June 10, 2024
Prepared by: Stefano Ramacciato

RE: Report No. 3311
40 Grand Trunk Avenue
Vaughan, ON
L6A 0X9

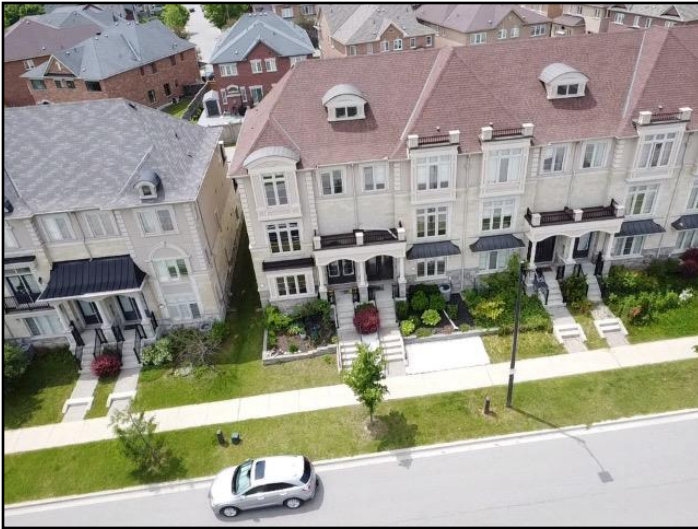
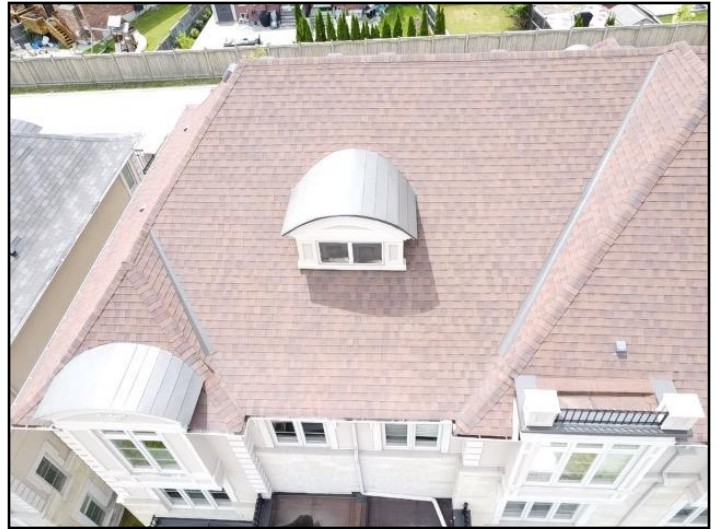
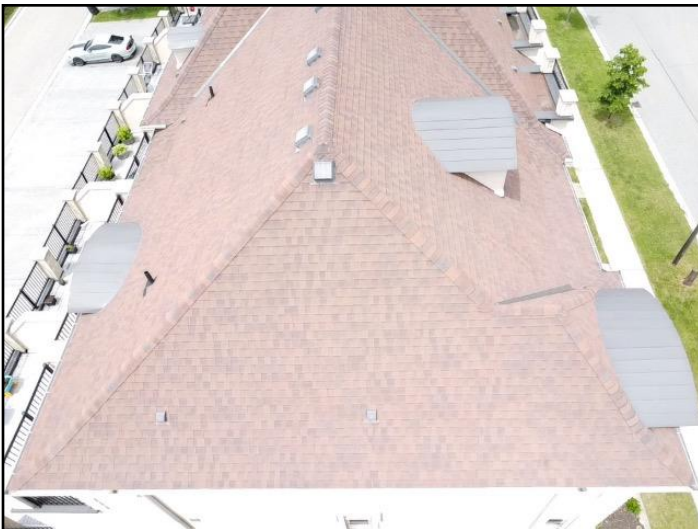
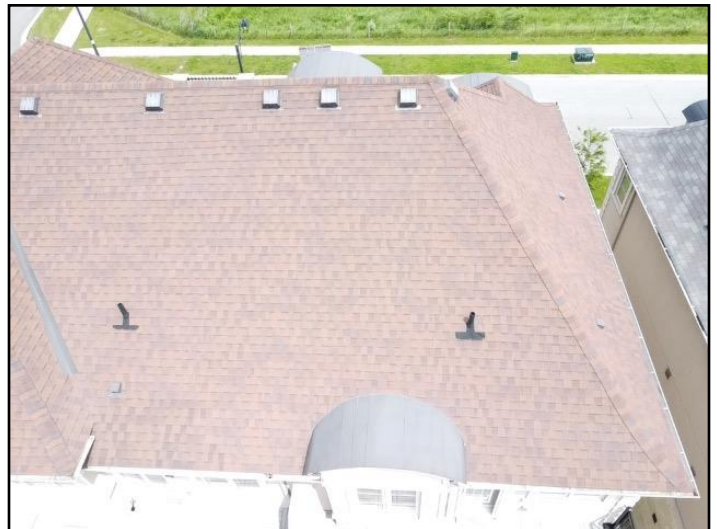
In great condition.

Approximately age 10 year old.

Probability of leakage is low.

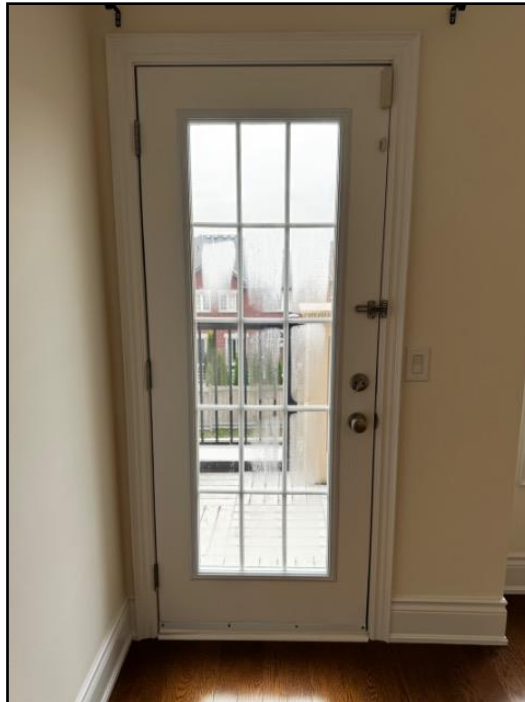
6. *Lost seal*

1. **Condition:** • [Lost seal](#)

Implication(s): Shortened life expectancy of material | Nuisance

Location: Rear Third Floor Balcony

Task: Repair

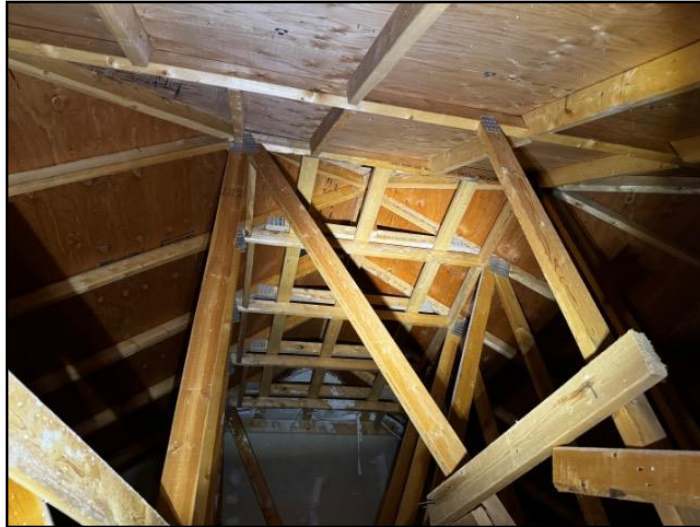
7.

No signs of water damage, mold or structural issues.

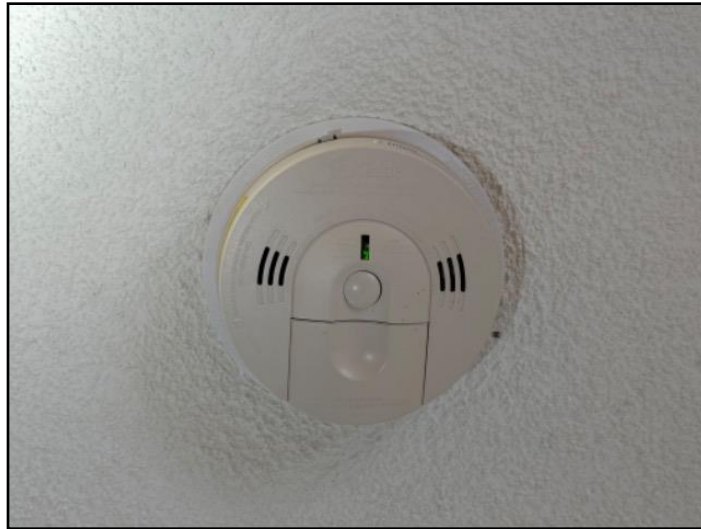
9.

2. Condition: • None observed

Implication(s): Health hazard

Location: First Floor

Task: Replace

Time: Immediate

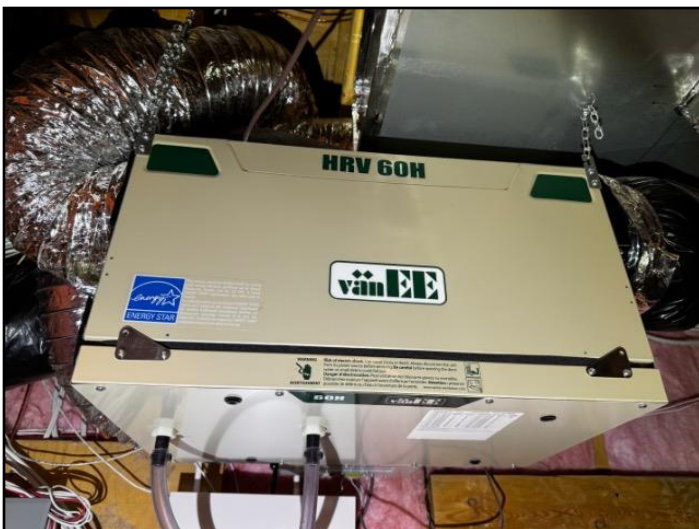
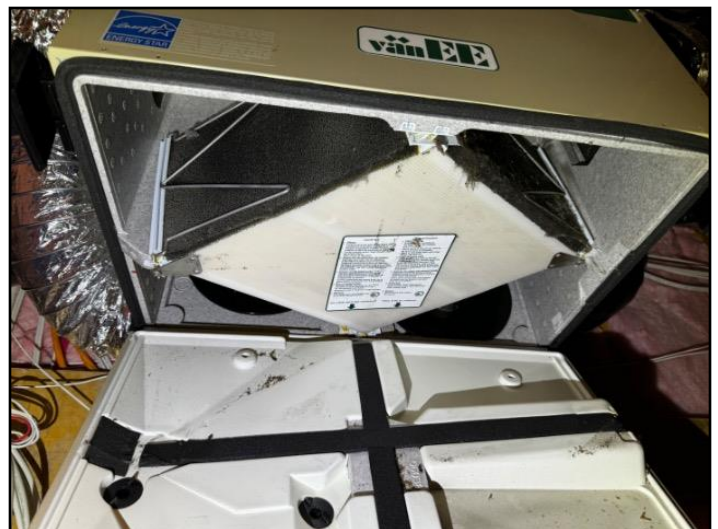
- Heat recovery ventilator (HRV)
- Located in the mechanical room.
Dirty Filters
Wash filters every 3 to 6 months.
Control pad is beside the thermostat.

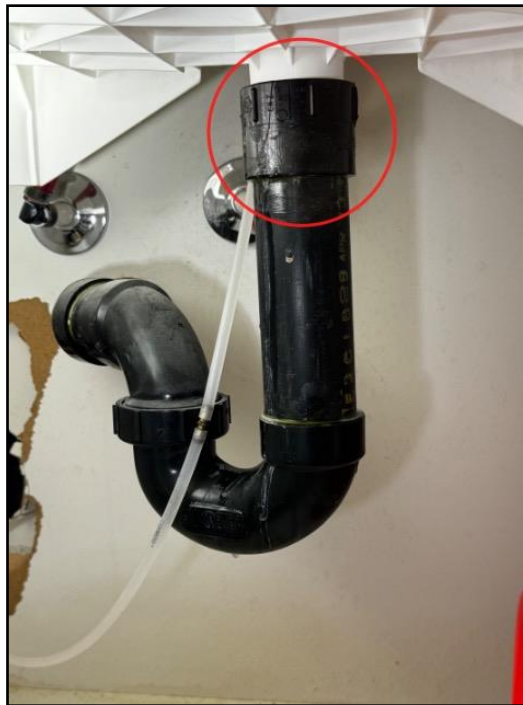
25.

3. Condition: • Water leak on the pipe connection.

Location: First Floor Laundry Tub

Task: Repair

Time: Immediate

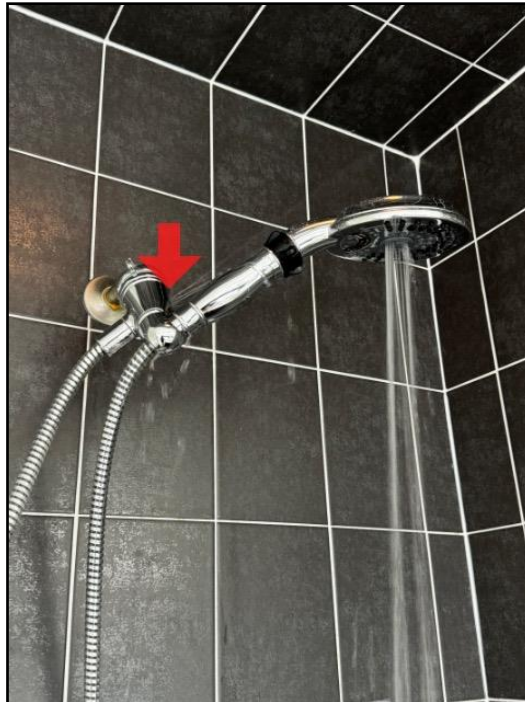
26.

4. Condition: • Leaking shower head

Location: Ensuite Bathroom

Task: Replace

Time: ASAP

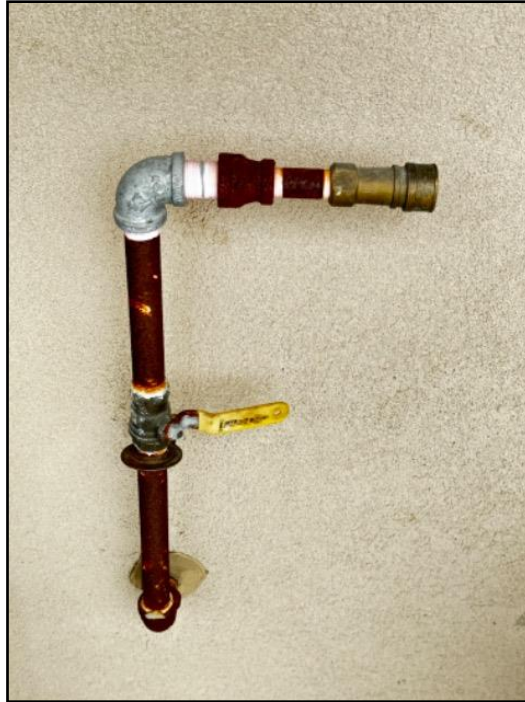
27.

General: • Installed barbeque gas line with shut off valve located rear balcony.
Rusty pipe needs repainting.

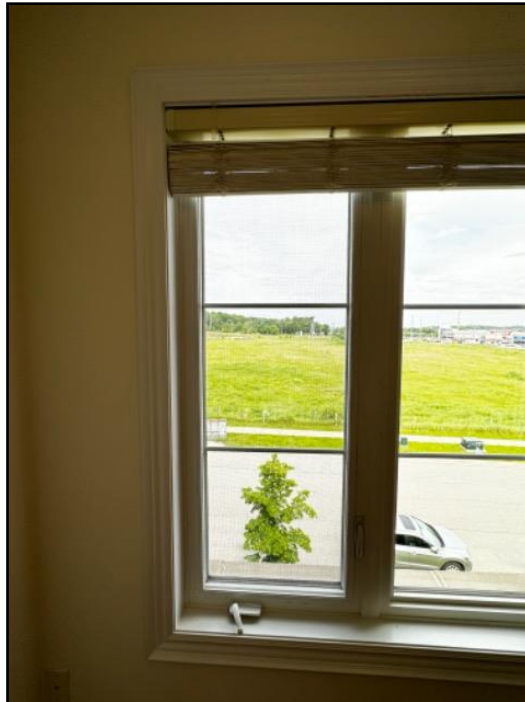
37.

5. Condition: • Difficult to open

Location: Front Third Floor Right Bedroom

Task: Repair

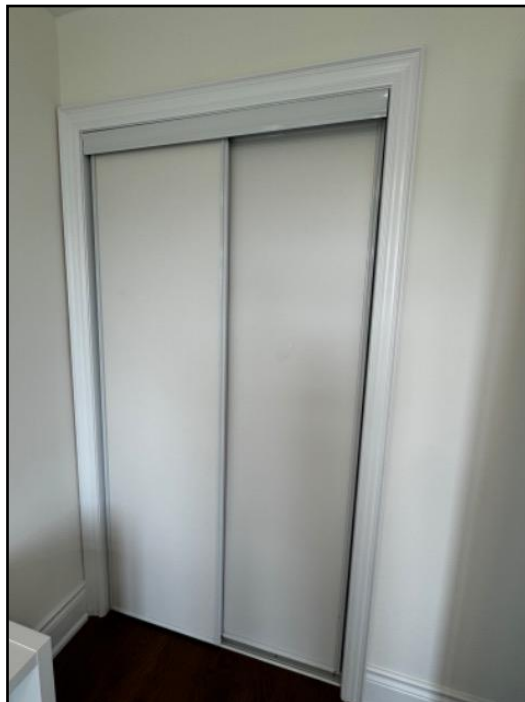
38.

6. **Condition:** • Needs adjustment

Location: Front Third Floor Left Bedroom Closet

Task: Repair

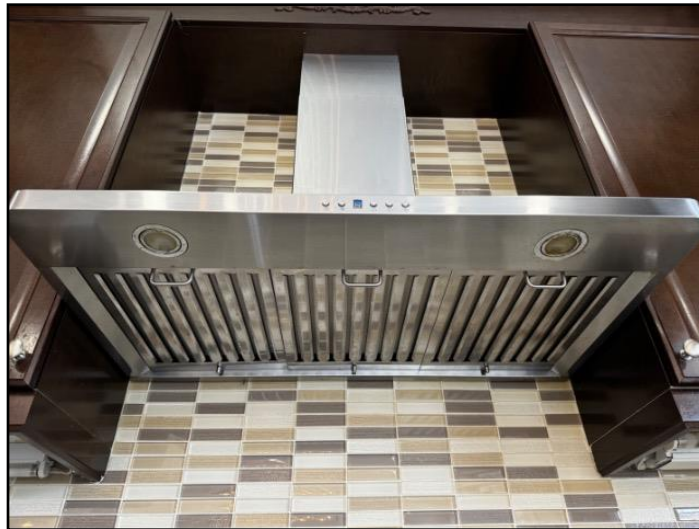
39.

7. Condition: • Noisy

Task: Repair

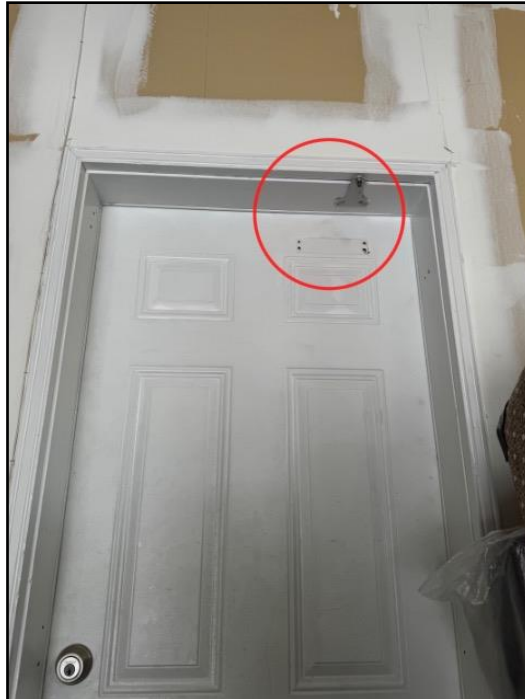
40.

8. Condition: • No self closer

Task: Correct
