PRE-LISTING HOME INSPECTION REPORT

48 Summit Dr, Vaughan, Ontario

Report Number : 21110436

Inspection Date: 2021-11-05

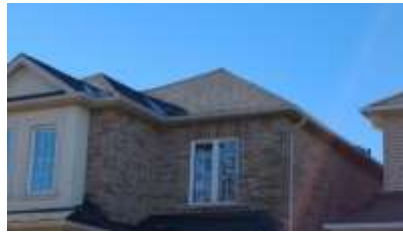
Roof was showing normal wear, but was in overall adequate condition. Original builder's roof covering has a normal life expectancy of about 15 years, budget for replacement accordingly.

Pic. 2: Original roof covering

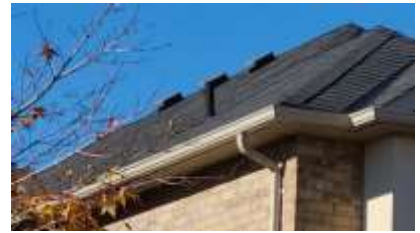
Pic. 3: Original roof covering

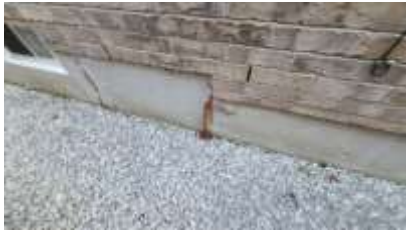
Pic. 4: Repaired foundation cracks

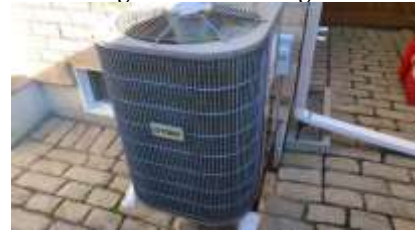
Pic. 6: AC unit 2007

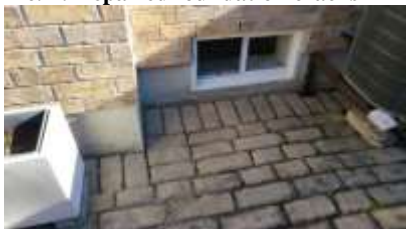
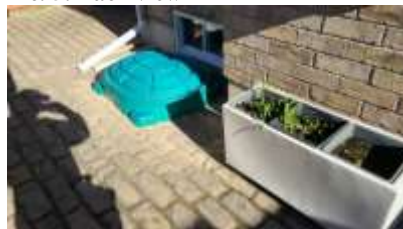
Pic. 7: Rear patio sloped towards the foundation recommend regrading

Pic. 8: Rear patio sloped towards the foundation recommend regrading

Fencing is not part of a home inspection. General site drainage was properly sloping away from the house. Maintain a positive drainage slope away from the foundation. Rear patio bricks have some settlement along the back wall of the home, recommend regrading the patio bricks along the back wall.

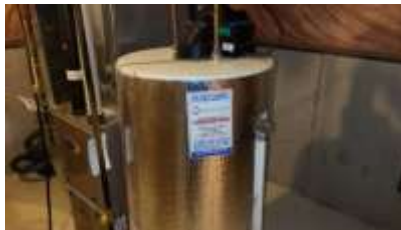
Pic. 29: Hot water tank 2014

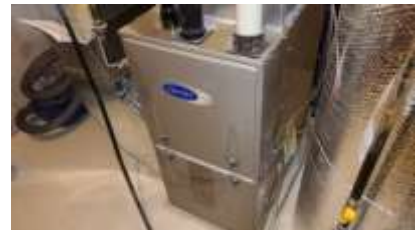
Pic. 30: Gas furnace 2017

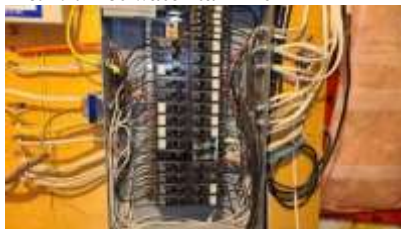
Panel size appeared to be compatible to service size. Branch breaker distribution appeared normal. No signs of overheating were evident at the time of the inspection. Outlets were randomly tested and had correct polarity, except as noted.

Pic. 32: 100 amp breaker panel with all copper wire
