PRE-LISTING HOME INSPECTION REPORT

525 Cody Cres, Newmarket, Ontario

Report Number: 23070396

Inspection Date: 2023-07-24

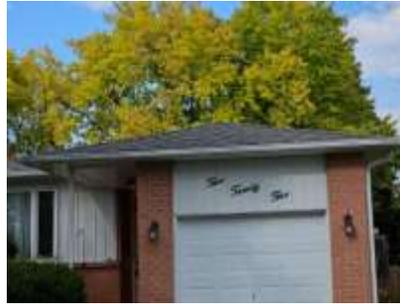
Roof covering appeared in overall satisfactory condition at the time of the inspection.

Pic. 2: Updated roof covering

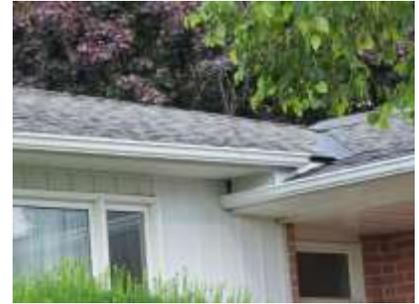
Pic. 3: Updated roof covering

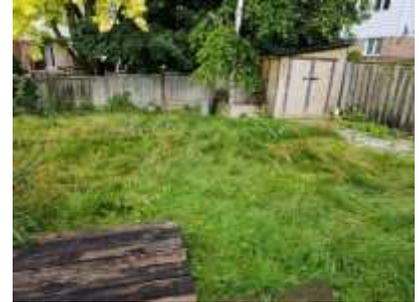
Fencing is not part of a home inspection. General site drainage was properly sloping away from the house. Maintain a positive drainage slope away from the foundation. Backyard grass maintenance needed, overgrown.

Pic. 6: Grass overgrown

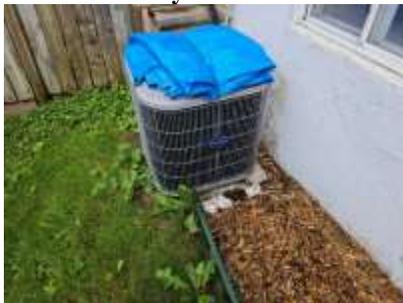
A/C unit was operating in satisfactory condition.

Pic. 7: AC unit 2022

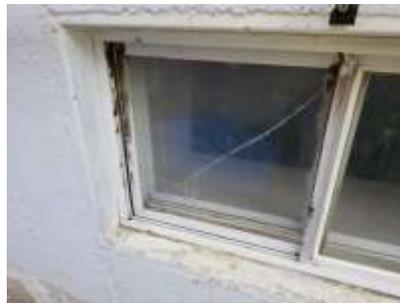
Smoke detector over 5 years old
Cracked basement window panel

At the time of the inspection the room was found to be in overall satisfactory condition. One window panel has a cracked glass panel, replace accordingly.

Pic. 8: Cracked window panel

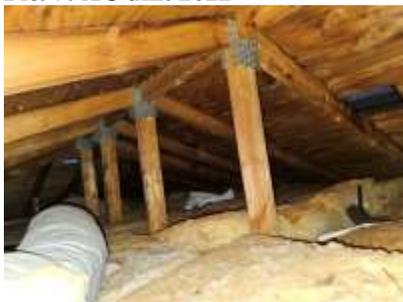
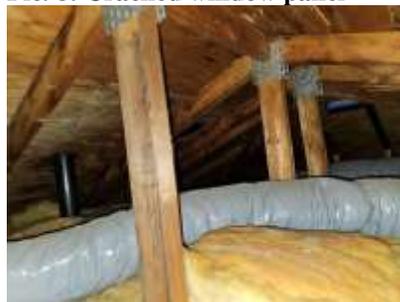
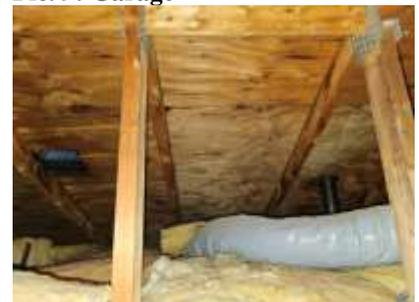
Trusses showed no major defects or damage at the time of inspection. Roof sheathing, examined from the attic, showed no major defects or moisture damage. Insulation was normal for the age of the home; additional insulation would be helpful. Additional soffit venting would be helpful. Vapour barrier not visible.

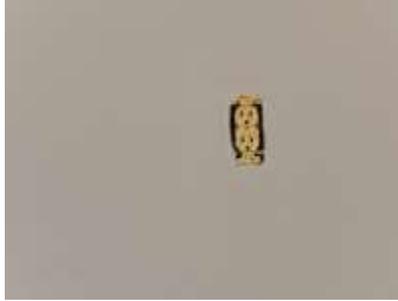
Pic. 17: Missing cover plate

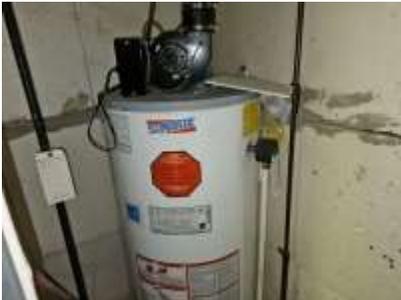
Pic. 25: Hot water tank 2011

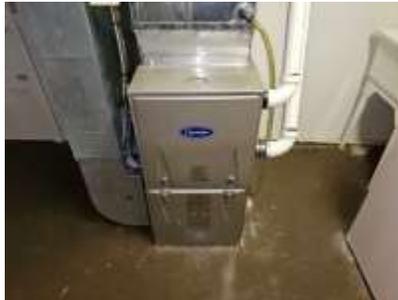
Pic. 26: Gas furnace 2022

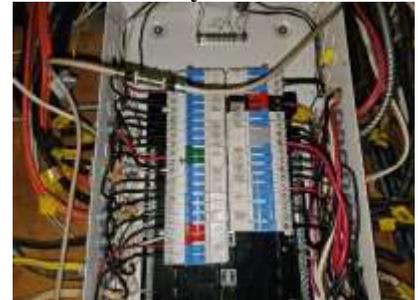
Panel size appeared to be compatible to service size. Branch breaker distribution appeared normal. No signs of overheating were evident at the time of the inspection. With the presents of solid conductor branch aluminum wiring, insurance companies may require an ESA (Electrical Safety Authority) inspection confirming correct bonding of the aluminum wiring for insurability of the home. Outlets were randomly tested and had correct polarity, except as noted.

Pic. 27: 100 amp breaker panel with copper and aluminum wiring
