# INSPECTION REPORT

For the Property at:  
**53 MINTWOOD ROAD**  
THORNHILL, ON L4J 9C3

RE: Report No. 3288  
53 Mintwood Road  
Thornhill, ON  
L4J 9C3

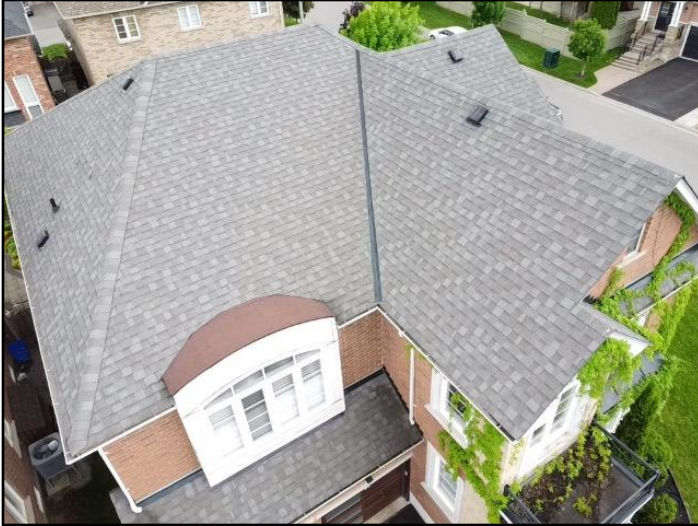
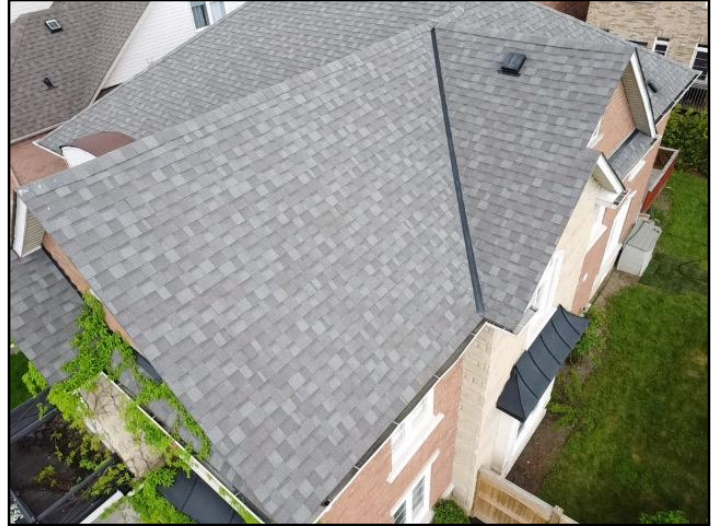
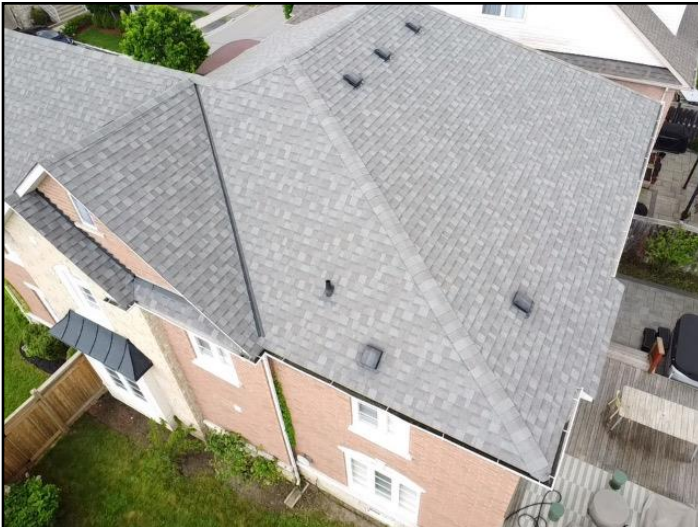
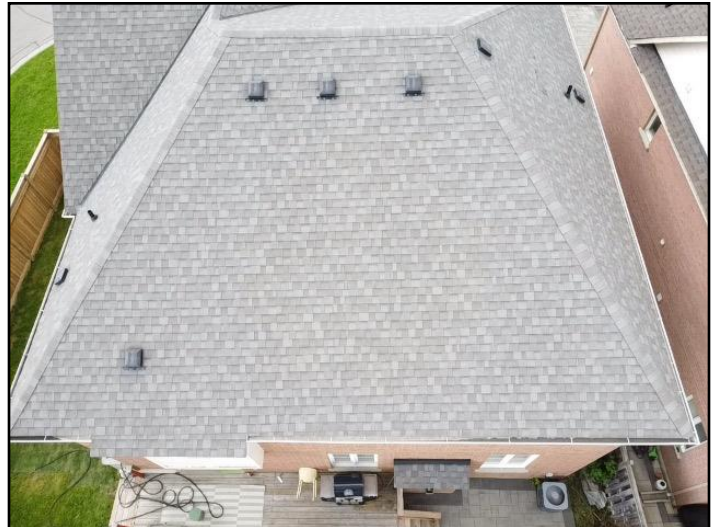
In great condition.

Approximately age 10 years old.

Probability of leakage is low.

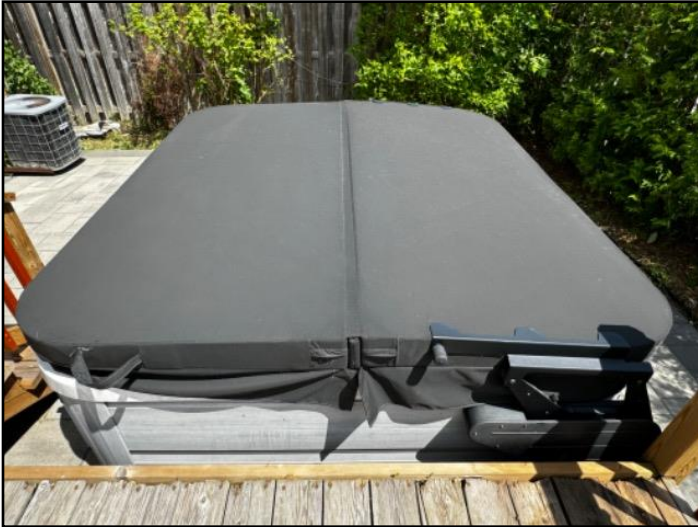
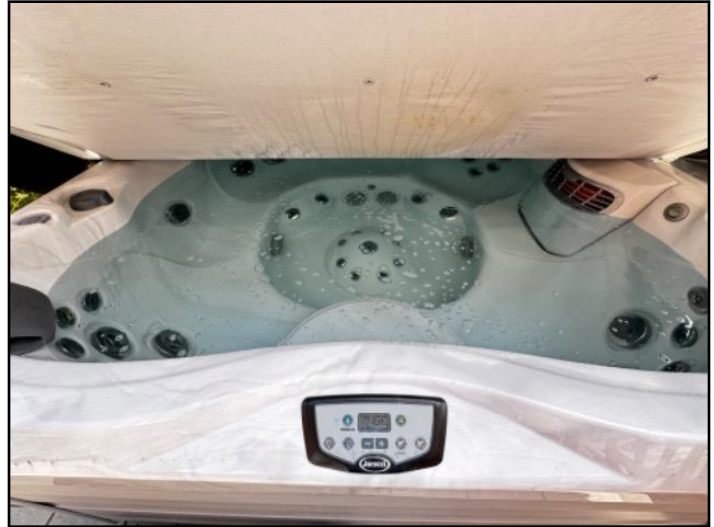
**General:** • Installed hot tub.  
In good working condition.

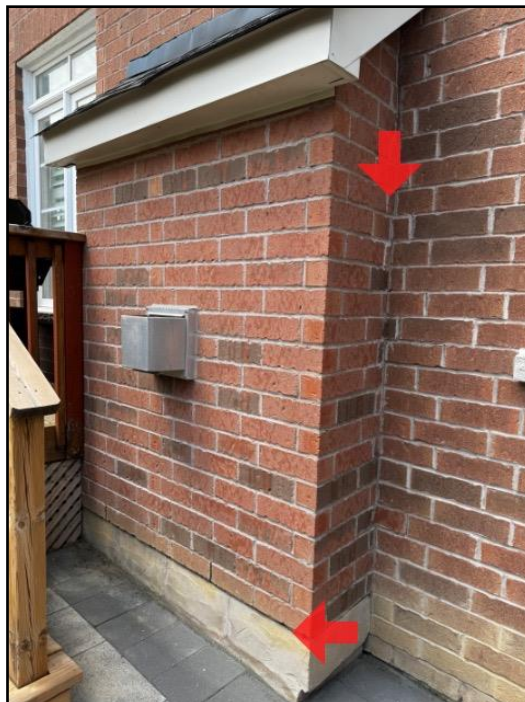
11.

2. **Condition:** • Cracked mortar

**Location:** Rear Exterior Wall

**Task:** Repair

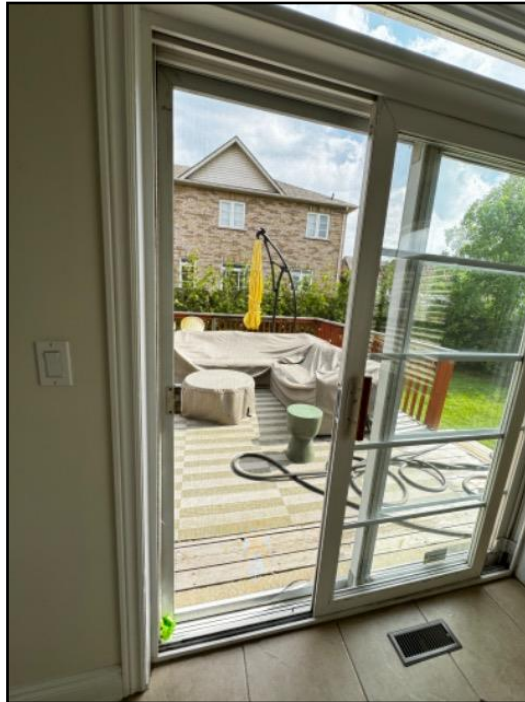
12.

**3. Condition:** • Torn bug screen

**Location:** Rear Exterior Wall

**Task:** Repair

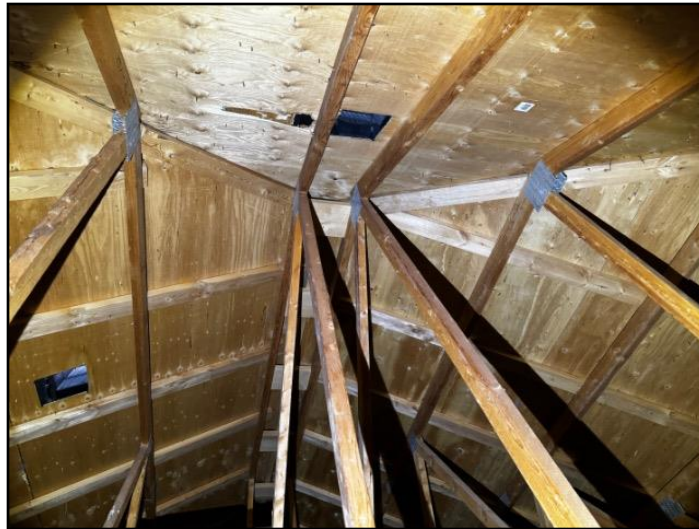
13.

No signs of water damage or structural issues.

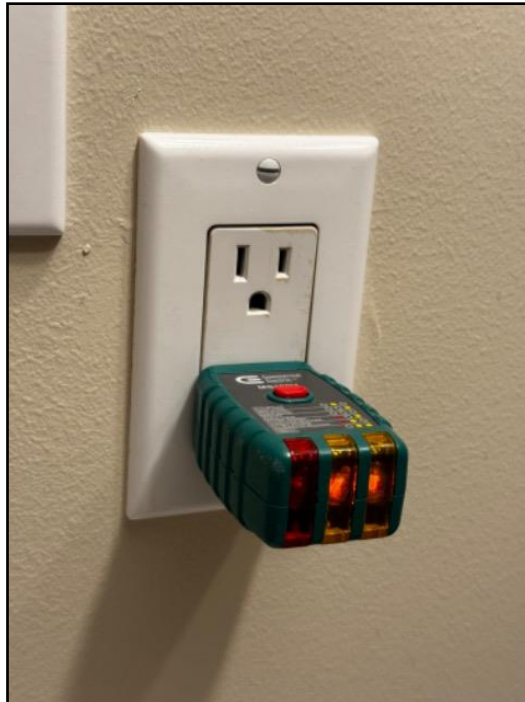
16.

**4. Condition:** • GFCI receptacle needed

**Location:** Basement Washroom

**Task:** Correct

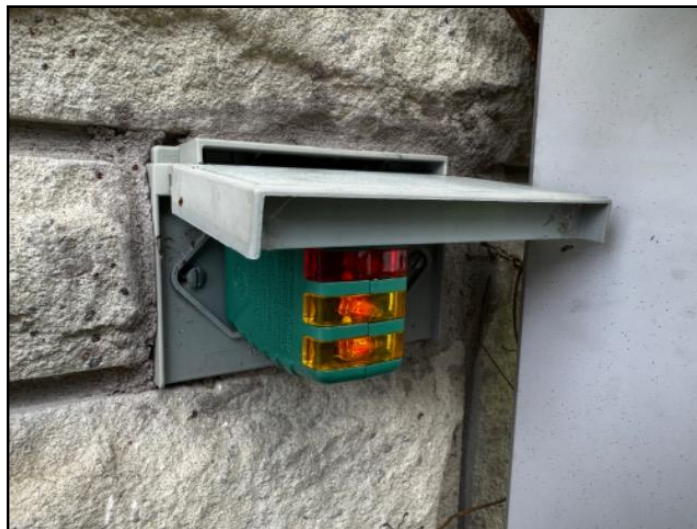
**5. Condition:** • Test faulty on GFCI/GFI (Ground Fault Circuit Interrupter)

**Location:** Front Exterior Porch

17. Test faulty on GFCI/GFI (Ground Fault...

**Task:** Replace

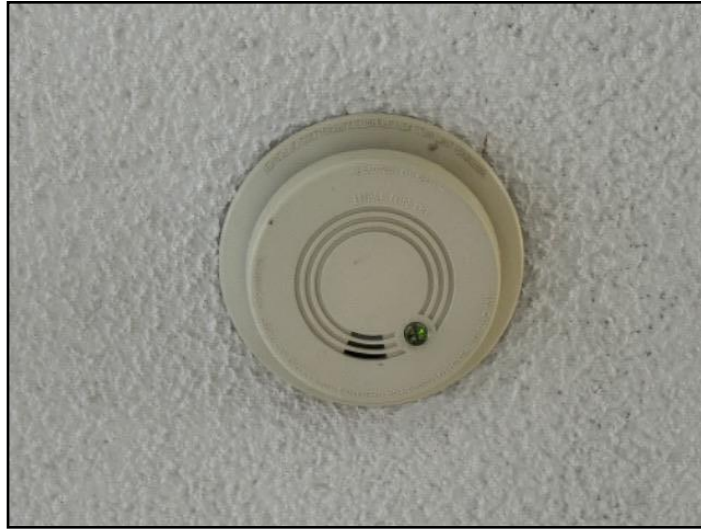
**6. Condition:** • Old

**Implication(s):** Life safety hazard

**Location:** First Floor & Basement

18. *Old*

Install combo units, Carbon Monoxide & Smoke

**Task:** Replace

**Time:** ASAP

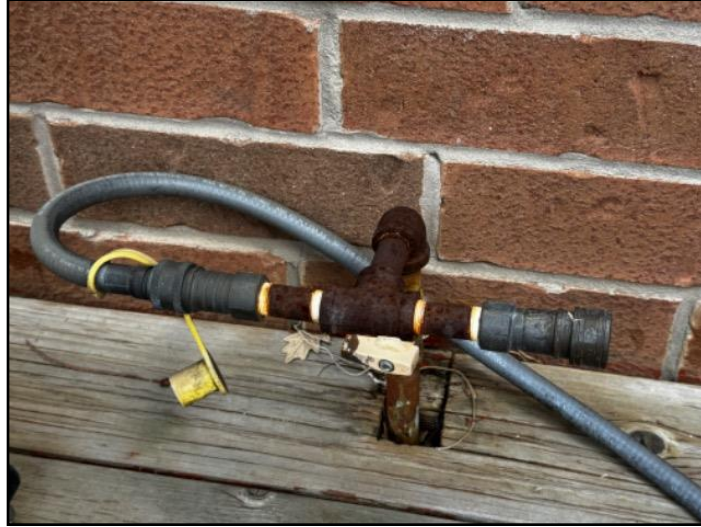
19.

**General:** • Installed barbeque gas line with shut off valve.  
Rusty pipe needs repainting.

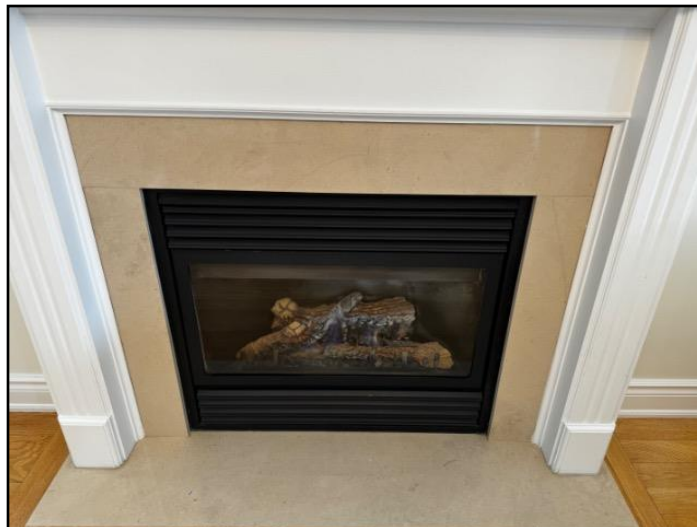
22.

Gas fireplaces in good working condition.

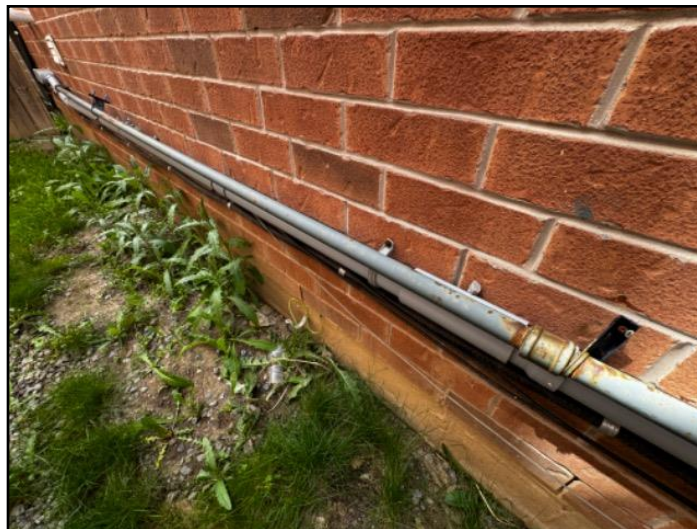
24.

**7. Condition:** • Loose gas pipe.

**Location:** Left Side Exterior Wall

**Task:** Repair support brackets

**Time:** ASAP

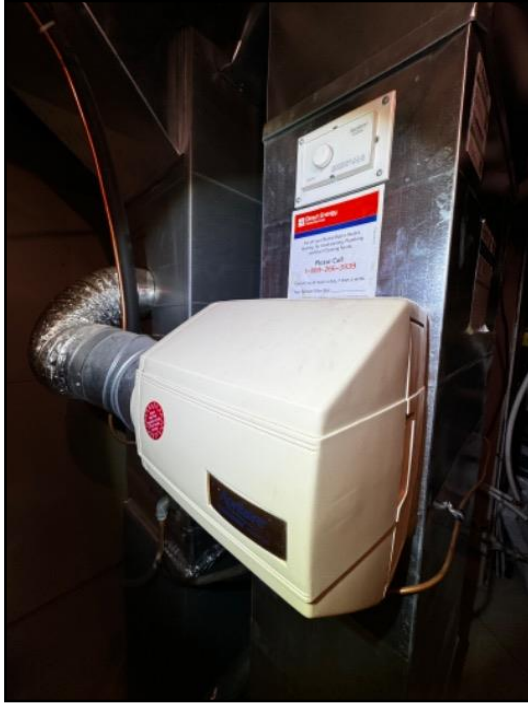
**8. Condition:** • Not connected to a water line.

**Location:** Basement Furnace Room

25. Trickle/cascade type

**Task:** Repair

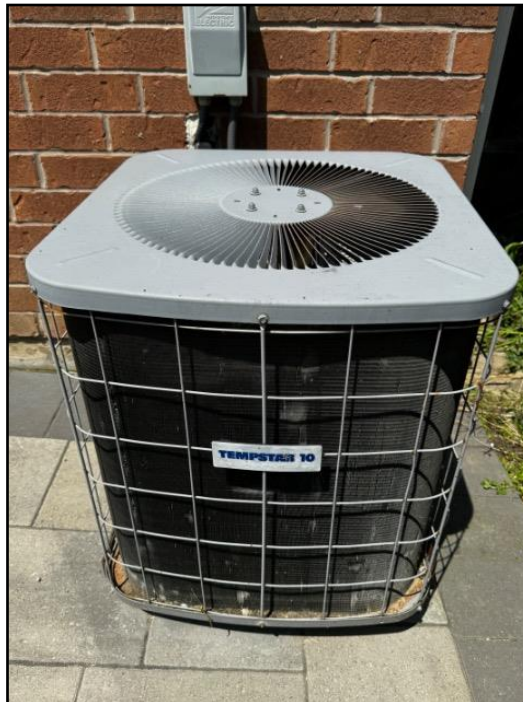
27.

**9. Condition:** • Old Unit

In good working condition.

**Location:** Rear Exterior Wall

Budget for replacement in the future

**Task:** Service annually

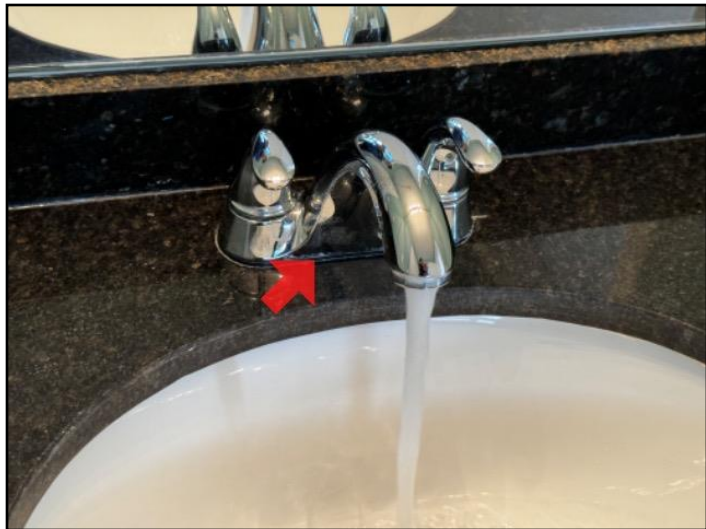
34.

**10. Condition:** • Loose faucet

**Location:** Jack & Jill Bathroom

**Task:** Repair

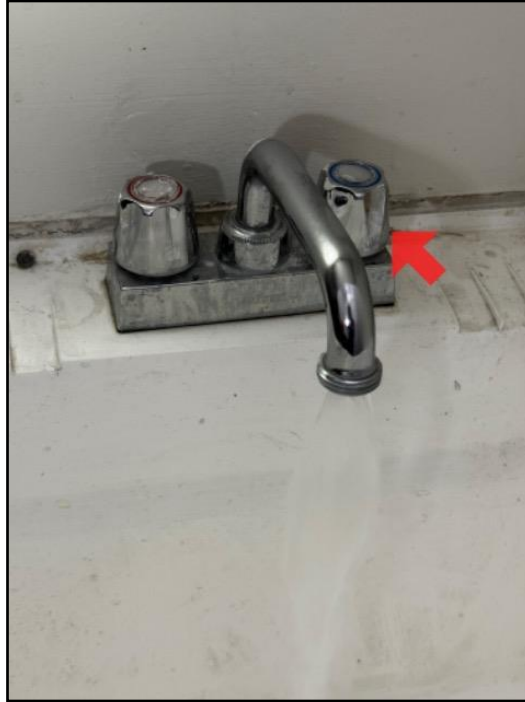
35.

**11. Condition:** • Leaking faucet hand valve.

**Location:** Laundry Room Tub

**Task:** Repair

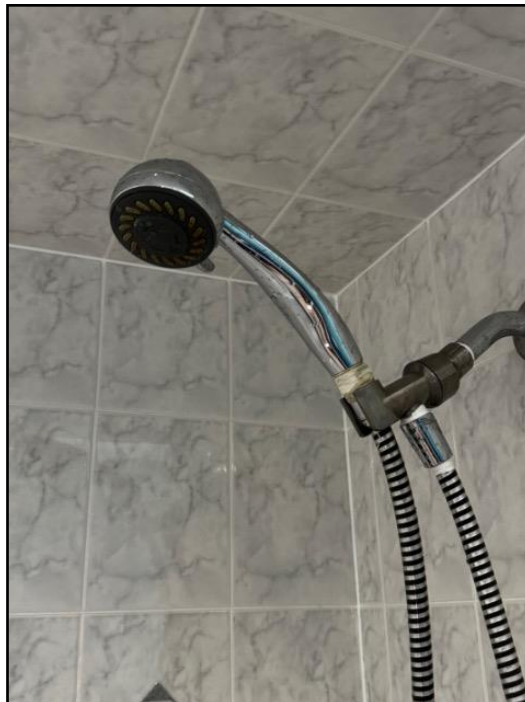
36.

**12. Condition:** • Leaking shower head

**Location:** Jack & Jill Bathroom

**Task:** Replace

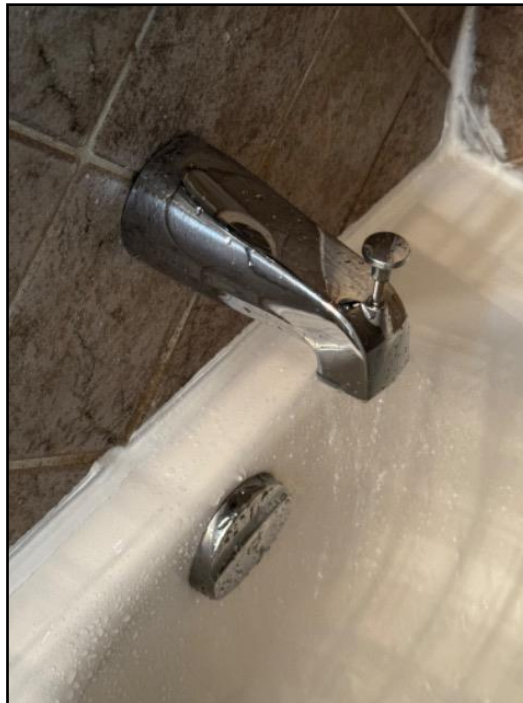
37.

**13. Condition:** • Leaking spout due to sediment buildup.

**Location:** Front Second Floor Bathroom

**Task:** Replace

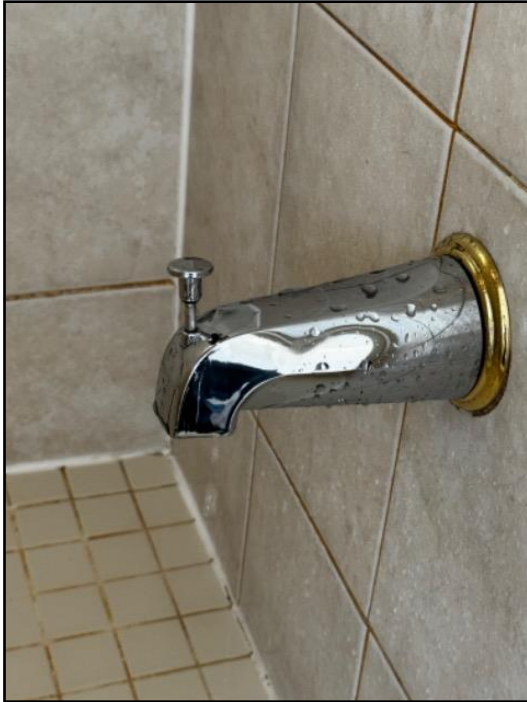
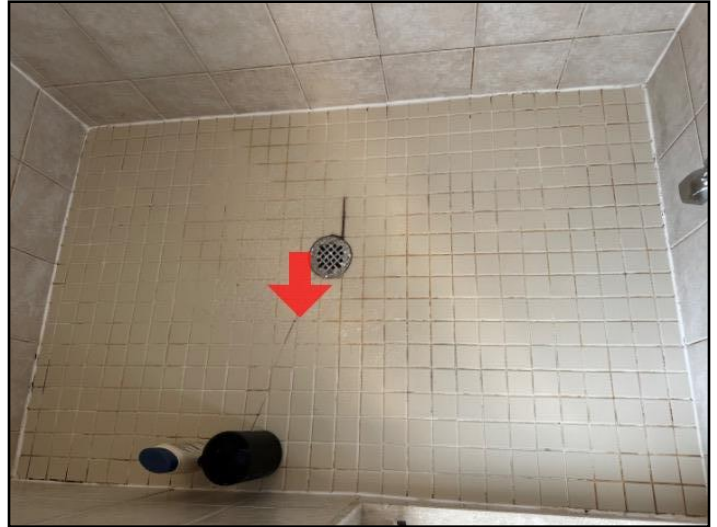
**14. Condition:** • Seized pulled pin on the spout.

Visible cracked tile repaired with silicone caulking.

**Location:** Ensuite Bathroom

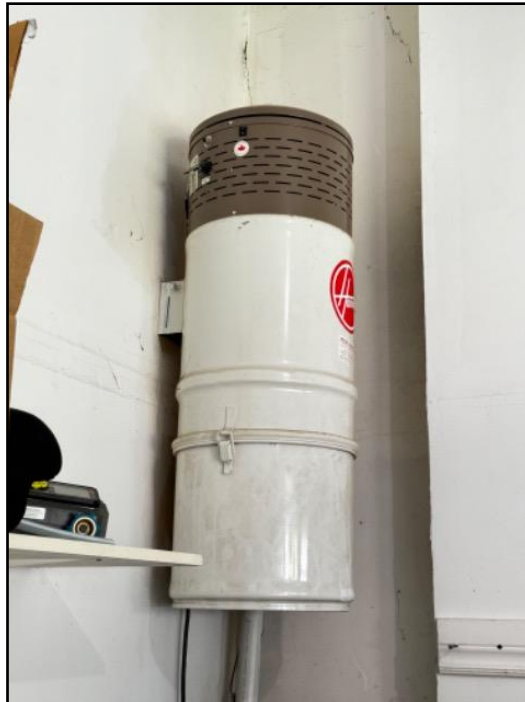
48.

Inventory Central Vacuum: • Unable to test unit was unplugged.

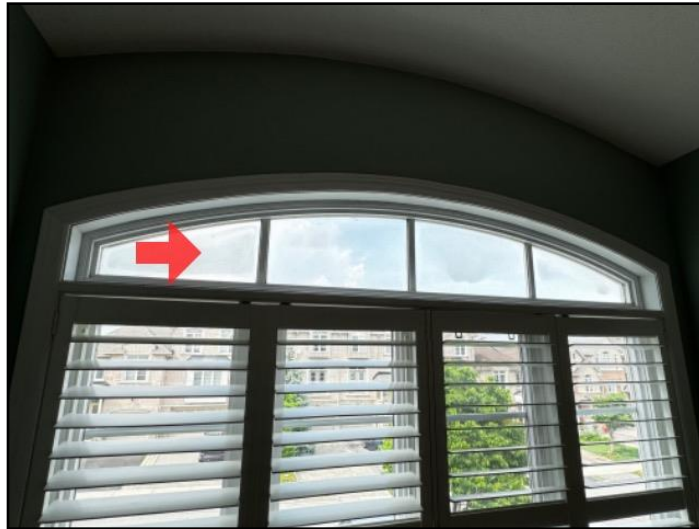
49.

**15. Condition:** • [Lost seal on double or triple glazing](#)

**Implication(s):** Shortened life expectancy of material

**Location:** Front Second Floor Bedroom

**Task:** Repair

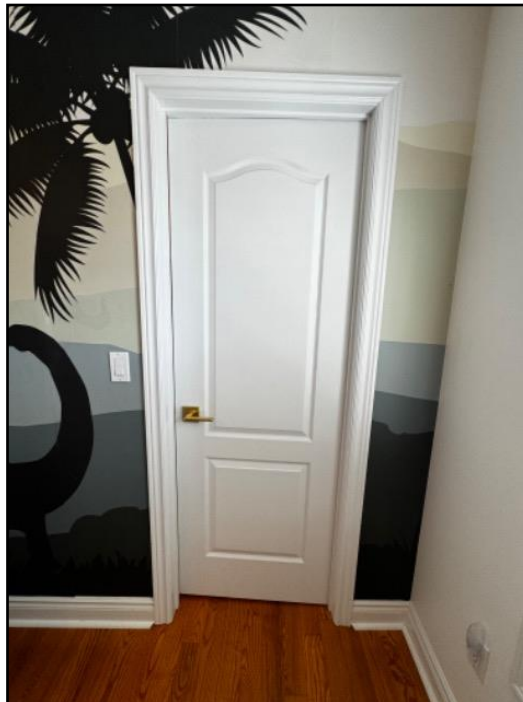
50.

**16. Condition:** • Closet door needs adjustment

**Location:** Right Side Second Floor Bedroom

**Task:** Repair

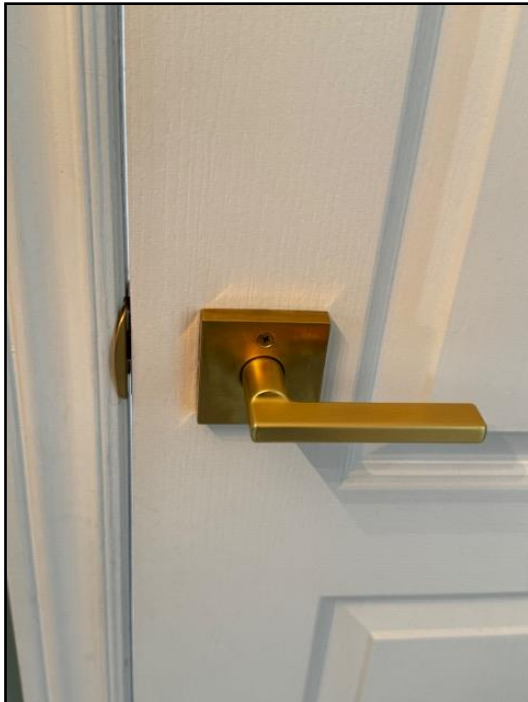
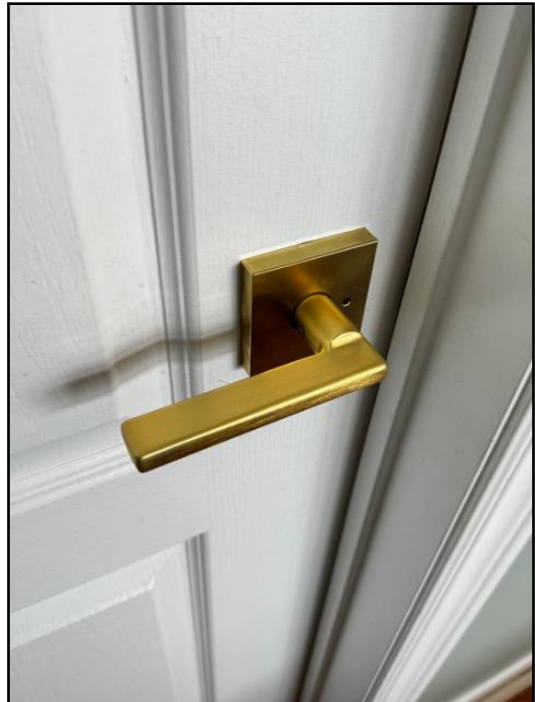
**17. Condition:** • Locking latch need adjustment.

**Location:** Second Floor Bathrooms

**Task:** Repair

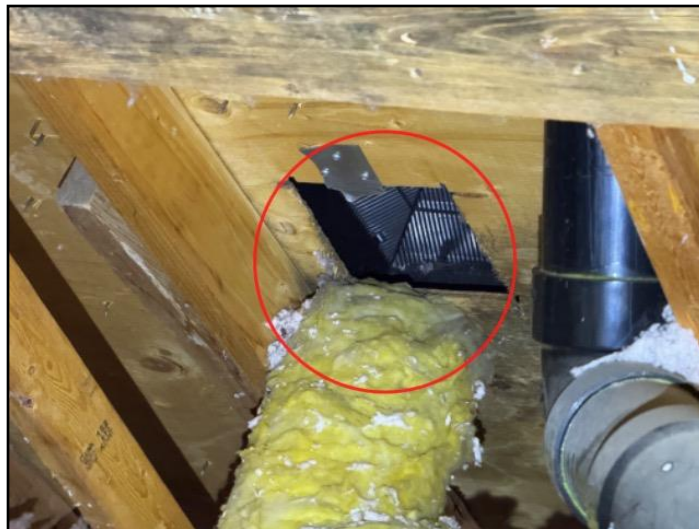
53.

**18. Condition:** • Disconnected

**Location:** Attic

**Task:** Repair

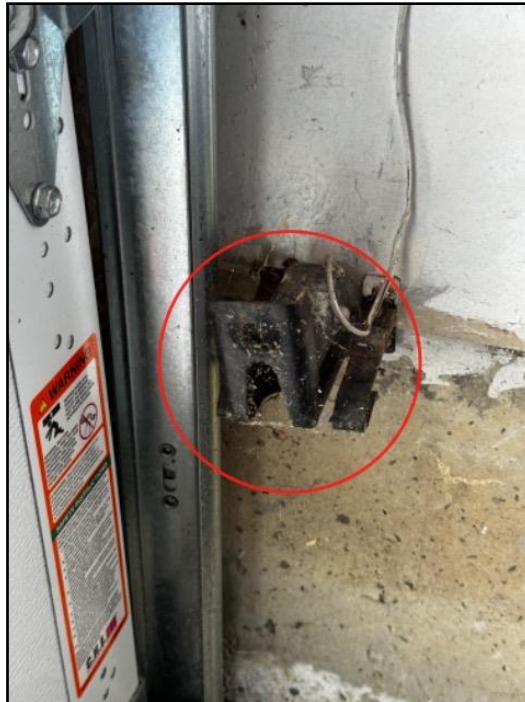
54.

**19. Condition:** • Sensors need adjustment

**Task:** Repair
