INSPECTION REPORT

For the Property at:
573 CHANCELLOR DRIVE
WOODBIDGE, ON L4L 5G3

Prepared for: DAVE ELFASSY
Inspection Date: Thursday, June 13, 2024
Prepared by: Stefano Ramacciato

RE: Report No. 3320
573 Chancellor Drive
Woodbridge, ON
L4L 5G3

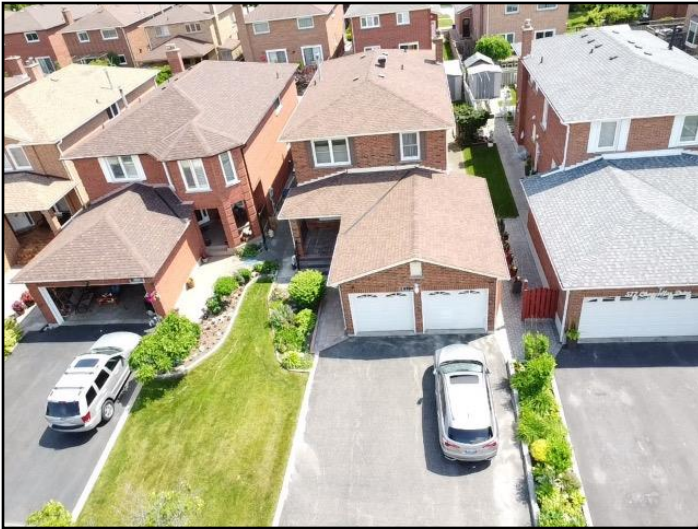
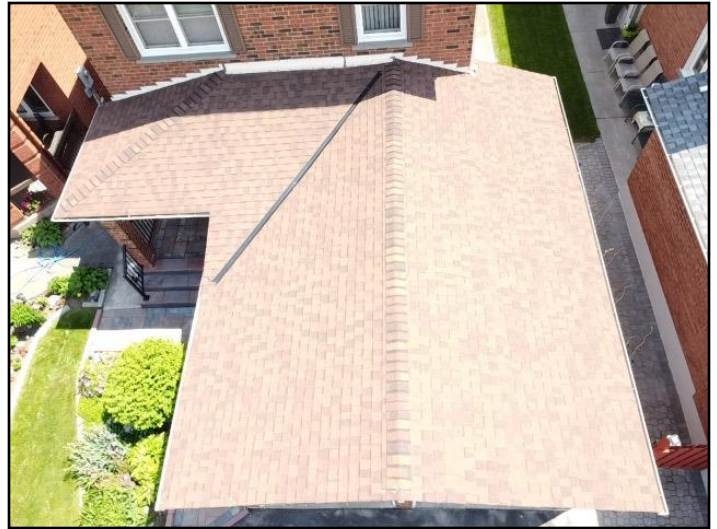
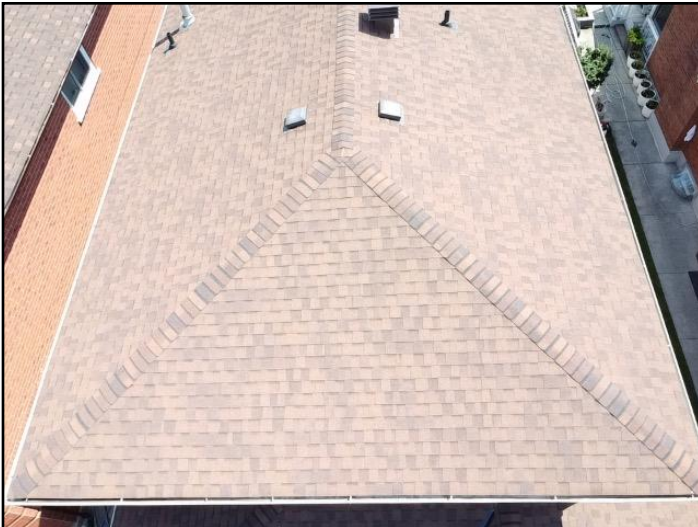
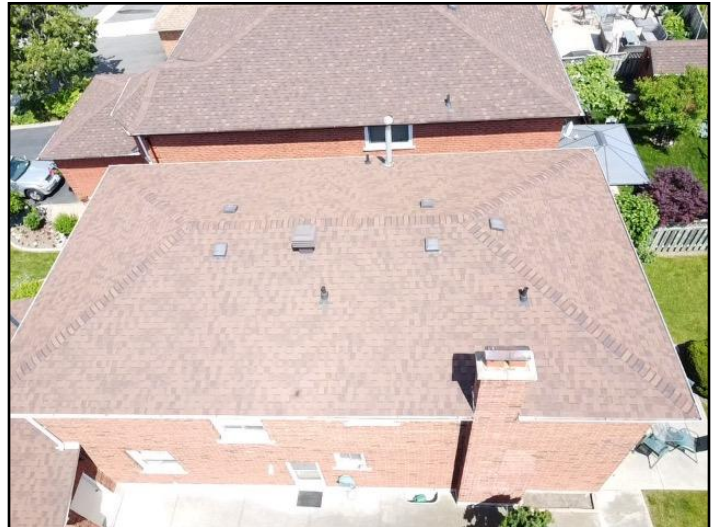
In great condition.

Approximate age 5 years old.

Probability of leakage is low.

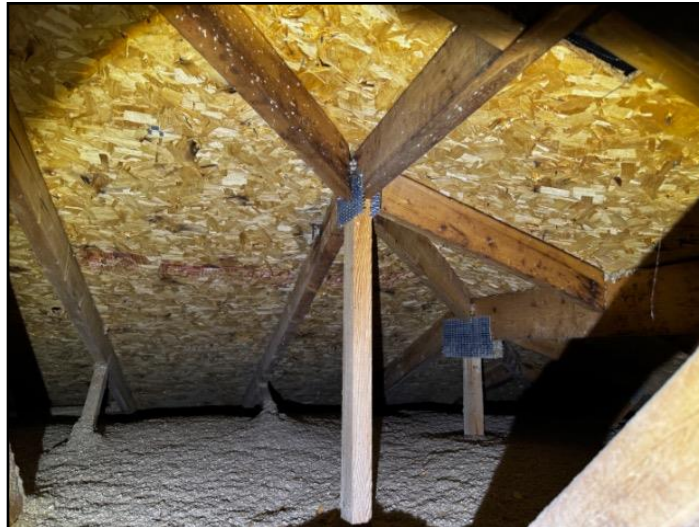
10.

No signs of water damage, mold or structural issues.

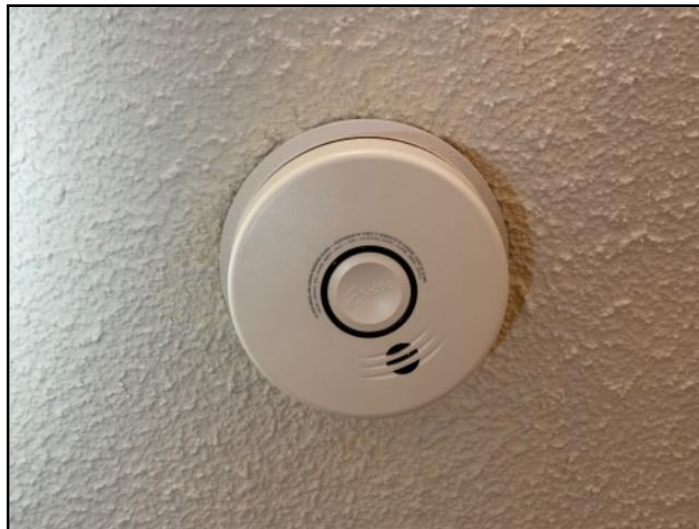
13.

Combo units installed, Carbon Monoxide & Smoke

Test monthly.

Replace units every 10 years.

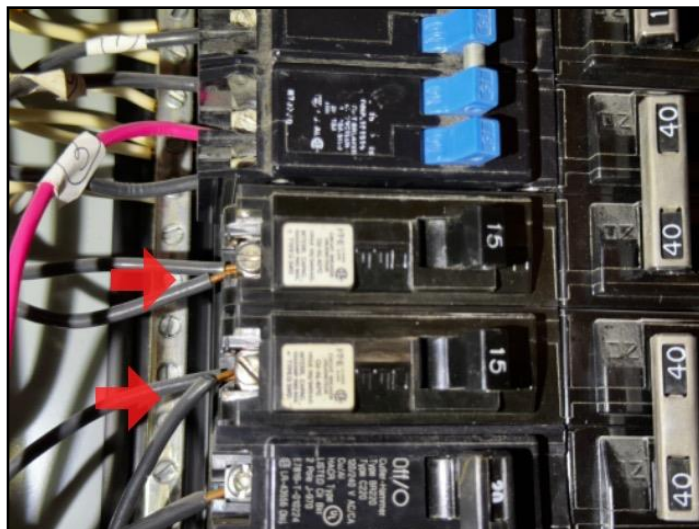
14.

2. Condition: • Double taps

Install twin breakers

Contact a licensed electrical contractor

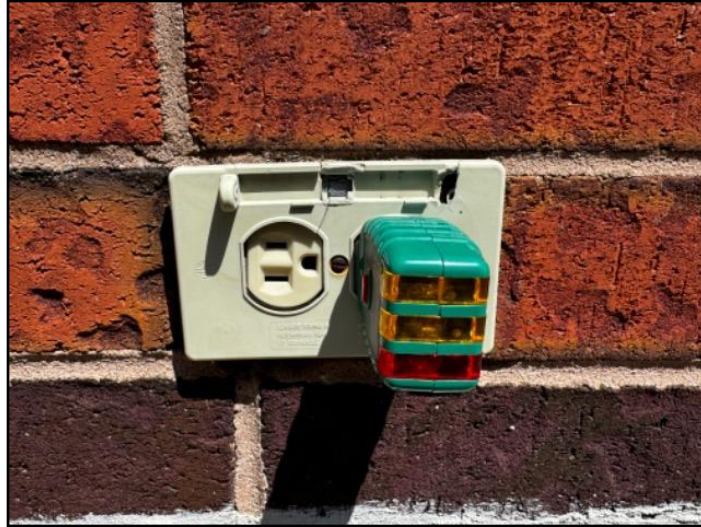
15.

4. Condition: • Damaged outdoor cover

Location: Right Side Exterior Wall

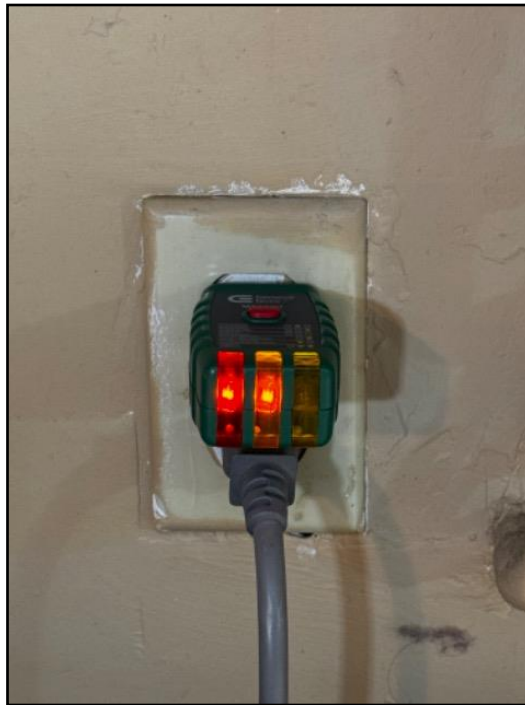
16.

5. Condition: • Receptacle is in reverse polarity.

Location: Basement Laundry Area

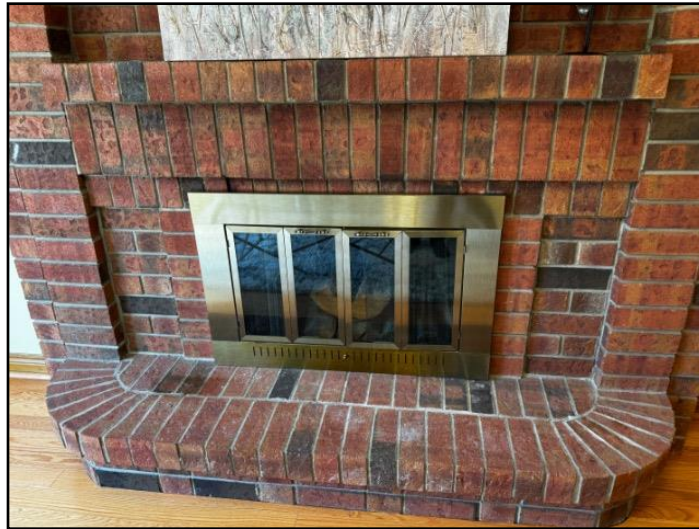
19.

Rusty gas pipe.

Contact Consumers Gas to service.

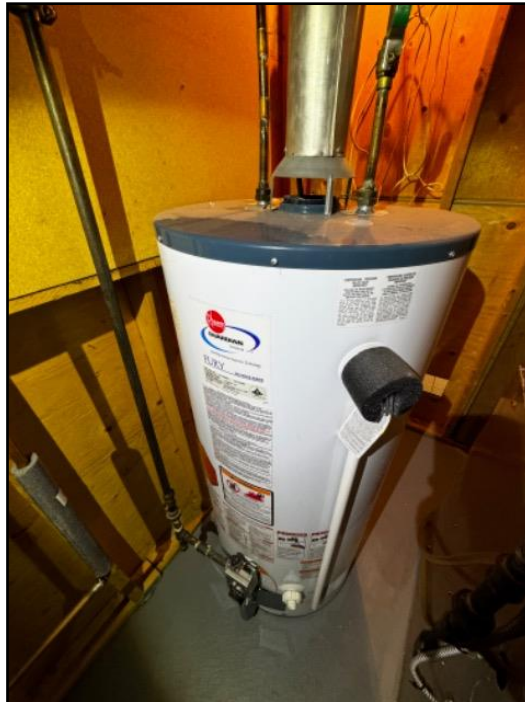
29.

6. Condition: • [Near end of life expectancy](#)

Rental Unit

Model Year 2011

Implication(s): No hot water

Location: Basement Mechanical Room

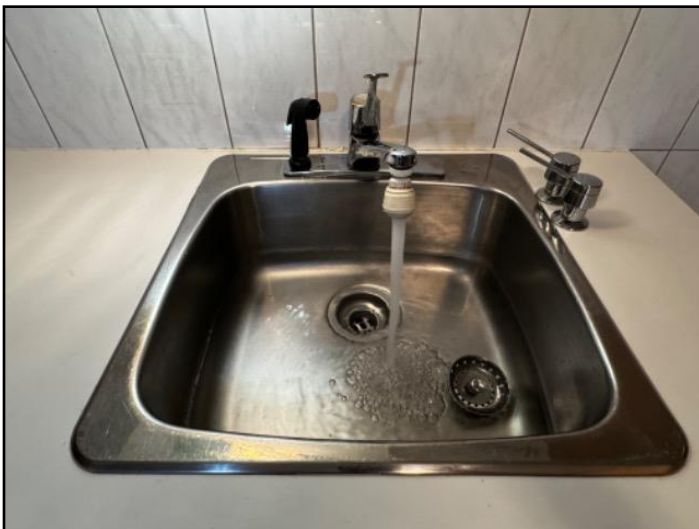
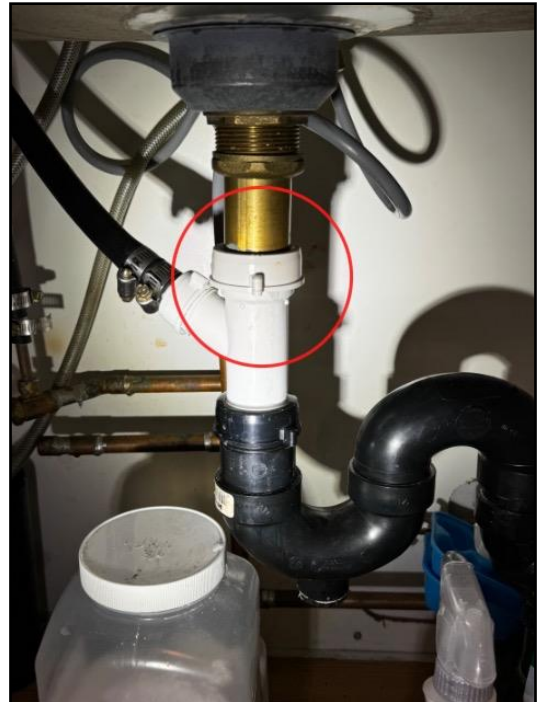
7. Condition: • Slow drain

Leaking spray nozzle

Leaking pipe connection

Implication(s): Chance of water damage to contents, finishes and/or structure.

Location: Basement Kitchen

Contact a licensed plumber

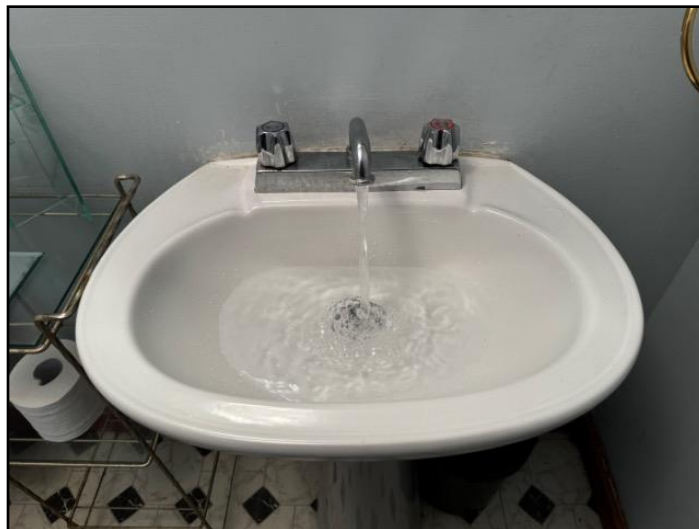
32.

8. Condition: • Loose faucet and seized hot water hand valve.

Location: Basement Washroom

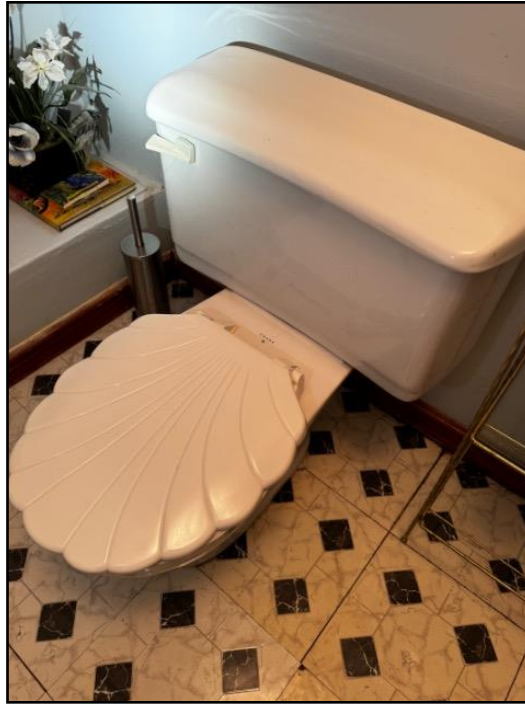
33.

9. Condition: • Leaking toilet tank.

Implication(s): Chance of water damage to contents, finishes and/or structure.

Location: Basement Washroom

Contact a licensed plumber

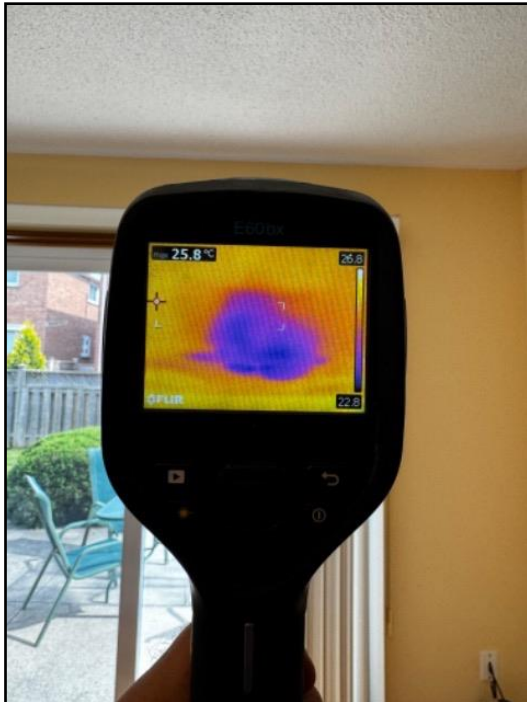
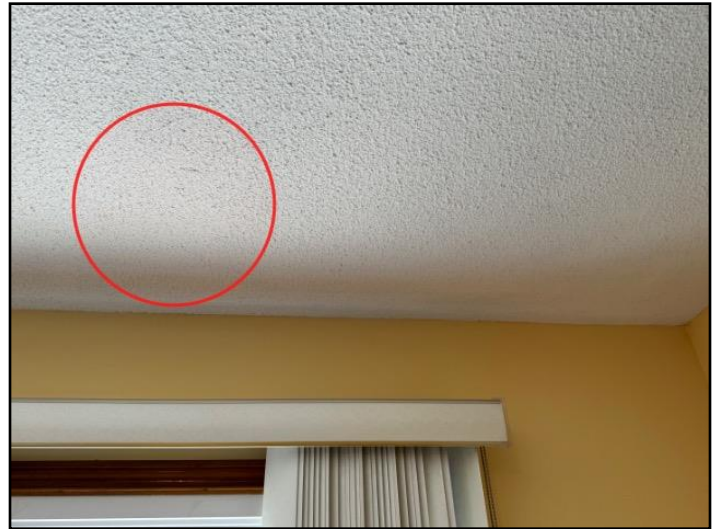
10. Condition: • Infrared thermal imaging confirming water damage on the family room ceiling coming from the primary bathroom toilet.

Implication(s): Chance of water damage to contents, finishes and/or structure.

Contact a licensed plumber.

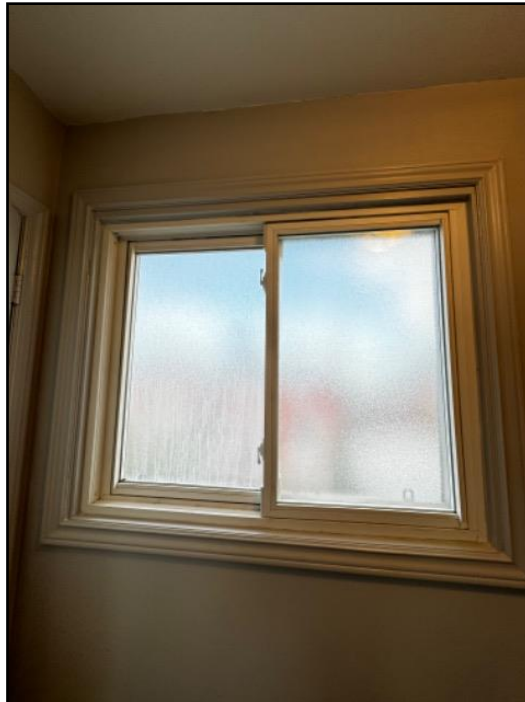
44.

12. Condition: • [Lost seal on double or triple glazing](#)

Implication(s): Shortened life expectancy of material

Location: Primary Bathroom & Main Kitchen

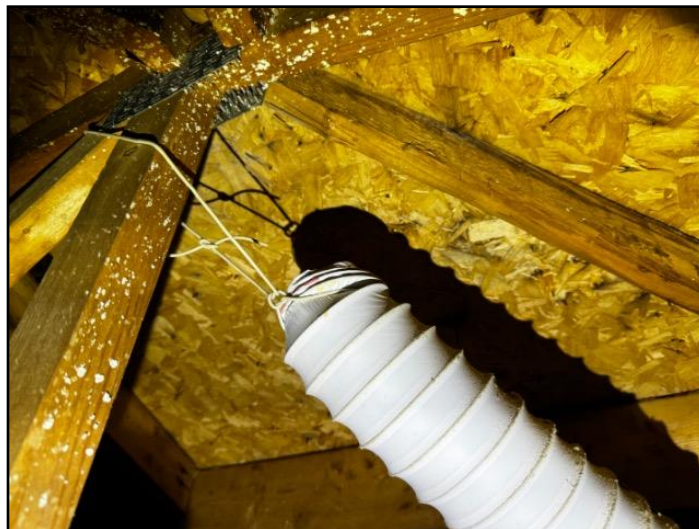
13. Condition: • Does not discharge to exterior
Venting into the attic.

Implication(s): Poor ventilation can cause condensation. | Chance of condensation damage to finishes and/or structure

45. Does not discharge to exterior

Replace the white duct with Aluminum semi rigid insulated duct.

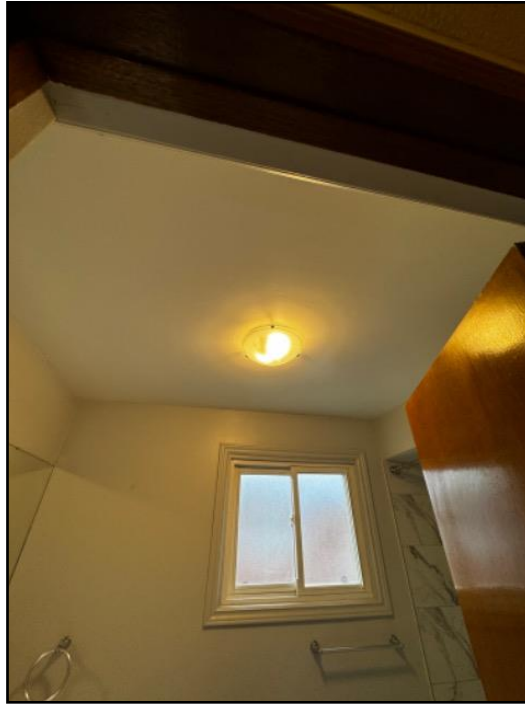
46.

14. Condition: • Missing

Implication(s): Chance of condensation damage to finishes

Location: Second Floor Bathroom

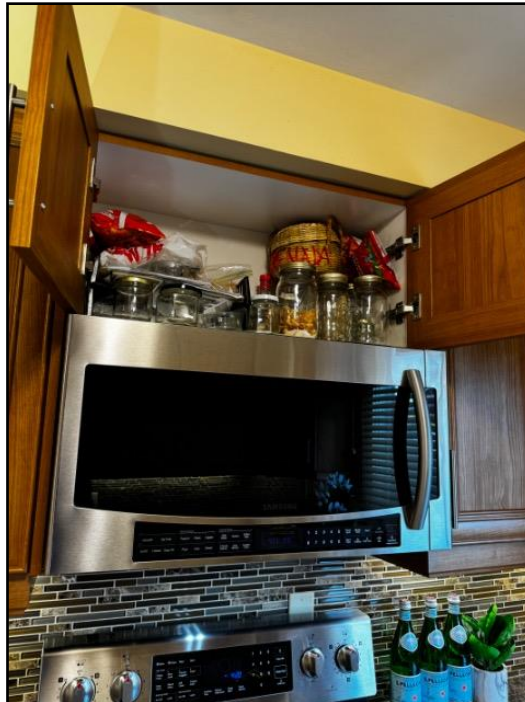
15. Condition: • Not vented to exterior

Implication(s): Chance of condensation damage to finishes and/or structure

Location: First Floor Kitchen & Basement Kitchen

47. Not vented to exterior

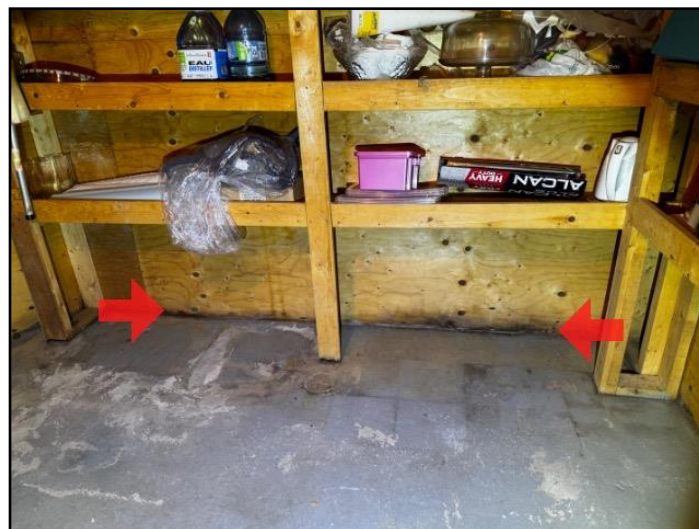
48.

16. **Condition:** • Visible signs of moisture
