PRE-LISTING HOME INSPECTION REPORT

58 Erinlea Cres, Scarborough, Ontario

Report Number : 23080427

Inspection Date: 2023-08-15

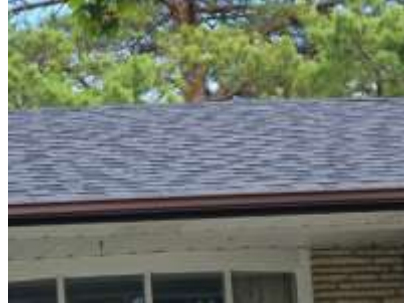
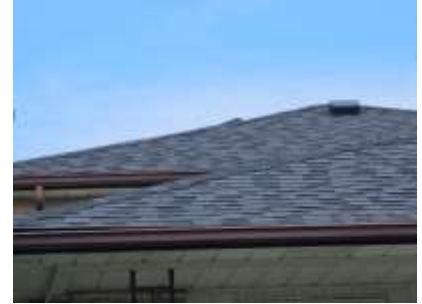
Roof covering appeared in overall satisfactory condition at the time of the inspection.

Pic. 2: Updated roof covering

Pic. 3: Updated roof covering

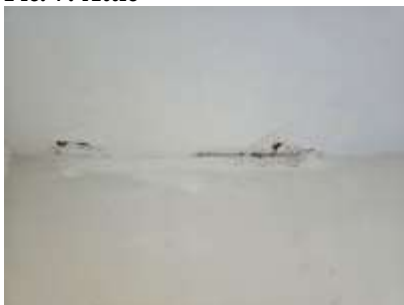
There is a small area of old water damage on the ceiling, no active moisture was present at the time of the inspection, repaired as necessary.

Pic. 10: Old water damage on ceiling of 2nd bedroom

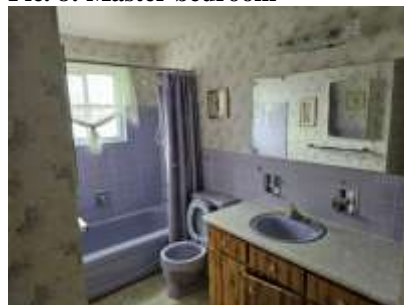
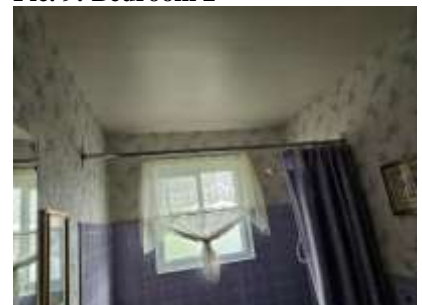
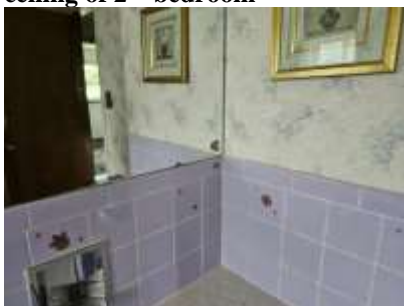
Pic. 11: Main bath

At the time of the inspection, the bathroom and its components were found to be in satisfactory condition except as noted. Shower water diverter appears to be seized, have reviewed and repaired accordingly, water cannot come out of the shower head. Recommend the addition of an exhaust fan vented to the exterior of the home to improve ventilation in the home and prevent moisture build up especially in the winter months.

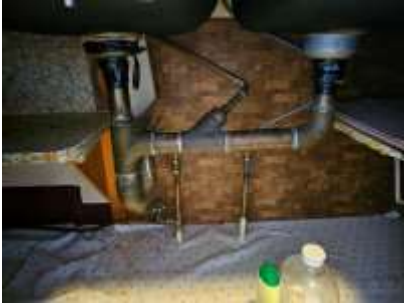
Counter top has normal wear. Cabinets have normal wear. Water flow was normal with several fixtures operated at the same time. Sink drain is leaking and the backing up, have reviewed and repaired accordingly. Outlets were randomly tested and had correct polarity, except as noted.

Pic. 19: Sink drain leaking

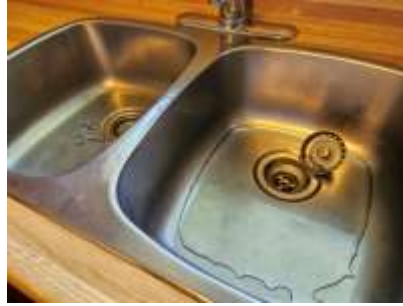
Pic. 20: Sink drain backing up

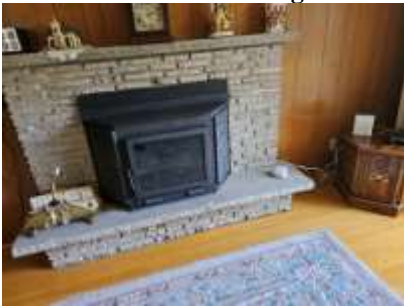
Trusses showed no major defects or damage at the time of inspection. Roof sheathing, examined from the attic, showed no major defects or moisture damage. Insulation was normal for the age of the home; additional insulation would be helpful. Ventilation was normal. Vapour barrier not visible. A WETT certificate may be required for the wood burning stove for insurability of the home.

Pic. 22: WETT certificate may be required for insurability of the home

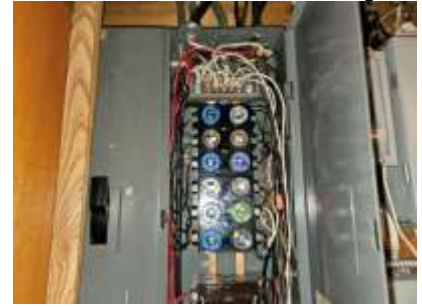
Panel size appeared to be compatible to service size. Branch breaker distribution appeared normal. No signs of overheating were evident at the time of the inspection. Outlets were randomly tested and had correct polarity, except as noted. Some circuits appear to be over fused and should be reviewed and corrected accordingly. Recommend considering upgrading to a breaker panel.

Pic. 33: Some circuits appear over fused
