PRE-LISTING HOME INSPECTION REPORT

7235 Sedan Sq, Mississauga, Ontario

Report Number : 21080355

Inspection Date: 2021-08-24

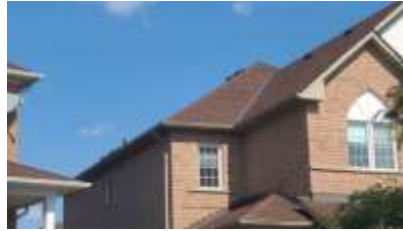
Roof covering appeared in overall satisfactory condition at the time of the inspection.

Pic. 2: Updated roof covering

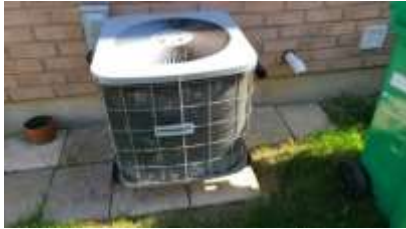
A/C unit was operating in satisfactory condition. Unit is aging and at or approaching the end of its normal life expectancy, recommend budgeting for replacement.

Pic. 4: AC unit 2001

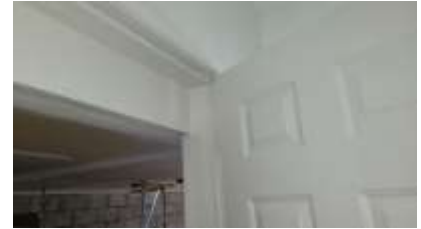
No auto closer on garage entry door
Garage entry steps are steep - Trip hazard

Pic. 6: Auto closer needed for garage entry door

Doors were reviewed and found to be in working order. Lights appeared to be in normal condition: not all lights were tested. Exterior outlets tested were in normal working order. An auto closer is required for the garage entry door for safety. Step into the garage are step with a narrow tread, caution is advised while using the steps – trip hazard.

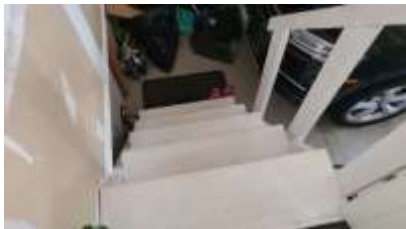
Pic. 7: Garage steps are steep with narrow steps – caution advised while using

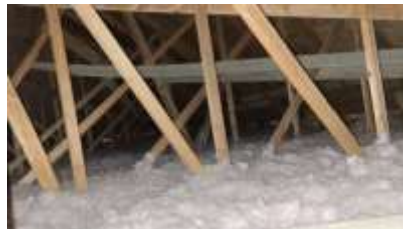
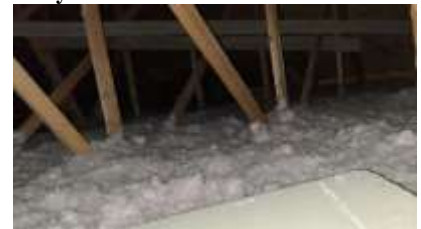
Trusses showed no major defects or damage at the time of inspection. Roof sheathing, examined from the attic, showed no major defects or moisture damage. Insulation was sufficient for homes in this area. Ventilation was normal. Vapour barrier not visible. Smoke & CO detectors are past their normal life expectancy and should be replaced.

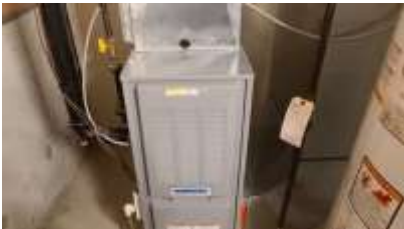
Pic. 25: Original gas furnace 2002

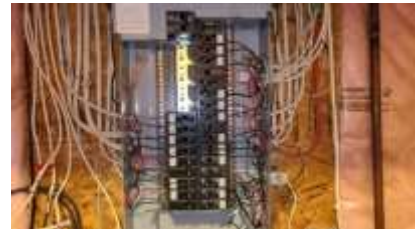
Panel size appeared to be compatible to service size. Branch breaker distribution appeared normal. No signs of overheating were evident at the time of the inspection. Outlets were randomly tested and had correct polarity, except as noted.

Pic. 27: 100 amp breaker panel
