PRE-LISTING HOME INSPECTION REPORT

7 Via Romano Blvd, Vaughan, Ontario

Report Number : 21120476

Inspection Date: 2021-12-05

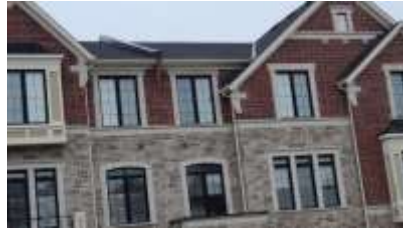
Pic. 2: Front view and roof covering

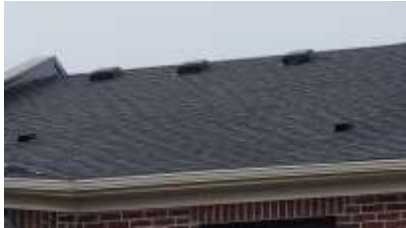
Roof covering appeared in overall satisfactory condition at the time of the inspection.

Pic. 4: Roof covering

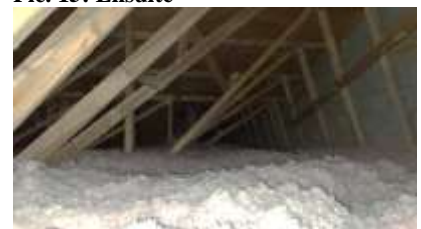
Pic. 18: Attic

Trusses showed no major defects or damage at the time of inspection. Roof sheathing, examined from the attic, showed no major defects or moisture damage. Insulation was sufficient for homes in this area. Ventilation was normal. Vapour barrier not visible.

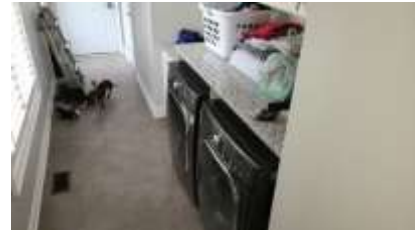
Pic. 27: Laundry

At the time of the inspection the laundry facilities were in satisfactory condition.

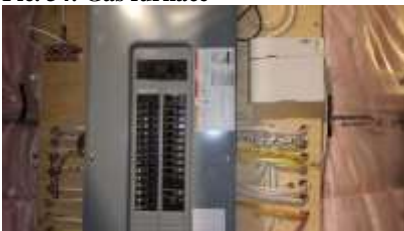
Pic. 37: 200 amp breaker panel

Panel size appeared to be compatible to service size. Branch breaker distribution appeared normal. No signs of overheating were evident at the time of the inspection. Outlets were randomly tested and had correct polarity, except as noted.
