PRE-LISTING HOME INSPECTION REPORT

87 Kyla Cres, Markham, Ontario

Report Number : 22050205

Inspection Date: 2022-05-10

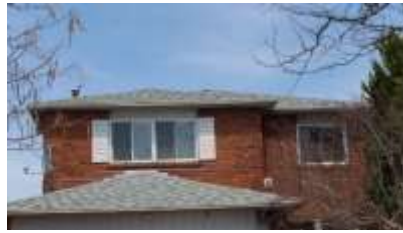
Roof covering appeared in overall satisfactory condition at the time of the inspection.

Pic. 2: Updated roof covering

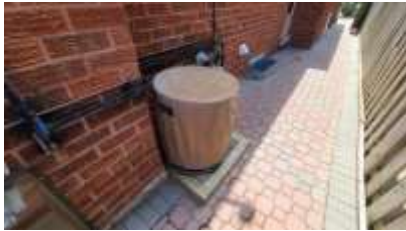
Doors were reviewed and found to be in working order. Lights appeared to be in normal condition: not all lights were tested. Exterior outlets tested were in normal working order. AC compressor cover could not be removed and could not be reviewed.

Pic. 4: AC unit – old – cover could not be reviewed

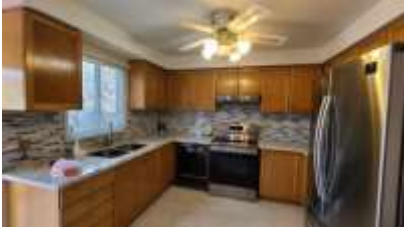
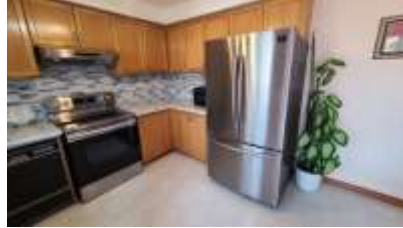
Pic. 22: Kitchen

Counter top has normal wear. Cabinets have normal wear. Water flow was normal with several fixtures operated at the same time. There were no visible active piping leaks at the time of the inspection. Drain lines had no visible leaks or signs of backup at the time of inspection. Outlets were randomly tested and had correct polarity, except as noted.

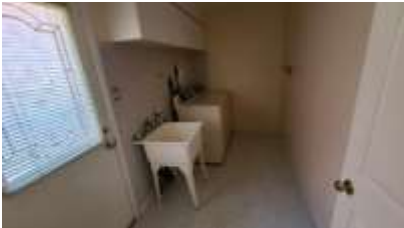
Pic. 25: Laundry

At the time of the inspection the laundry facilities were in satisfactory condition.

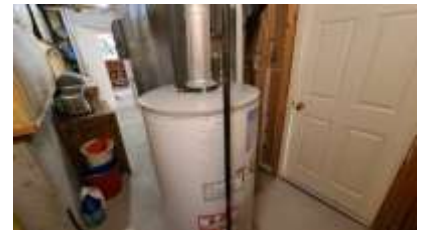
Pic. 30: Rental hot water tank 2008

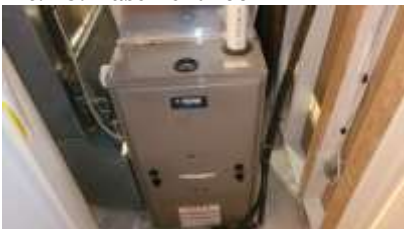
Pic. 31: Gas furnace 2014

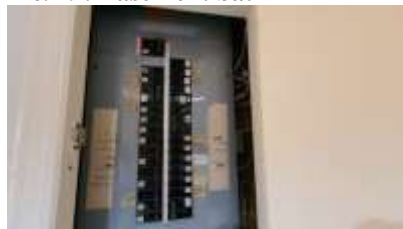
Panel size appeared to be compatible to service size. Branch breaker distribution appeared normal. No signs of overheating were evident at the time of the inspection. Outlets were randomly tested and had correct polarity, except as noted.

Pic. 32: 100 amp breaker panel
