# INSPECTION REPORT

For the Property at:  
**92 JEANNE DRIVE**  
VAUGHAN, ON L4L 1X9

Prepared for: DAVE ELFASSY  
Inspection Date: Wednesday, June 12, 2024  
Prepared by: Stefano Ramacciato

RE: Report No. 3316  
92 Jeanne Drive  
Vaughan, ON  
L4L 1X9

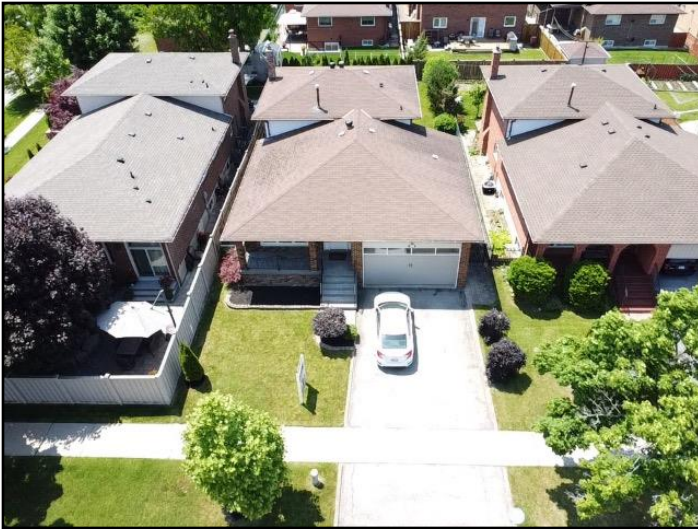
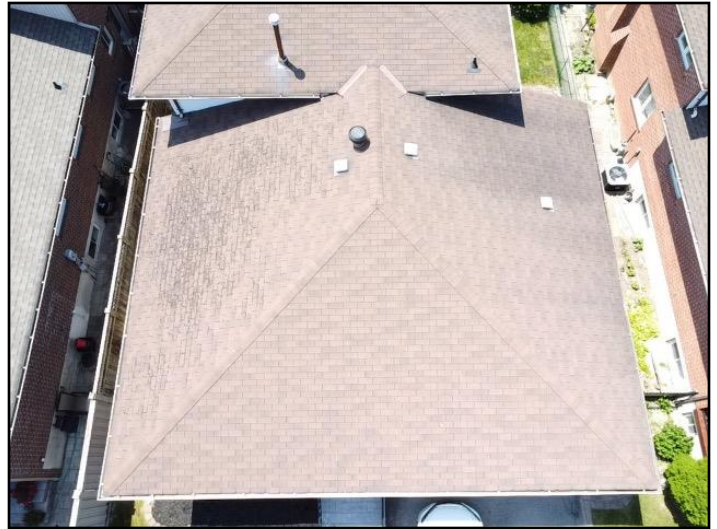
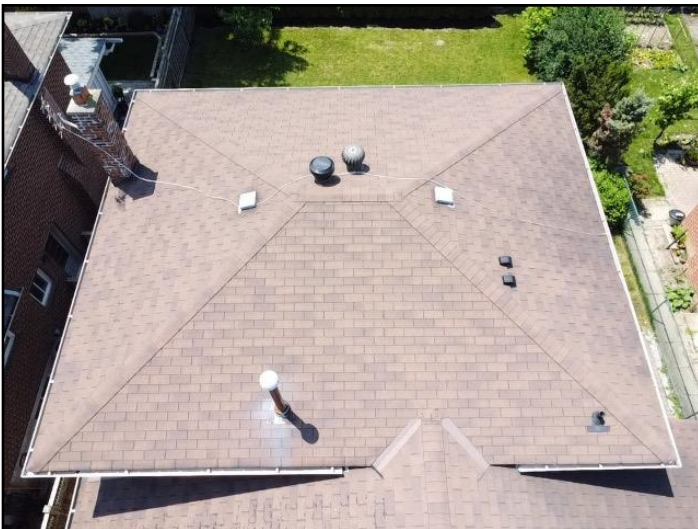
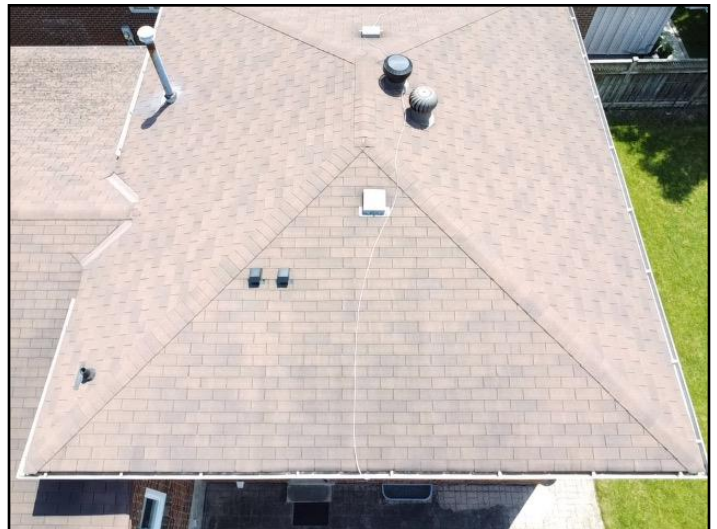
Approximate age 10 years old.

Aging on the left side roof.

Budget for replacement in the future.

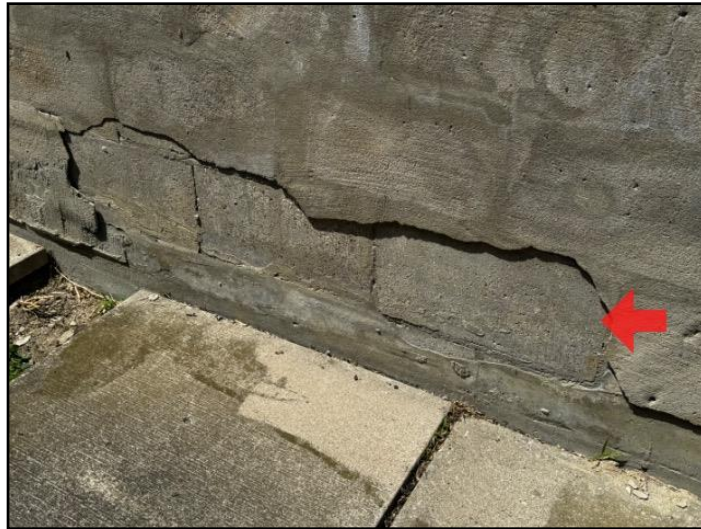
8.

2. Condition: • [Parging damaged or missing](#)

Implication(s): Chance of damage to structure | Shortened life expectancy of material

Location: Left & Right Side Exterior Wall

Task: Repair

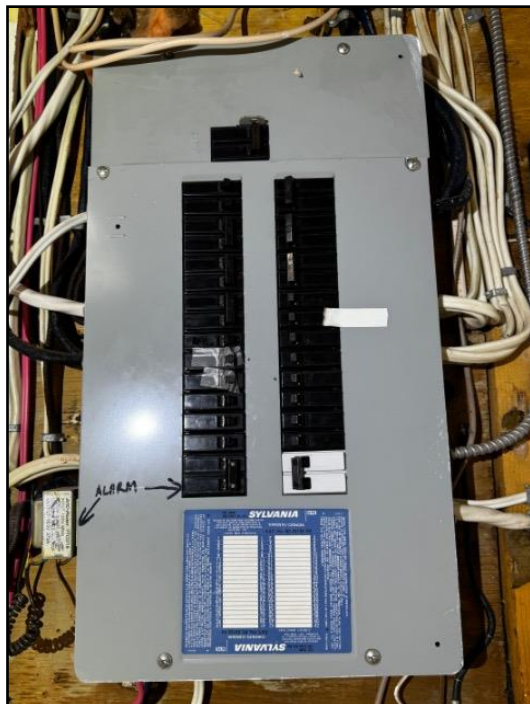
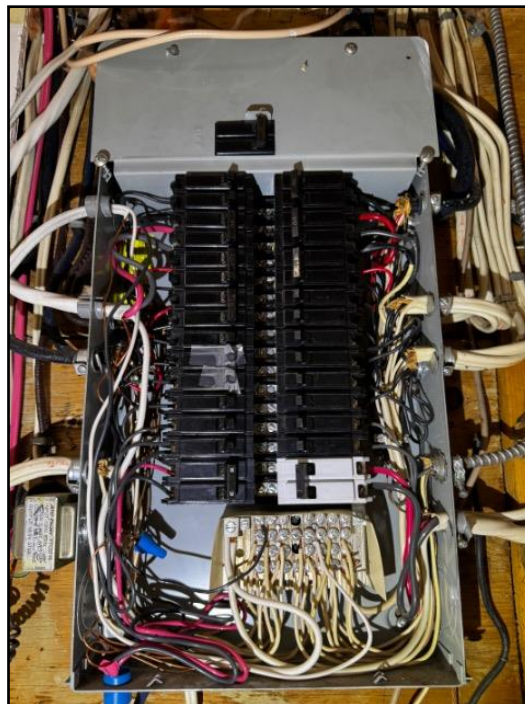
Arc Fault Circuit Interrupter (AFCI) needed.

Located in the basement.

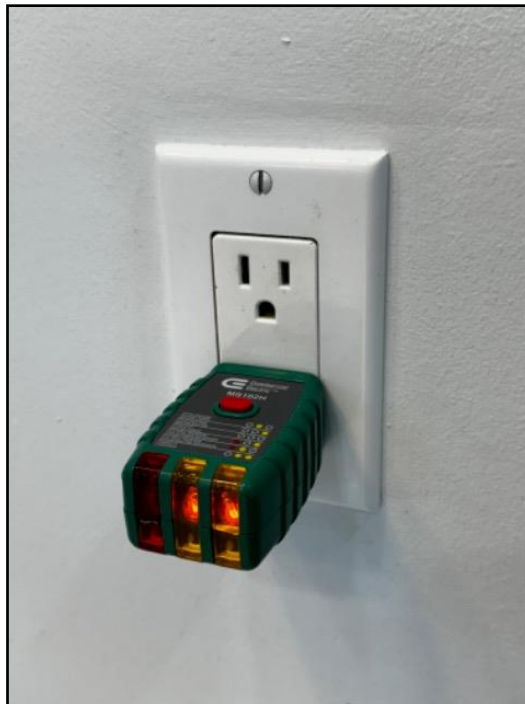
11.

**3. Condition:** • GFCI receptacles needed.

**Location:** Kitchen, Bathrooms, Front Exterior Porch & Rear Exterior Wall

**Task:** Correct

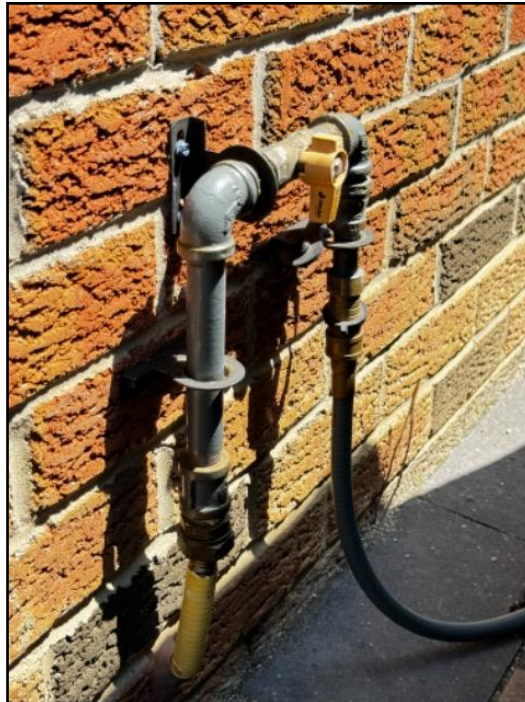
12.

**General:** • Installed barbeque gas line with shut off valve located in the rear exterior wall.

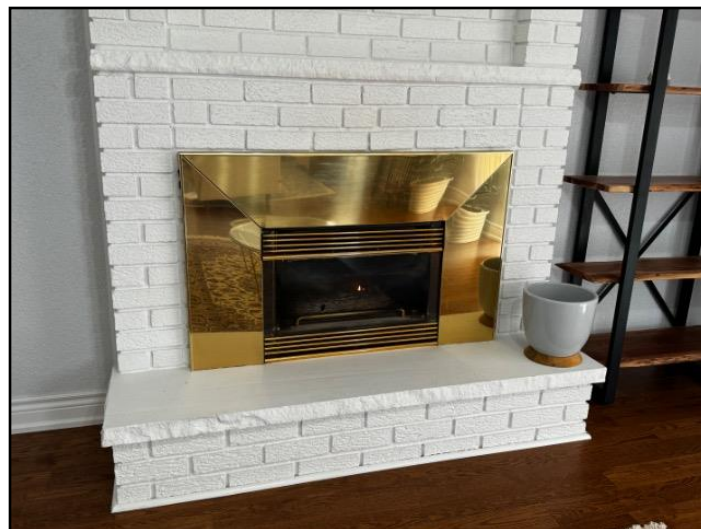
13.

**General:** • Installed gas fireplace.  
In good working condition.

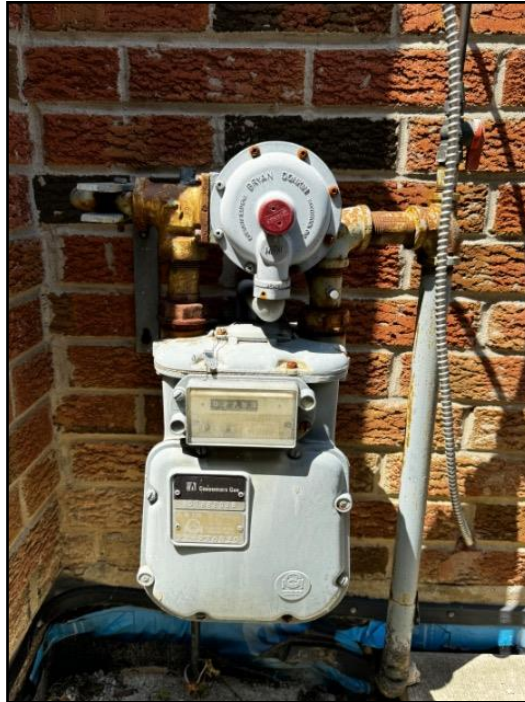
14. Meter

• Meter  
Located left side exterior wall.

Rusty gas pipe connection.

Contact Consumers Gas for service.

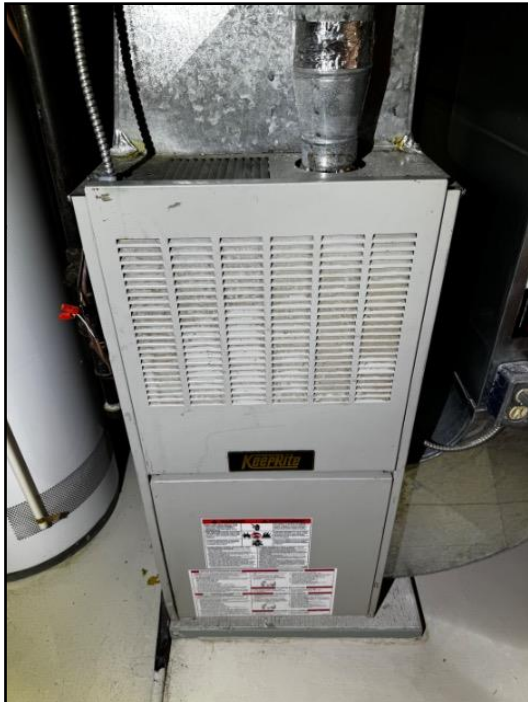
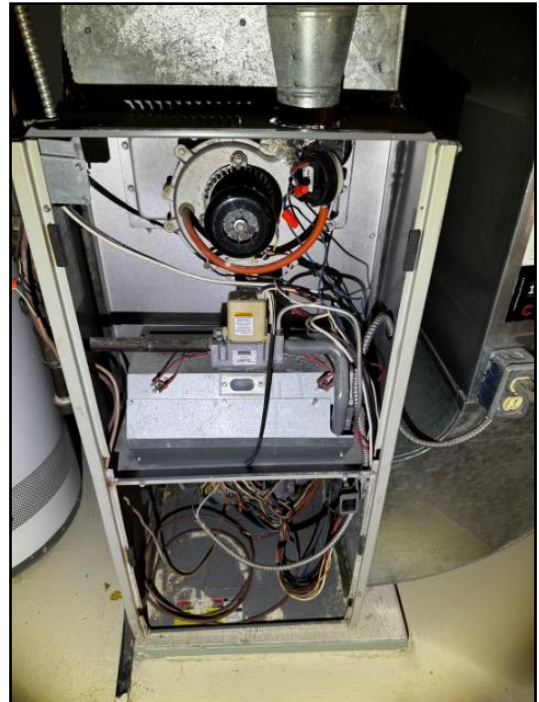
**5. Condition:** • Old

In good working condition

Model Year 1997

Mid efficiency furnace

100,000 BTU's

Replace filter every 3 months

Budget for replacement in the future

**Task:** Service annually

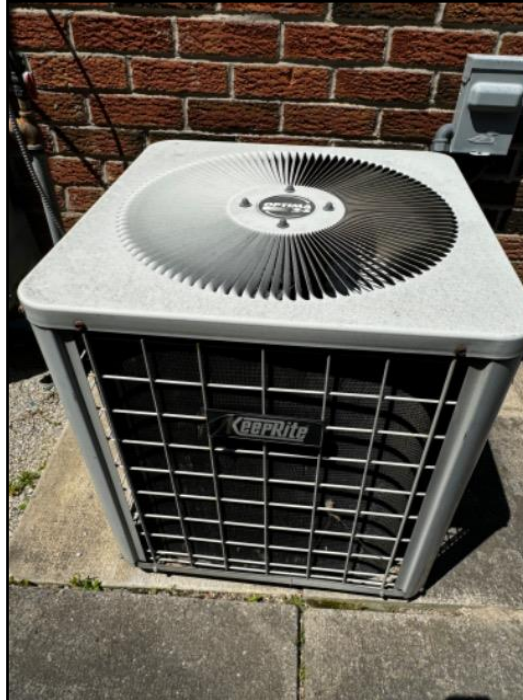
19.

**6. Condition:** • Old

In good working condition.

Model Year 2000

2.5 Tons Unit

Budget for replacement in the future

**Task:** Service annually

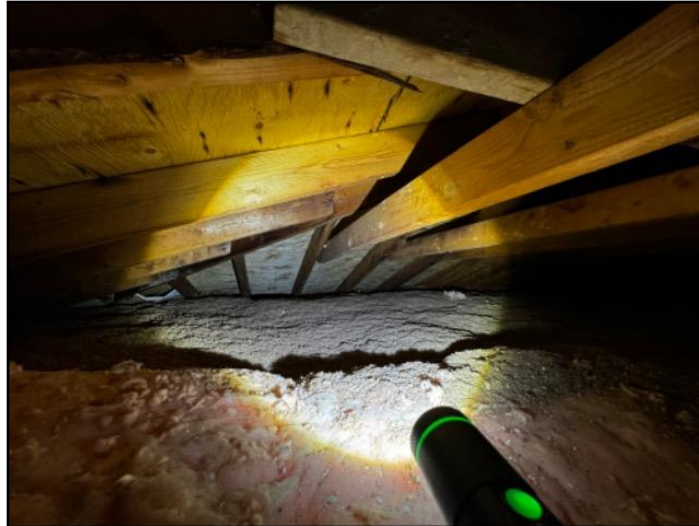
20.

- [Cellulose](#)

- Batt Insulation

Upgrade in the future

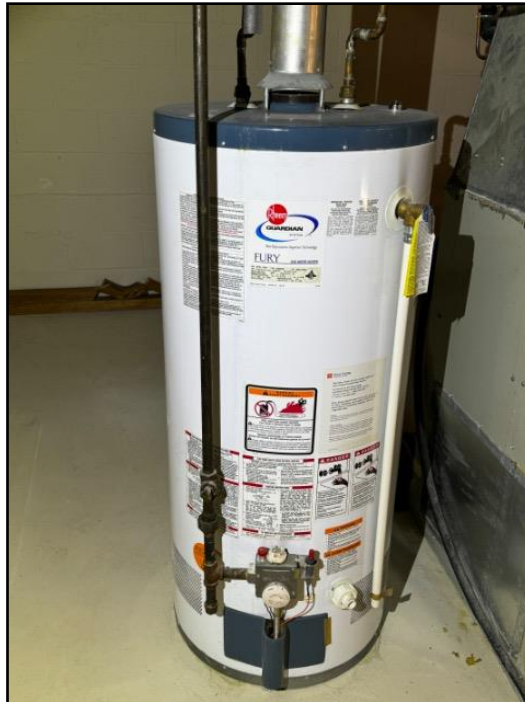
22. Rental

Old Unit

Call direct energy to replace.

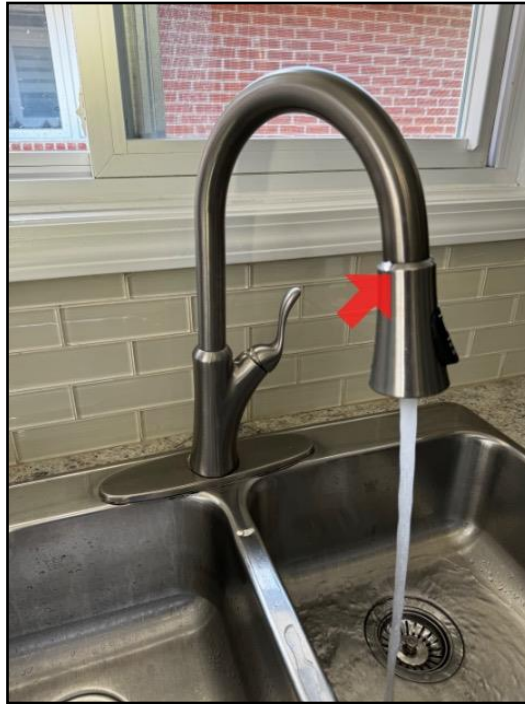
26.

**8. Condition:** • Leaking spray nozzle on the faucet.

**Location:** Kitchen

**Task:** Repair

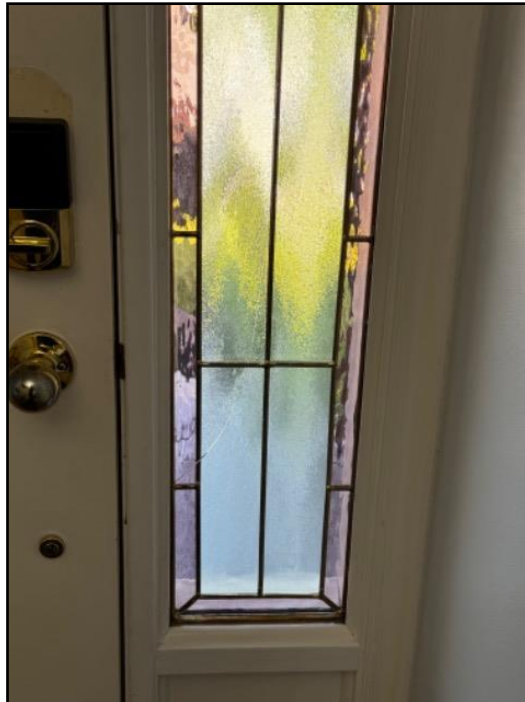
36.

10. **Condition:** • Cracked panel  
**Location:** Front Exterior  
**Task:** Replace

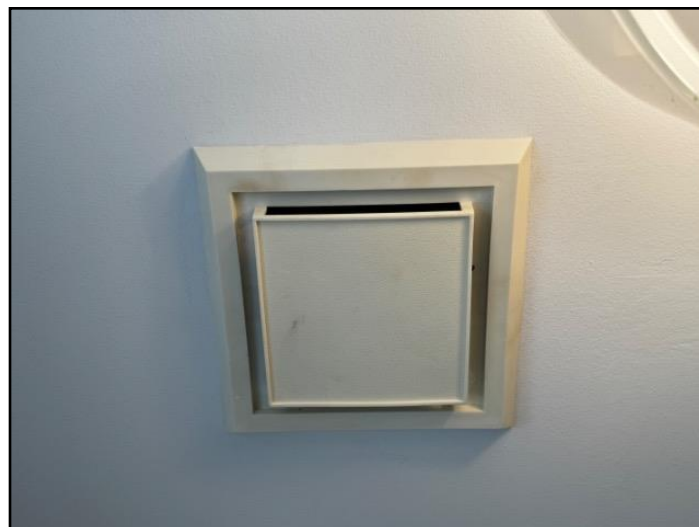
37.

12. **Condition:** • Inoperative

**Implication(s):** Chance of condensation damage to finishes

**Location:** First Floor Bathroom

**Task:** Replace
