## **PRE-LISTING HOME INSPECTION REPORT**

**119 Evahill Cres, Richmond Hill, Ontario**

**Report Number: 24100602**

**Inspection Date: 2024-10-23**

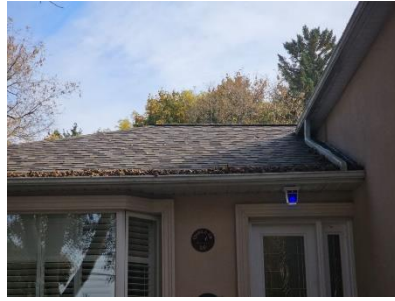
**Pic. 2: Updated roof covering**

Roof covering appeared in overall satisfactory condition at the time of the inspection.

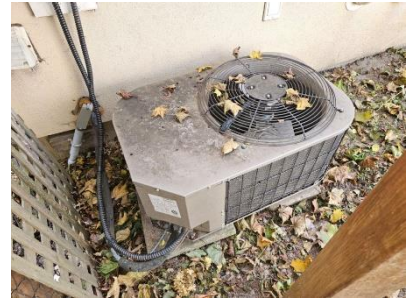
**Pic. 9: AC compressor 2005**

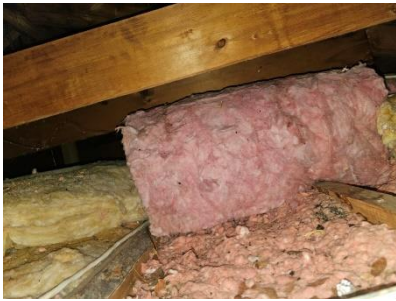
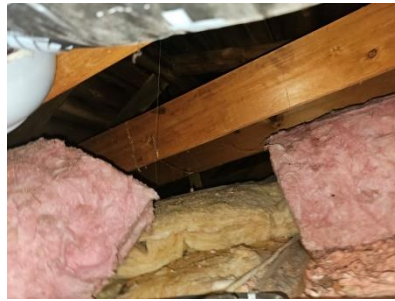
**Pic. 10: Attic**

**Pic. 11: Attic**

Rafters / Trusses showed no major defects or damage at the time of inspection. Roof sheathing, examined from the attic, showed no major defects or moisture damage. Insulation level is normal for the age of the home. Ventilation was normal. One exhaust fan vent pipe has become disconnected and is venting into the attic, recommend review and repair as necessary.

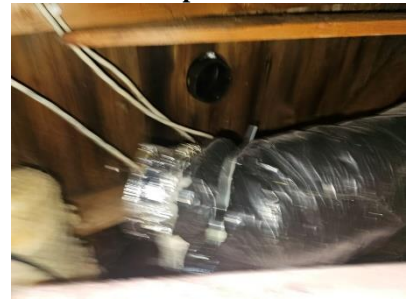
**Pic. 12: Exhaust vent pipe not connected to roof vent**

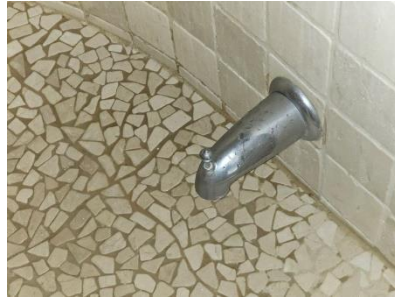
**Pic. 17: Shower water diverter seized**

At the time of the inspection, the bathroom and its components were found to be in satisfactory condition except as noted. Shower water diverted is seized, repair or replace as necessary.

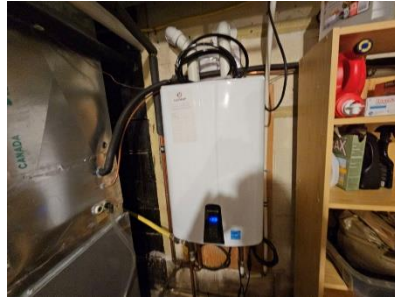
**Pic. 32: Tankless hot water system 2019**

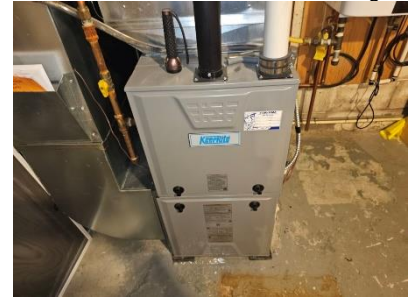
**Pic. 33: Gas furnace 2021**

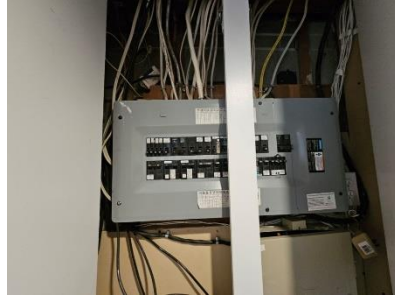
**Pic. 35: 100 amp breaker panel**

Panel size appeared to be compatible to service size. Branch breaker distribution appeared normal. No signs of overheating were evident at the time of the inspection. Outlets were randomly tested and had correct polarity, except as noted.
