PRE-SALE HOME INSPECTION REPORT

140 Greenock Dr, Maple, Ontario

Report Number: 24090555

Inspection Date: 2024-09-18

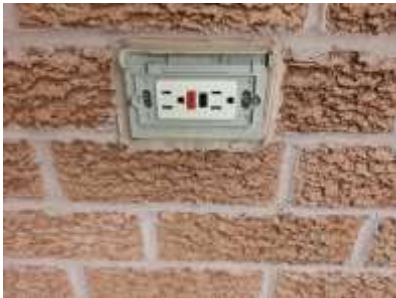
Pic. 7: Exterior cover advised

Doors were reviewed and found to be in working order. Lights appeared to be in normal condition: not all lights were tested. Exterior outlets tested were in normal working order. A cover is advised for the front GFCI outlet.

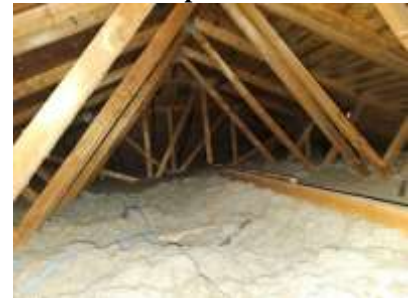
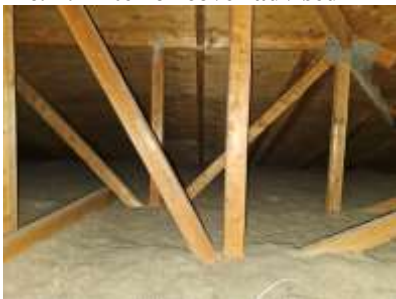
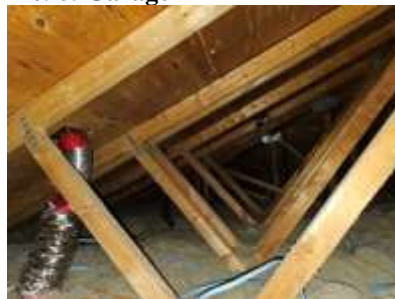
Pic. 9: Attic

Rafters / Trusses showed no major defects or damage at the time of inspection. Roof sheathing, examined from the attic, showed no major defects or moisture damage. Insulation level is normal for the age of the home. Ventilation was normal.

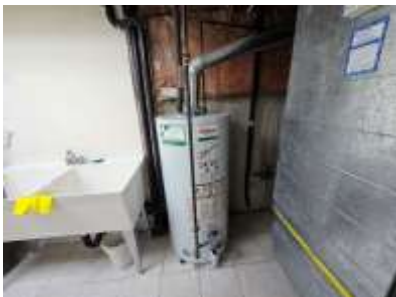
Pic. 28: Rental hot water tank 2012

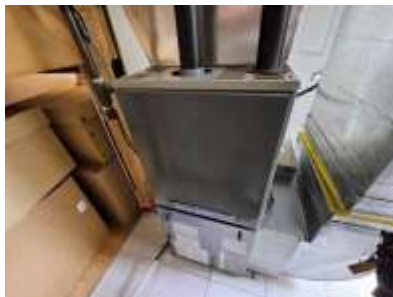
Pic. 29: Gas furnace 2005

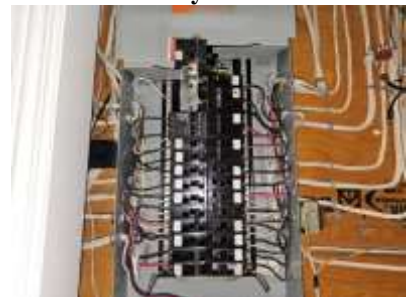
Panel size appeared to be compatible to service size. Branch breaker distribution appeared normal except for a couple of breakers which are double tapped and should be reviewed and corrected accordingly. No signs of overheating were evident at the time of the inspection. Outlets were randomly tested and had correct polarity, except as noted.

Pic. 30: 100 amp breaker panel
