HOME INSPECTION REPORT

169 Jones Ave Unit 11, Toronto, Ontario

Report Number: 24040296

Inspection Date: 2024-04-20

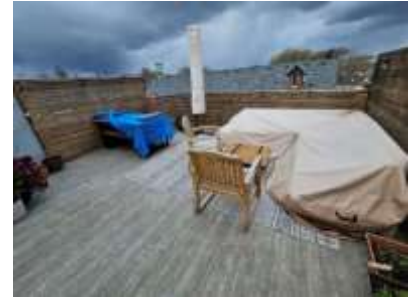
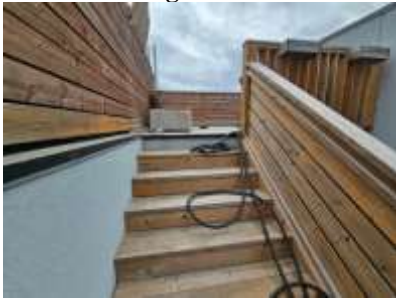
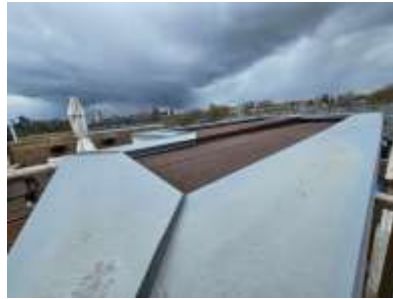
General site drainage was properly sloping away from the house. Maintain a positive drainage slope away from the foundation. Multi level roof top terrace was found to be in satisfactory condition.

Pic. 3: Terrace

Pic. 4: Terrace

Pic. 5: Terrace

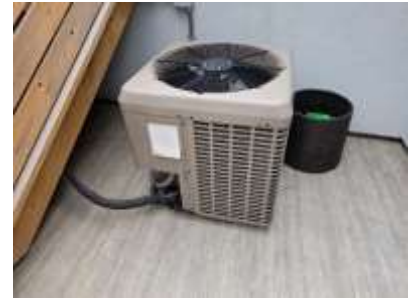
System Components	<input type="checkbox"/> None	Approximate age: 5 to 7 yrs
Energy source: Electric	Central air: Air Cooled	
Operated: No	Operation: Not operated	
Refrigerant lines:	<input type="checkbox"/> Leak	<input type="checkbox"/> Damaged
Through wall unit(s):	<input checked="" type="checkbox"/> N/A	<input type="checkbox"/> Insulation missing
	<i>Operated:</i> <input type="checkbox"/> Yes	<input checked="" type="checkbox"/> Satisfactory
	<input type="checkbox"/> No	<input type="checkbox"/> Needs service

Pic. 6: AC unit

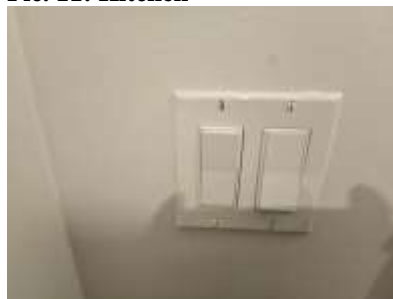
At the time of the inspection, the bathroom and its components were found to be in satisfactory condition except as noted. Exhaust fan switch is faulty and should be replaced.

Pic. 14: Exhaust fan switch faulty and should be replaced

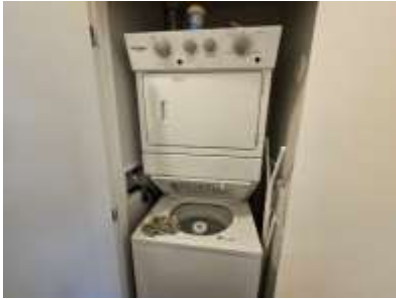
At the time of the inspection the laundry facilities were in satisfactory condition.

Pic. 19: Laundry

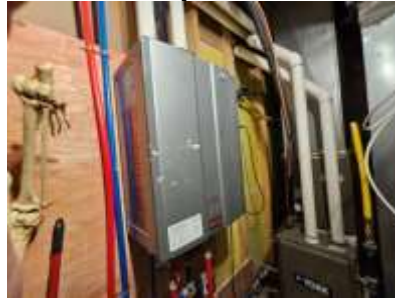
Water Heater		
<i>Brand name:</i> Rinnai		
Energy Source: Gas	Approx. age: 5 to 7 yrs	Capacity: Tankless
Rental Unit: Yes	Seismic restraints needed: <input checked="" type="checkbox"/> N/A <input type="checkbox"/> Yes <input type="checkbox"/> No	
Relief valve: <input checked="" type="checkbox"/> Yes <input type="checkbox"/> No	Extension proper: <input checked="" type="checkbox"/> Yes <input type="checkbox"/> No <input type="checkbox"/> Missing	
Vent pipe: <input type="checkbox"/> N/A <input checked="" type="checkbox"/> Satisfactory	<input type="checkbox"/> Improper pitch <input type="checkbox"/> Rusted	<input type="checkbox"/> Safety Hazard

Pic. 20: Tankless hot water

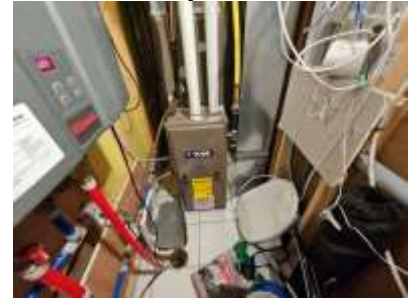
Fuel Shutoff for Building	Main fuel shutoff location: Outside at gas meter		
Forced Air System	<input checked="" type="checkbox"/> Central Unit	<input type="checkbox"/> Wall Furnace	<input type="checkbox"/> Floor Furnace
<i>Brand name:</i> York		<i>Approximate age:</i> 5 to 10 yrs	
Energy source:	Gas	Furnace Efficiency:	High Efficiency
Hot air systems:	Direct drive		
Heat exchanger:	Sealed unit, not visible	View is extremely limited - See Remarks page about options	
Distribution:	Metal Ducts	Flue piping: Plastic	
Filter: Standard	Filter Condition: Satisfactory		
Operated:	When turned on by thermostat:		<input checked="" type="checkbox"/> Fired <input type="checkbox"/> Did not fire
Operation:	Satisfactory: <input checked="" type="checkbox"/> Yes <input type="checkbox"/> No	<input type="checkbox"/> Recommend HVAC technician examine	<input type="checkbox"/> Before closing
Controls:	<input type="checkbox"/> Disconnect	<input checked="" type="checkbox"/> Normal operating and safety controls observed

Pic. 21: Gas furnace

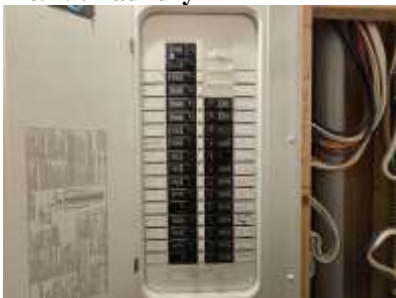
Panel size appeared to be compatible to service size. Branch breaker distribution appeared normal. No signs of overheating were evident at the time of the inspection. Outlets were randomly tested and had correct polarity, except as noted.

Pic. 22: 100 amp breaker panel
