PRE-LISTING HOME INSPECTION REPORT

175 Gail Parks Cres, Newmarket, Ontario

Report Number: 25040276

Inspection Date: 2025-04-21

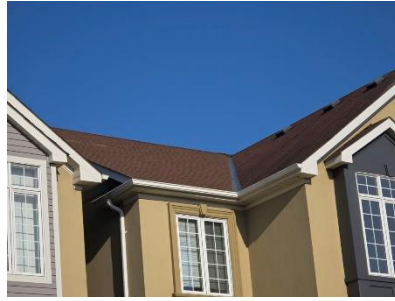
Gutters were in overall adequate condition. Siding appeared to be in overall adequate condition. Trim appeared to be intact and in overall maintained condition.

Pic. 2: Roof overhang

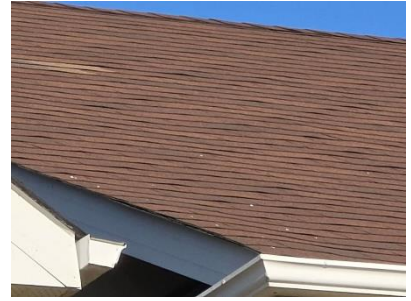
Roof covering appeared in overall satisfactory condition at the time of the inspection.

Pic. 3: Roof covering

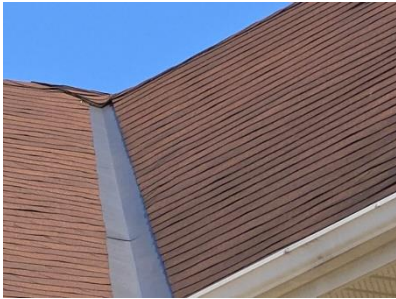
Pic. 4: Roof covering

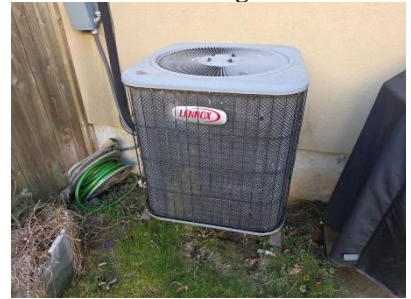
Pic. 6: AC compressor 2008

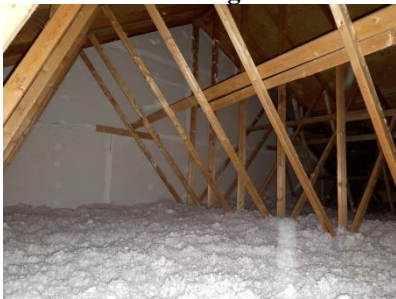
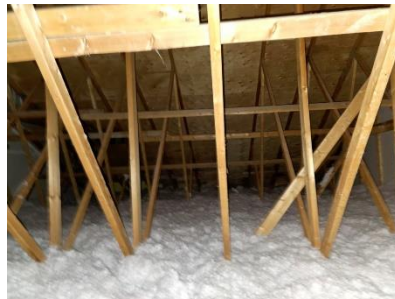
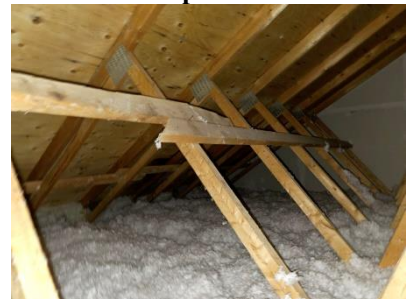
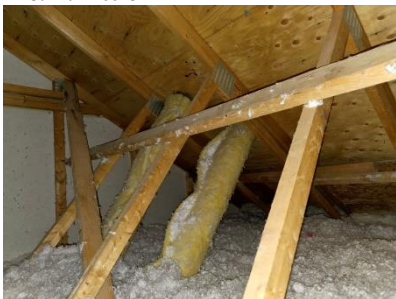
Rafters / Trusses showed no major defects or damage at the time of inspection. Roof sheathing, examined from the attic, showed no major defects or moisture damage. Insulation level is normal for the age of the home. Ventilation was normal.

Pic. 7: Attic

Pic. 8: Attic

Pic. 9: Attic

Pic. 10: Attic

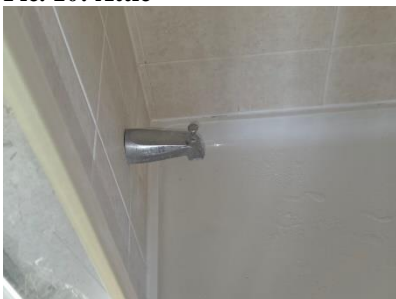
At the time of the inspection, the bathroom and its components were found to be in satisfactory condition except as noted. Shower water diverted to seized and should be repaired / replaced.

Pic. 13: Shower water diverter seized

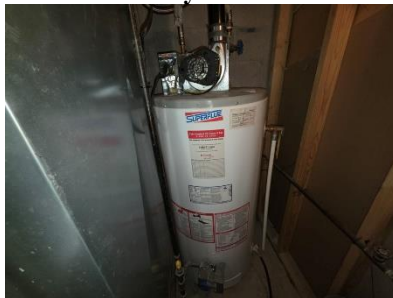
**Pic. 26: Rental hot water tank
2006**

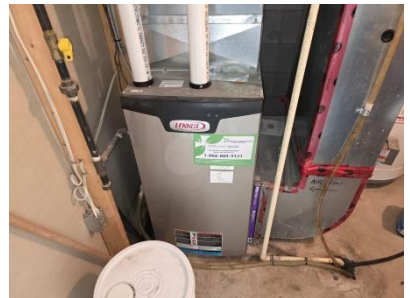
Pic. 27: Gas furnace 2015

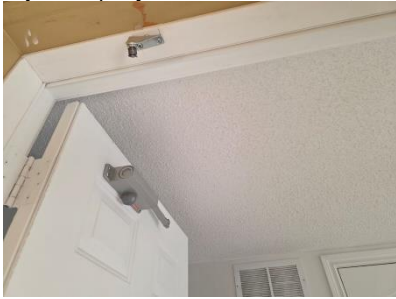
Auto closer for garage entry door damaged and not working

Doors were reviewed and found to be in working order. Lights appeared to be in normal condition: not all lights were tested. Exterior outlets tested were in normal working order. The auto closer for the garage entry door is damaged and disconnected, have reviewed and repaired or replaced accordingly.

Pic. 31: Auto closer disconnected and damaged

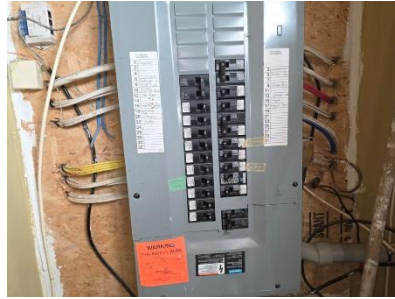
Panel size appeared to be compatible to service size. Branch breaker distribution appeared normal. No signs of overheating were evident at the time of the inspection. Outlets were randomly tested and had correct polarity, except as noted.

Pic. 32: 100 amp breaker panel
