## **PRE-LISTING HOME INSPECTION REPORT**

**18 Haven Road, Vaughan, Ontario**

**Report Number : 21010146**

**Inspection Date: 2021-02-21**

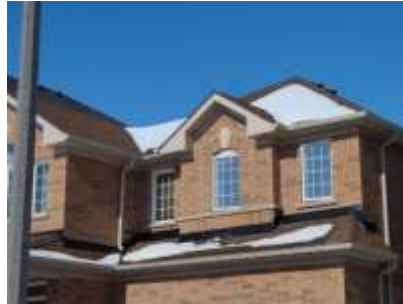
Roof covering appeared in overall satisfactory condition at the time of the inspection. Typical builder's original roof covering has a normal life expectancy of about 15 years, budget for replacement accordingly.

**Pic. 2: Original roof covering**

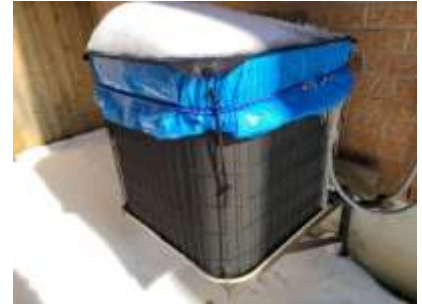
**Pic. 3: AC unit**

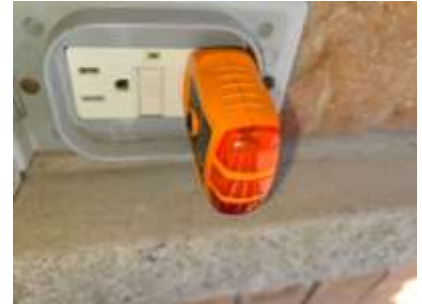
Doors were reviewed and found to be in working order. Lights appeared to be in normal condition: not all lights were tested. Front exterior GFCI outlet has no power and would not reset, have reviewed and repaired as necessary.

**Pic. 6: Front GFCI outlet no power**

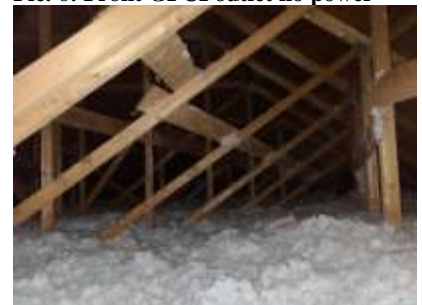
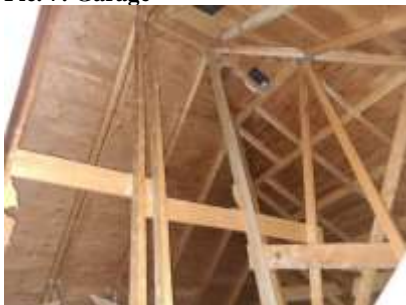
Trusses showed no major defects or damage at the time of inspection. Roof sheathing, examined from the attic, showed no major defects or moisture damage. Insulation was sufficient for homes in this area. Ventilation was normal. Vapour barrier not visible.

**Pic. 9: Attic**

**Pic. 10: Attic**

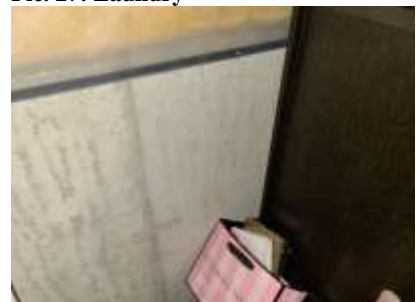
**Pic. 30: Typical foundation crack**

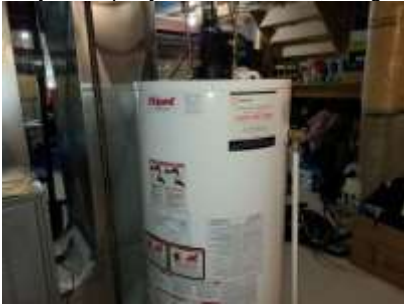
**Pic. 31: Rental hot water tank**

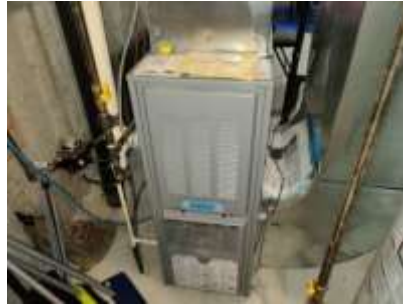
**Pic. 32: Gas furnace**

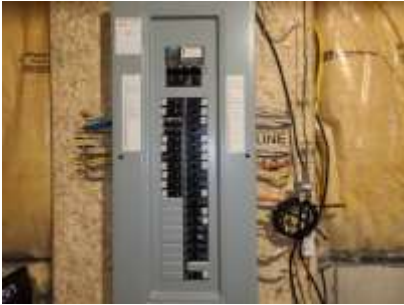
Panel size appeared to be compatible to service size. Branch breaker distribution appeared normal. No signs of overheating were evident at the time of the inspection. Outlets were randomly tested and had correct polarity, except as noted.

**Pic. 34: 200 amp breaker panel**
