HOME INSPECTION REPORT

1968 Annecca St, Innisfil, Ontario

Report Number: 24080510

Inspection Date: 2024-08-28

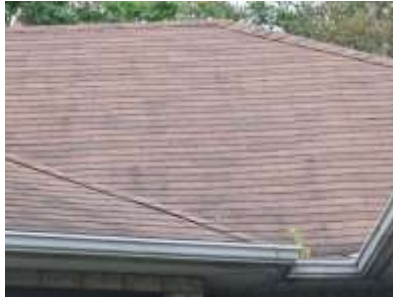
Roof covering appeared in overall satisfactory condition but is aging at the time of the inspection.

Pic. 2: Roof covering

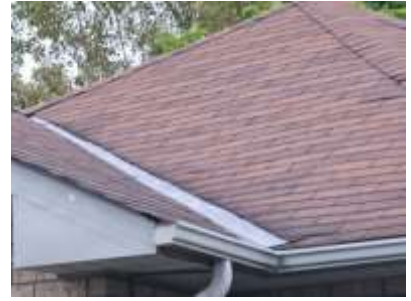
Pic. 3: Roof covering

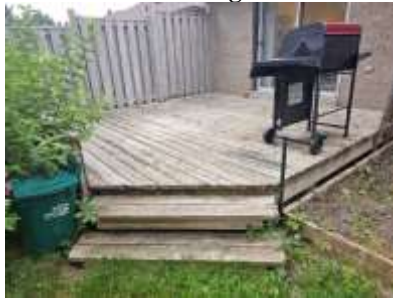
Fencing is not part of a home inspection. General site drainage was properly sloping away from the house. Maintain a positive drainage slope away from the foundation. Deck is aging with some rot, review and repair where necessary.

Pic. 5: Deck – again and needs some repairs

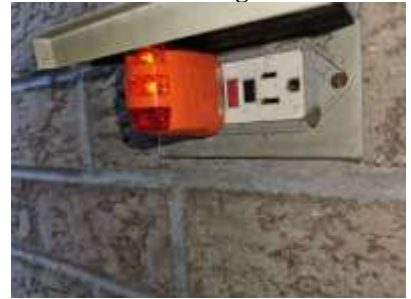
Exterior GFCI outlet defective, won't trip

Doors were reviewed and found to be in working order. Lights appeared to be in normal condition: not all lights were tested. Exterior GFCI was not operating properly - Repair and/or replace as necessary. .

Pic. 6: Rear GFCI outlet won't trip

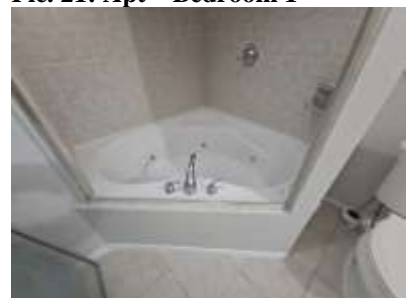
At the time of the inspection, the bathroom and its components were found to be in satisfactory condition except as noted. Whirlpool tub did not start, service if necessary.

Pic. 24: Whirl pool tub motors does not start

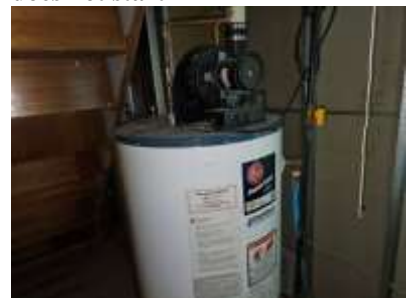
Pic. 27: Rental hot water tank 2008

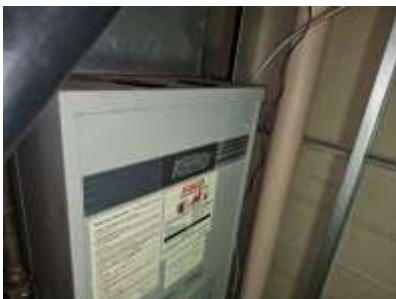
Pic. 28: Original gas furnace 1993

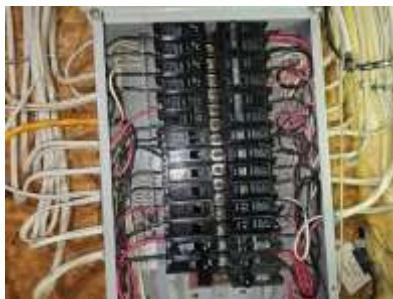
Pic. 29: 100 amp breaker panel

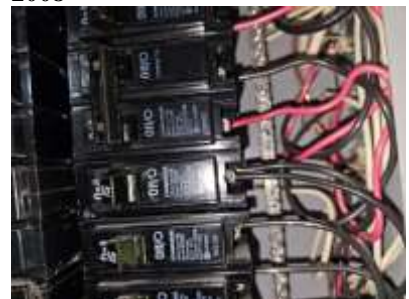
Panel size appeared to be compatible to service size. Branch breaker distribution appeared normal except for 1 breaker which is double tapped, have reviewed and corrected as necessary. No signs of overheating were evident at the time of the inspection. Outlets were randomly tested and had correct polarity, except as noted.

Pic. 30: 1 breaker double tapped
