## **PRE-LISTING HOME INSPECTION REPORT**

**30 Hillholm Blvd, Richmond Hill, Ontario**

**Report Number : 21020138**

**Inspection Date: 2021-02-11**

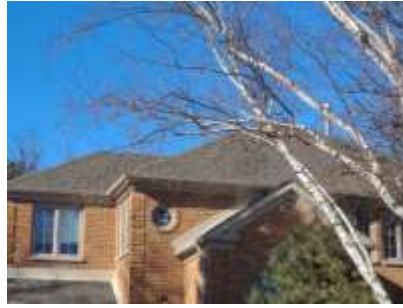
Review of the roof covering and some of its related components was limited due to snow covering. Roof covering appeared in overall satisfactory condition at the time of the inspection.

**Pic. 2: Updated roof covering**

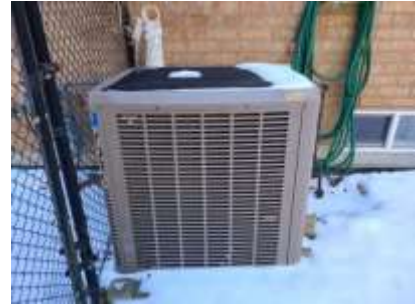
**Pic. 3: AC unit 2009**

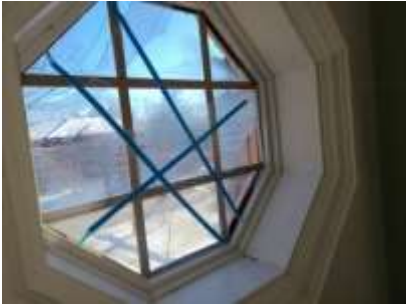
At the time of the inspection the room was found to be in overall satisfactory condition. Decorative front window has a broken glass panel, replace as necessary.

**Pic. 19: Broken window**

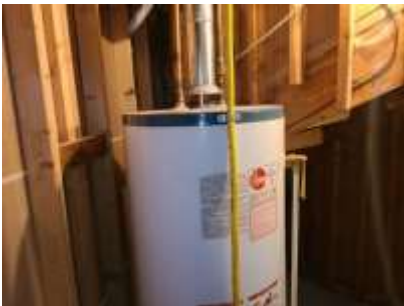
**Pic. 37: Rental hot water tank**

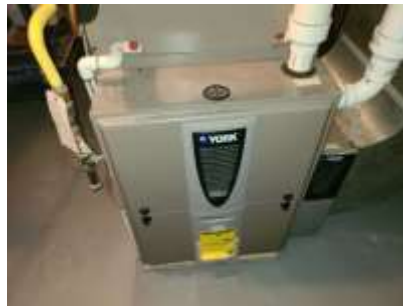
**Pic. 38: Gas furnace 2010**

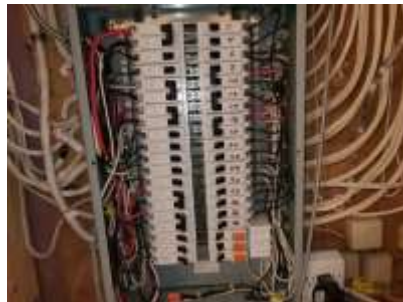
Panel size appeared to be compatible to service size. Branch breaker distribution appeared normal. No signs of overheating were evident at the time of the inspection. Outlets were randomly tested and had correct polarity, except as noted.

**Pic. 41: 200 amp main breaker panel with all copper wire**
