## **HOME INSPECTION REPORT**

**33 Prince Dr, Bradford, Ontario**

**Report Number: 24050371**

**Inspection Date: 2024-05-25**

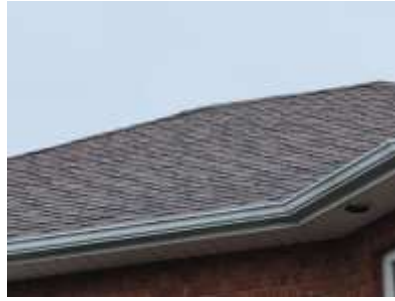
**Pic. 2: Roof covering**

Roof covering appeared in overall satisfactory condition at the time of the inspection.

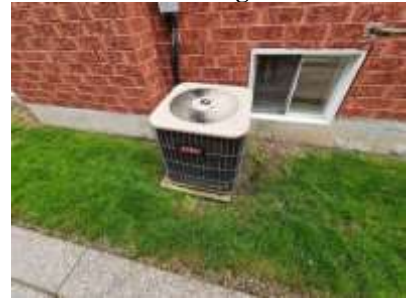
**Pic. 6: Original AC unit**

None Approximate age: 20 to 25 yrs  
**#1 Brand:** Lennox Shutoff: No  
 Condition:  Satisfactory  Marginal  Poor  Rusted/dirty Level:  Yes  No

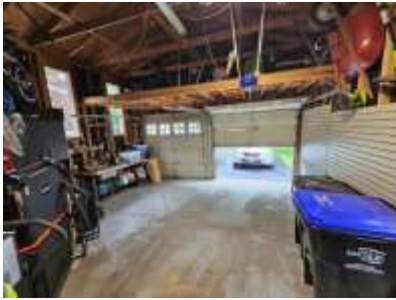
**Pic. 7: Garage**

Doors were reviewed and found to be in working order. Lights appeared to be in normal condition: not all lights were tested. Exterior outlets tested were in normal working order.

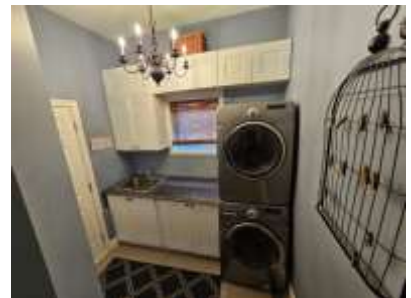
**Pic. 24: Laundry**

At the time of the inspection the laundry facilities were in satisfactory condition.

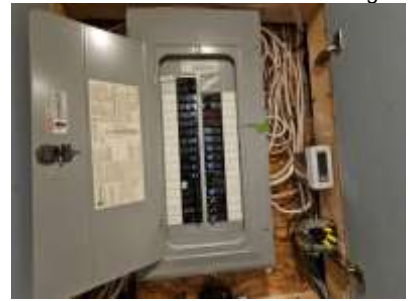
**Pic. 33: 100 amp breaker panel**

Panel size appeared to be compatible to service size. Branch breaker distribution appeared normal. No signs of overheating were evident at the time of the inspection. Outlets were randomly tested and had correct polarity, except as noted.
