## **PRE-SALE HOME INSPECTION REPORT**

**341 Lauderdale Dr, Vaughan, Ontario**

**Report Number: 24090551**

**Inspection Date: 2024-09-17**

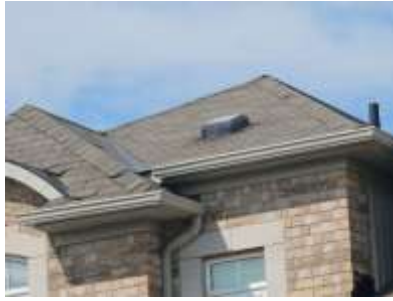
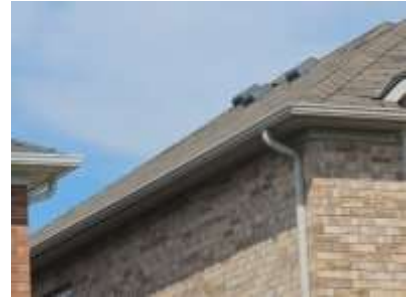
Roof covering appeared in overall satisfactory condition at the time of the inspection.

**Pic. 2: Roof covering**

**Pic. 3: Roof covering**

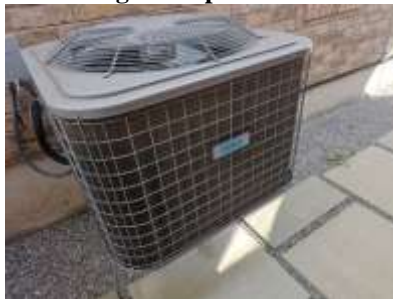
None Approximate age: 15 to 20 yrs  
 #1 Brand: Keeprite Shutoff: No  
 Condition:  Satisfactory  Marginal  Poor  Rusted/dirty Level:  Yes  No

**Pic. 8: AC unit 2008**

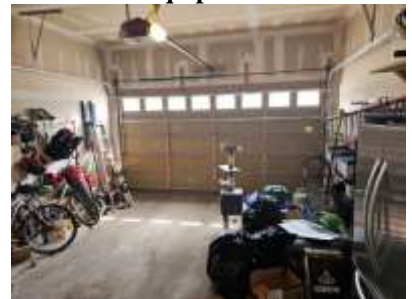
Doors were reviewed and found to be in working order. Lights appeared to be in normal condition: not all lights were tested. Exterior outlets tested were in normal working order.

**Pic. 9: Garage**

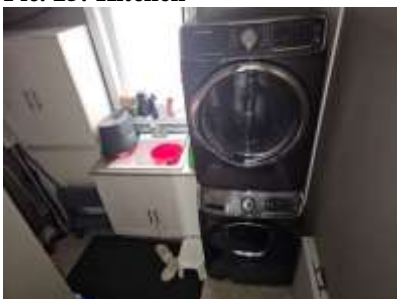
At the time of the inspection the laundry facilities were in satisfactory condition.

**Pic. 28: Laundry**

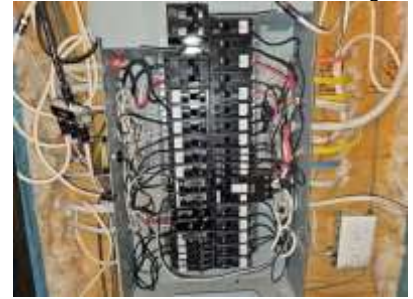
Panel size appeared to be compatible to service size. Branch breaker distribution appeared normal. No signs of overheating were evident at the time of the inspection. Outlets were randomly tested and had correct polarity, except as noted.

**Pic. 33: 100 amp breaker panel**
