HOME INSPECTION REPORT

52 Sedgeway Heights, Vaughan, Ontario

Report Number: 24050380

Inspection Date: 2024-05-31

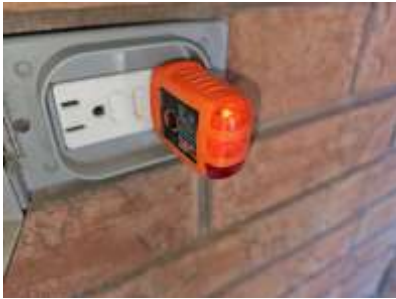
Pic. 4: Front GFCI wont trip

Exterior GFCI outlet defective, won't trip

Doors were reviewed and found to be in working order. Lights appeared to be in normal condition: not all lights were tested. Both exterior GFCI are not operating properly won't trip - Repair and/or replace as necessary.

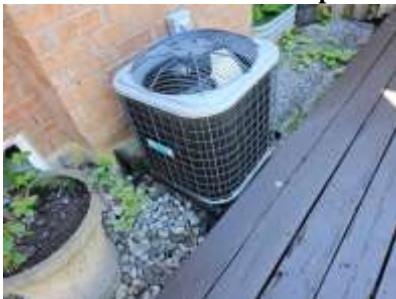
Pic. 7: AC unit

None Approximate age: 5 to 10 yrs
 #1 Brand: Keeprite Shutoff: Yes
 Condition: Satisfactory Marginal Poor Rusted/dirty Level: Yes No

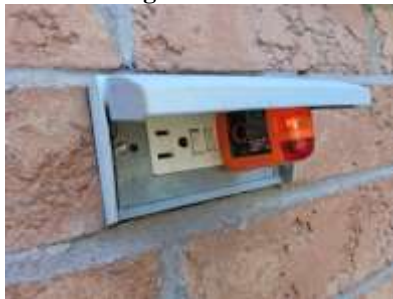
Pic. 8: Rear GFCI won't trip

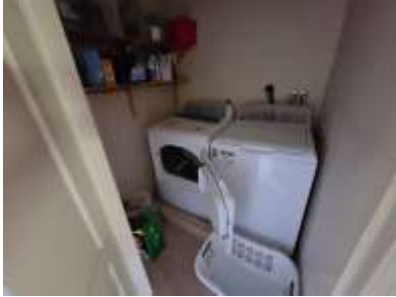
Pic. 19: Laundry

At the time of the inspection the laundry facilities were in satisfactory condition. Exhaust fan is not working have reviewed and repaired or replaced as necessary.

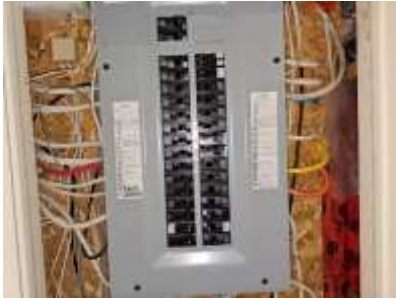
Pic. 34: 100 amp breaker panel

Panel size appeared to be compatible to service size. Branch breaker distribution appeared normal. No signs of overheating were evident at the time of the inspection. Outlets were randomly tested and had correct polarity, except as noted.
