## **PRE-LISTING HOME INSPECTION REPORT**

**60 Westbury Crt, Richmond Hill, Ontario**

**Report Number: 25010139**

**Inspection Date: 2025-01-30**

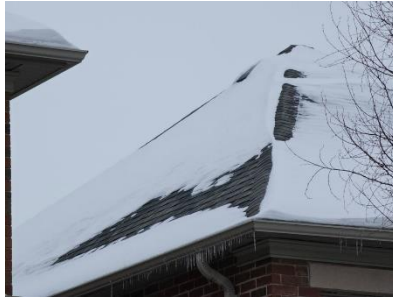
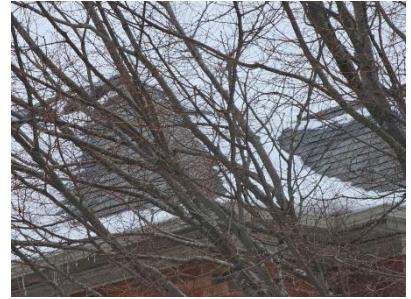
Roof covering appeared in overall satisfactory condition at the time of the inspection. Review of the roof covering and some its related components was limited by snow covering.

**Pic. 2: Visible roof covering**

**Pic. 3: Visible roof covering**

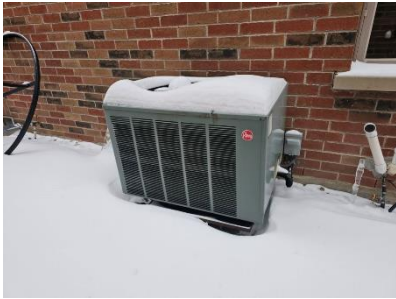
**Pic. 4: AC compressor 2009**

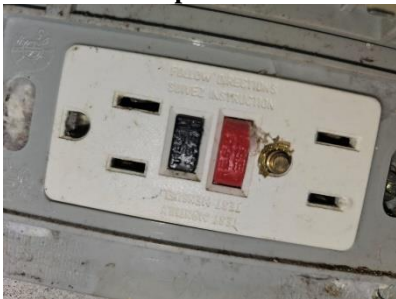
Doors were reviewed and found to be in working order. Lights appeared to be in normal condition: not all lights were tested. Exterior outlets tested were in normal working order. Rear exterior outlet has a broken ground pin inside and should be removed for safety.

**Pic. 7: Ground pin stuck inside exterior outlet needs to be removed**

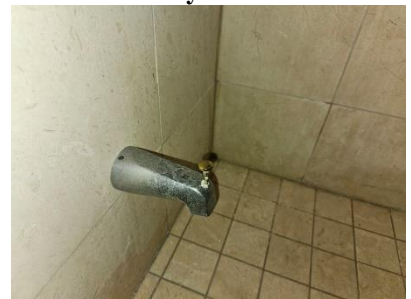
At the time of the inspection, the bathroom and its components were found to be in satisfactory condition except as noted. Shower water diverter is seized in the shower position, repair or replace as necessary.

**Pic. 15: Shower water diverter seized**

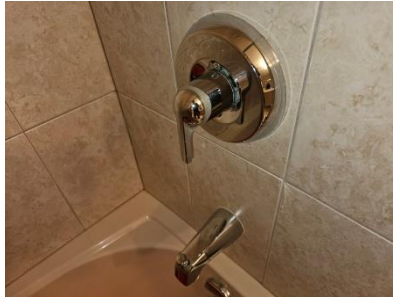
Tub could not be tested as the vendor advised the faucet leaks once turned on and is very difficult to stop the water from dripping, have the faucet reviewed and repaired or replaced accordingly.

**Pic. 20: Faucet drips of turned on – not tested**

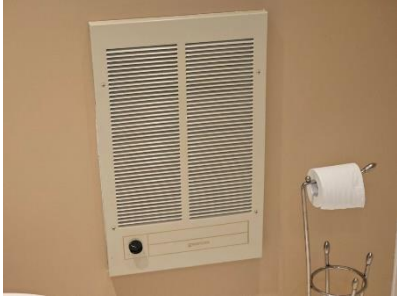
In wall heater in the bathroom does not turn on, have reviewed and repaired or replaced as necessary. Outlets within 3 feet of the sink should be considered for upgrading to GFCI protected outlets.

**Pic. 34: Waller heater could not be turned on**

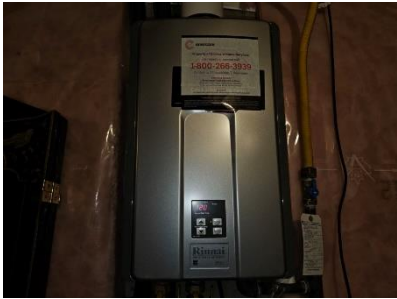
**Pic. 37: Tankless hot water boiler 2011**

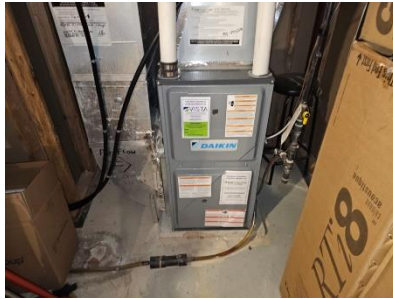
**Pic. 38: Gas furnace 2016**
