## **PRE-LISTING HOME INSPECTION REPORT**

**77 Walnut Ave, Toronto, Ontario**

**Report Number : 22050204**

**Inspection Date: 2022-05-10**

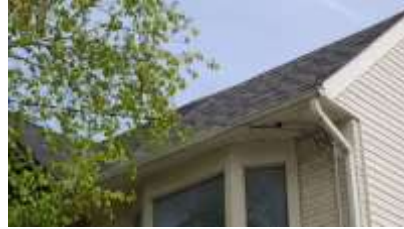
**Pic. 2: Updated roof covering**

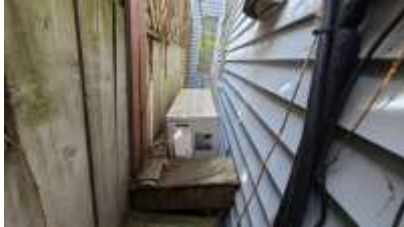
**Pic. 4: AC compress – should be levelled**

Doors were reviewed and found to be in working order. Lights appeared to be in normal condition: not all lights were tested. Exterior GFCI was not operating properly - Repair and/or replace as necessary. AC compressor should be level for proper performance. Some of the building siding is not secured along the bottom edge, have reviewed and corrected accordingly.

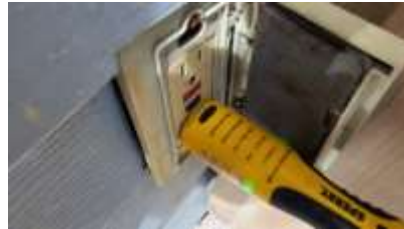
Exterior GFCI outlet defective, won't trip  
No handrailing for basement stairwell  
No Smoke detector in basement

**Pic. 8: Rear GFCI outlet wont trip and should be replaced**

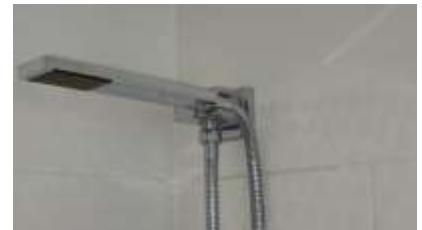
**Pic. 12: Water leak at handle pipe connection**

At the time of the inspection, the bathroom and its components were found to be in satisfactory condition except as noted. Hand shower leaks at the pipe connection have reviewed and repaired accordingly (tighten or add pumpers thread tape).

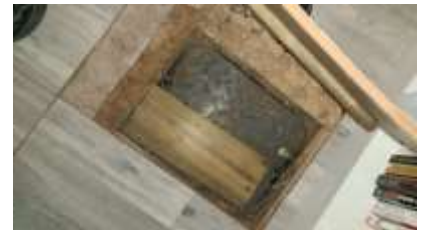
**Pic. 18: Back flow preventer**

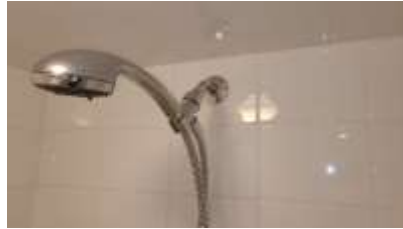
**Pic. 20: Water leak at handle pipe connection**

At the time of the inspection, the bathroom and its components were found to be in satisfactory condition except as noted. Hand shower leaks at the pipe connection have reviewed and repaired accordingly (tighten or add pumpers thread tape).

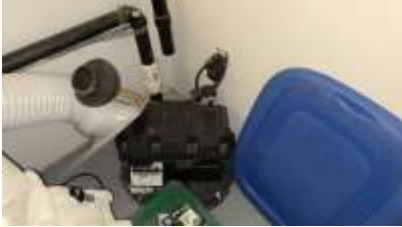
**Pic. 22: Sump pump #1**

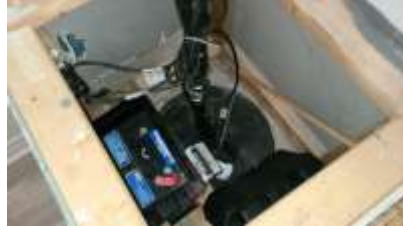
**Pic. 23: Sump pump #2**

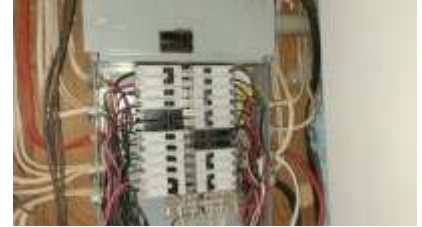
**Pic. 24: 125 amp breaker panel**

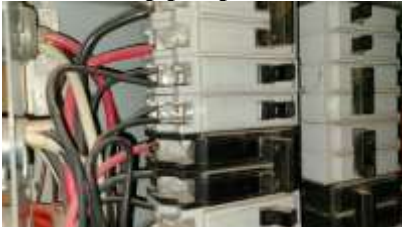
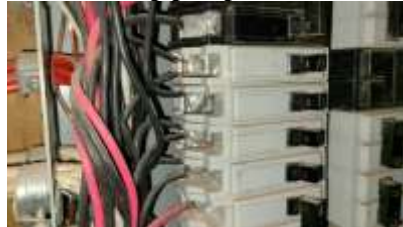
**Pic. 25: Several breakers double tapped**

**Pic. 26: Several breakers double tapped**

Panel size appeared to be compatible to service size. Several breaker are double tapped, have reviewed and corrected accordingly. No signs of overheating were evident at the time of the inspection. Outlets were randomly tested and had correct polarity, except as noted.

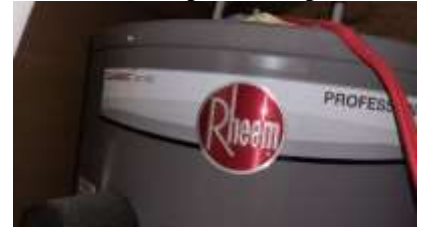
**Pic. 27: Electric hot water tank 2017**

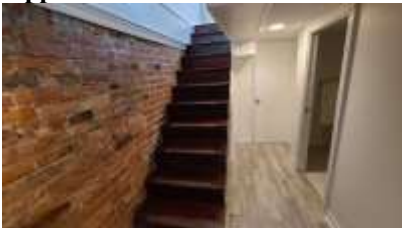
**Pic. 28: Recommend adding a handrailing for basement stairwell**

Floor appeared to be in overall satisfactory condition. Foundation appeared to be in overall satisfactory condition. Foundation walls were covered/partially covered with paneling/drywall/insulation and were not visible. No representation can be made to the conditions of the covered/partially covered walls. Thermal imaging scans of all the accessible basement exterior walls did not reveal any signs of moisture present. No active seepage visible at the time of the inspection. No representation can be made to future leaking of the basement walls. Recommend adding a handrailing to the basement for safety.
