PRE-SALE HOME INSPECTION REPORT

984 Jacarandah, Newmarket, Ontario

Report Number : 23050288

Inspection Date: 2023-05-24

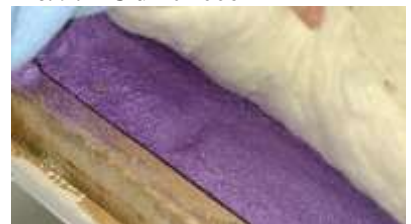
Pic. 11: Attic

Trusses showed no major defects or damage at the time of inspection. Roof sheathing, examined from the attic, showed no major defects or moisture damage. Insulation was sufficient for homes in this area. Ventilation was normal. Vapour barrier not visible. Gas fireplace could not be started, remote had dead batteries in it.
