PRE-LISTING HOME INSPECTION REPORT

2 Westolivia Trail, Vaughan, Ontario

Report Number : 21030196

Inspection Date: 2021-03-31

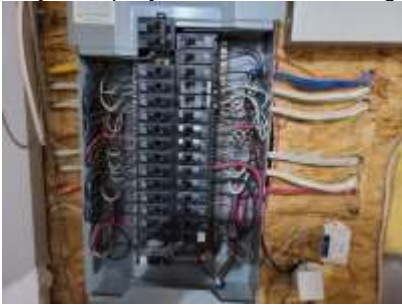
Panel size appeared to be compatible to service size. Branch breaker distribution appeared normal. No signs of overheating were evident at the time of the inspection. Outlets were randomly tested and had correct polarity, except as noted.

Pic. 31: 100 amp breaker panel
