PRE-LISTING HOME INSPECTION REPORT

38 Banshee Lane, Richmond Hill, Ontario

Report Number : 21090396

Inspection Date: 2021-09-27

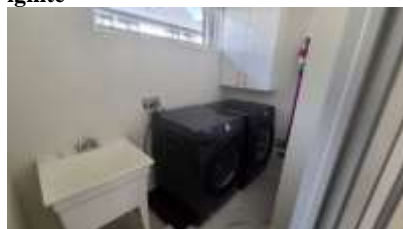
Pic. 17: Laundry

At the time of the inspection the laundry facilities were in satisfactory condition.

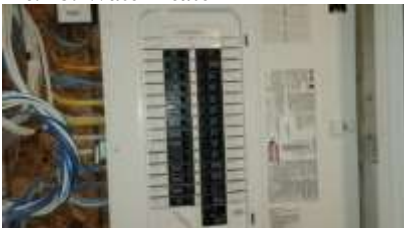
Pic. 31: 100-amp breaker panel

Panel size appeared to be compatible to service size. Branch breaker distribution appeared normal. No signs of overheating were evident at the time of the inspection. Outlets were randomly tested and had correct polarity, except as noted.
