# INSPECTION REPORT

For the Property at:  
**92 JEANNE DRIVE**  
VAUGHAN, ON L4L 1X9

Prepared for: DAVE ELFASSY  
Inspection Date: Wednesday, June 12, 2024  
Prepared by: Stefano Ramacciato

RE: Report No. 3316  
92 Jeanne Drive  
Vaughan, ON  
L4L 1X9

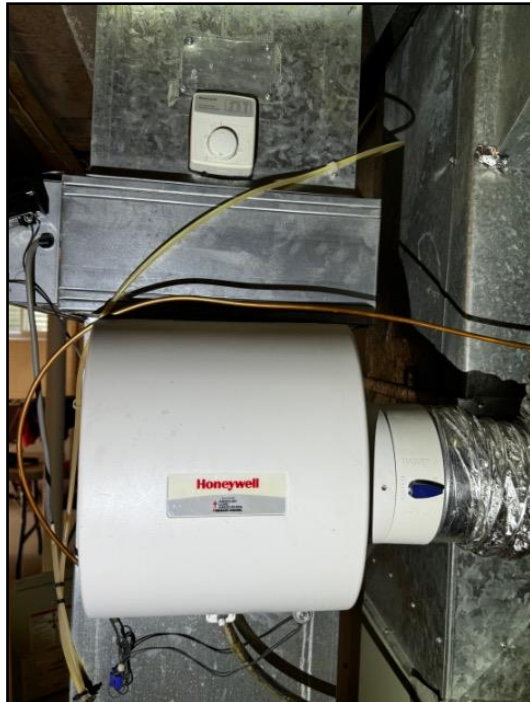
15. Trickle/cascade type

Located behind the furnace.

Replace filter every fall.

Make sure the humidistat is set about 35%

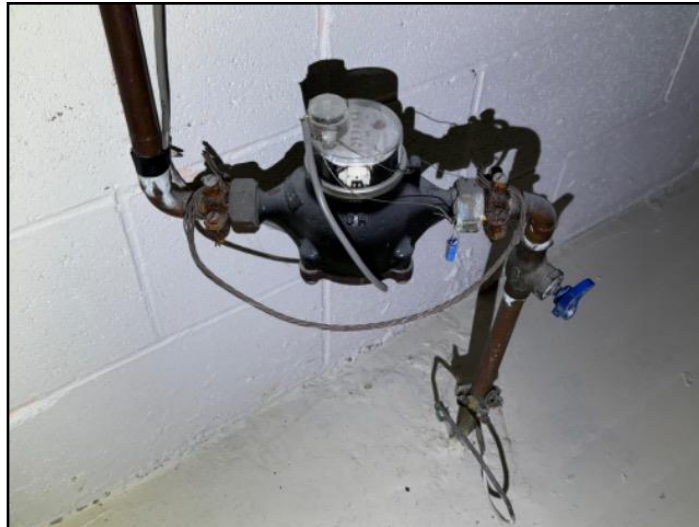
21. Meter

Located by the furnace

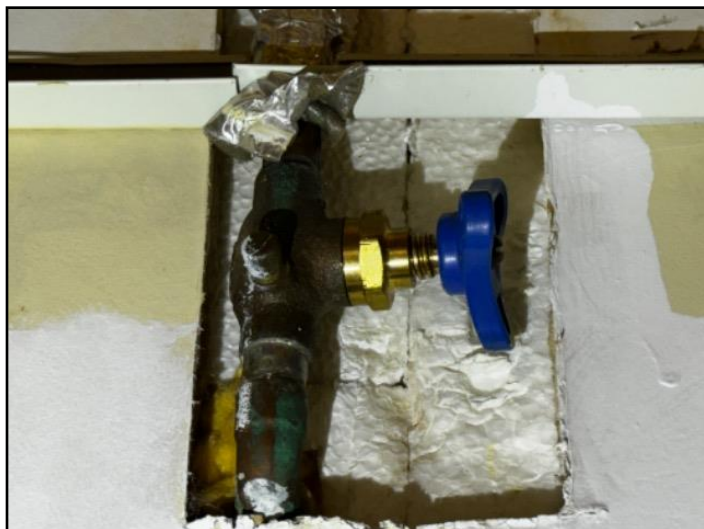
24. Hosebib shut off valve

This shutoff must be turned off and the water drained between this point and the exterior hose bib before the outside temperature drops below freezing. Damage will occur to your plumbing if this is not performed.

Turn this valve off and unscrew the small cap on the side of the shutoff. Open hose bib outside of your house or in the garage. Once all the water has been drained out of the pipe between the small cap and the hose bib, proceed to tighten the small cap. Do not reopen this shutoff until the exterior hose bib is once again needed in the spring.

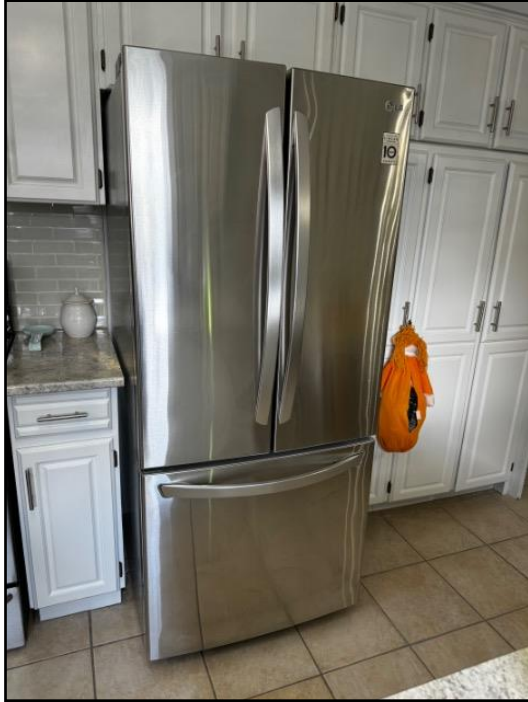
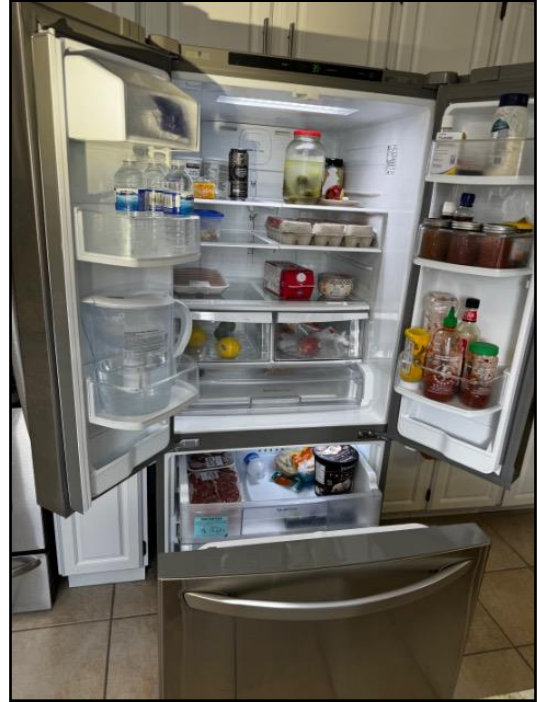
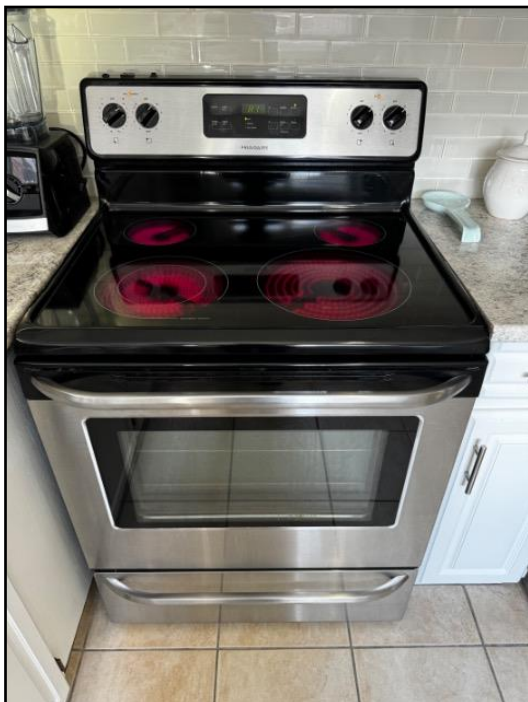
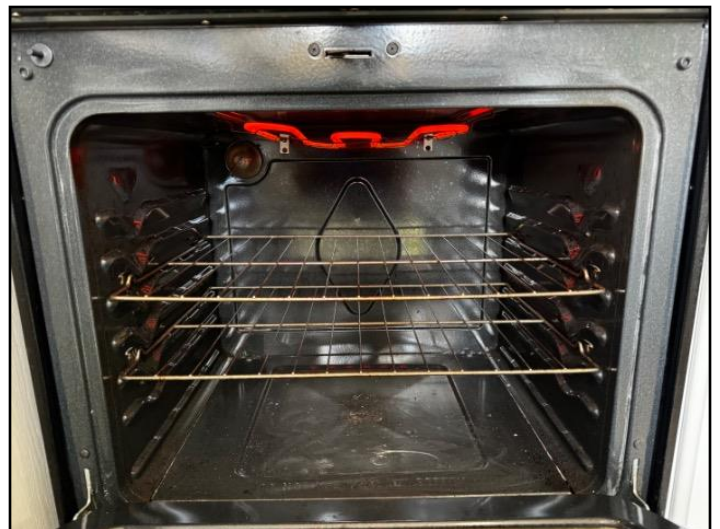
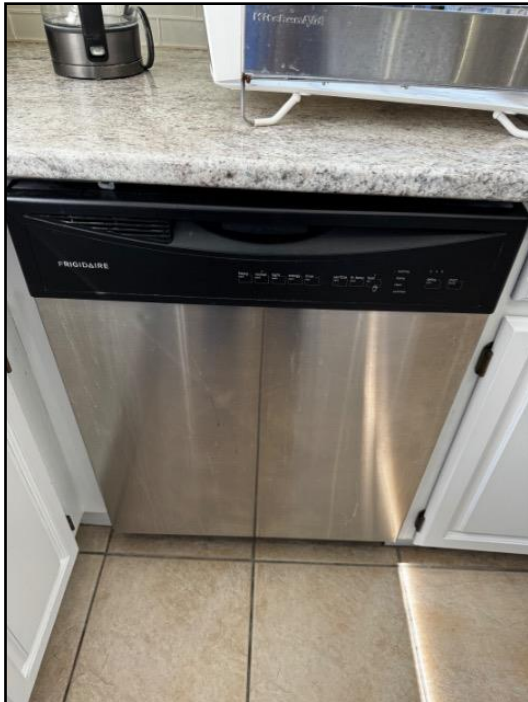
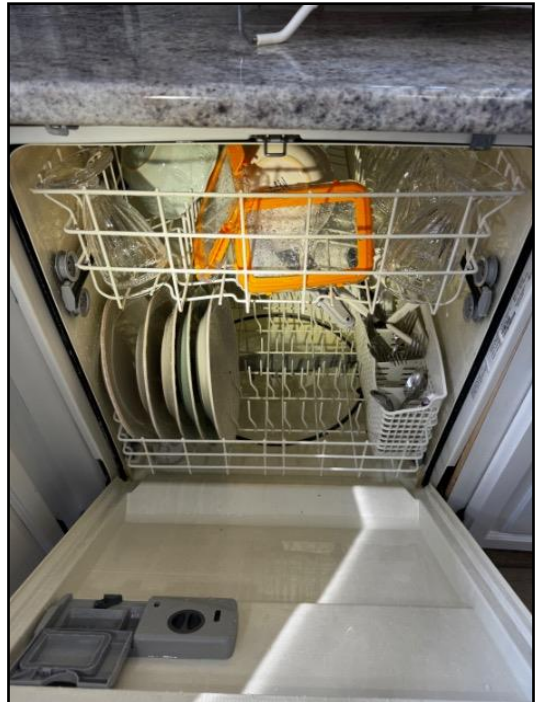
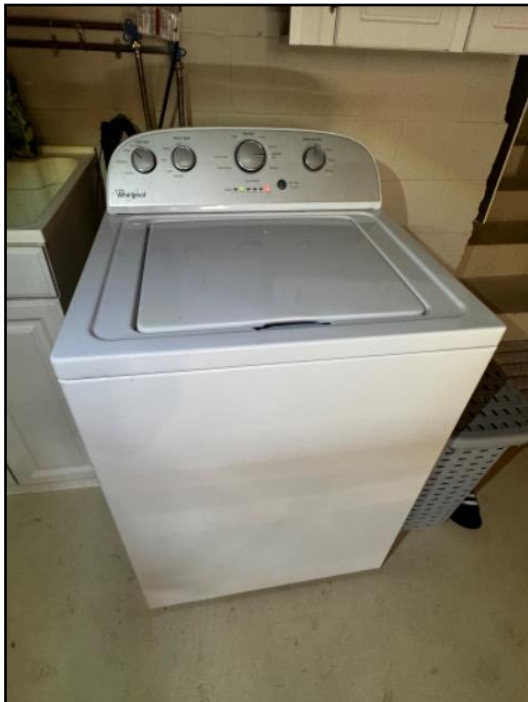
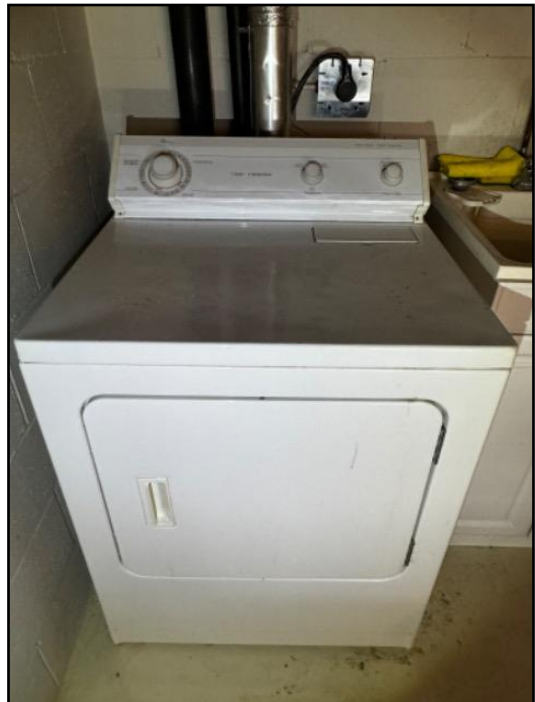
**Appliances:** • Tested all appliances, all in good working condition.  
Noticed the dishwasher is loose screw in the brackets.
